# TECHNICAL SERVICE BULLETIN

Classification: RS22-004C	Reference: ITB22-021C	Date: September 19, 2024
------------------------------	--------------------------	-----------------------------

## SEAT BELT REMINDER SERVICE INFORMATION

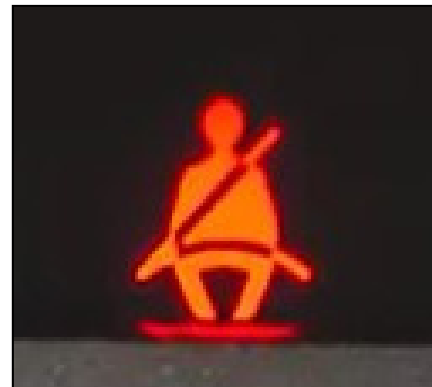
Figure 1

Seat Belt Warning Light for driver and front passenger.

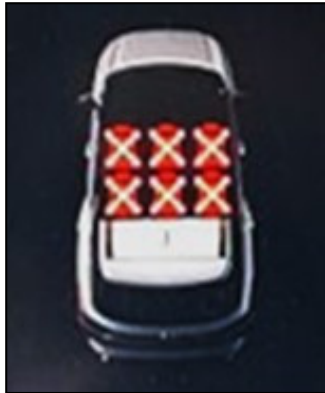
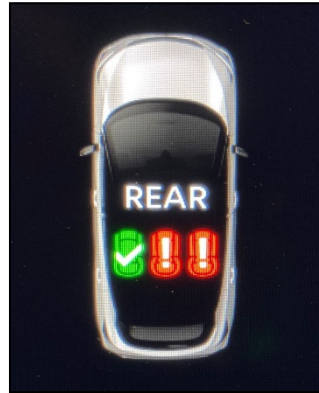
Figure 2

Seat Belt Warning for Rear (Second and Third Row only, with Second Row Bench Seat)

- Red occupant or red exclamation point displays for unbuckled status.
- Grey/green occupant or green check mark displays for buckled status.

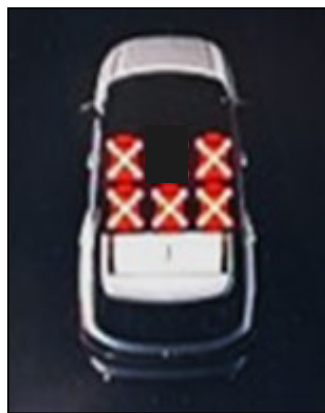
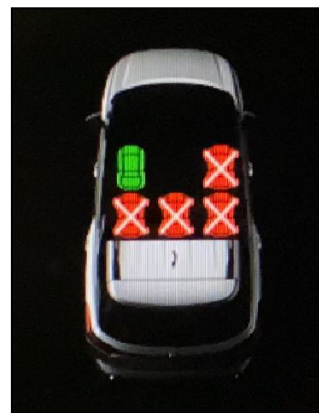
Figure 4

Seat Belt Warning for Rear (Second and Third Row only, with Second Row Bucket Seats)

- Red occupant or red exclamation point displays for unbuckled status.
- Grey/green occupant or green check mark displays for buckled status.
