# Service Bulletin

Bulletin No.: 24-NA-049

**Subject:** Information on Blazer EV Police Vehicle Air Deflector Installation

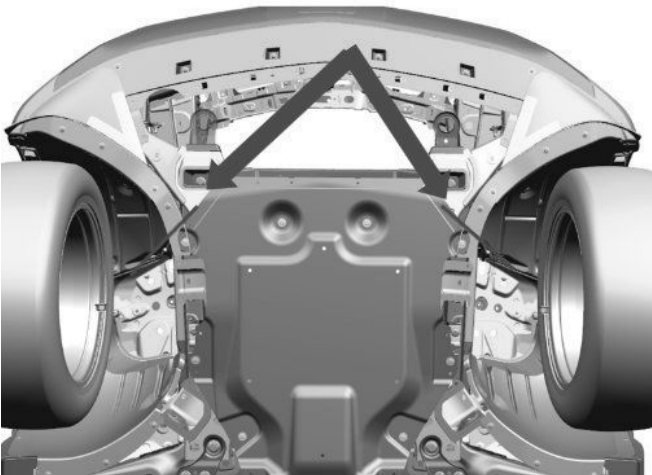
6576071

| Condition | On Blazer EV POLICE vehicles during PDI the dealer may find that the front air deflectors are too long and interfere with an underbody shield. |
| Cause | The cause of the condition may be due to the aero panel was added after the air deflectors were developed. |

| Correction | Trim the air deflectors like illustrated below. |

If you encounter a vehicle with the above concern, trim the air deflectors in the locations illustrated below.
