TECHNICAL SERVICE BULLETIN

24-2326

Moan Noise In The Rear Brakes When Vehicle Is Driven In Reverse In Cold Weather And/Or High Humidity

Ford 2021-2024 Bronco Sport 2020-2024 Escape

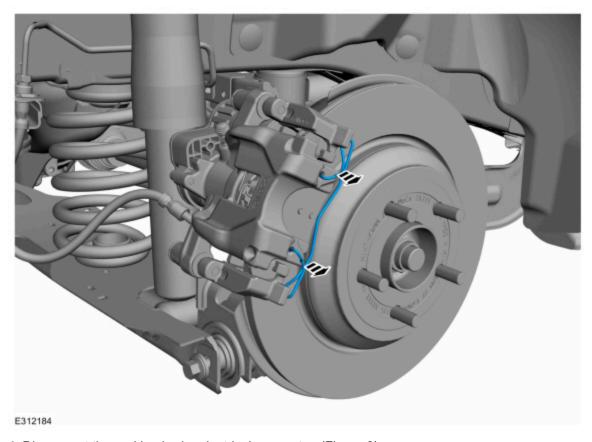
Figure 1

- 2. Remove the wheel and tire. Refer to the <u>WSM</u>, Section 204-04A Wheels and Tires > Removal and Installation.
- **3.** Remove the brake caliper spring. (Figure 1)

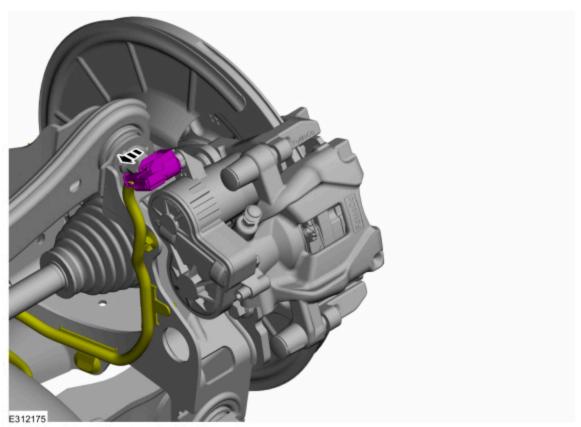
Figure 2

4. Disconnect the parking brake electrical connector. (Figure 2)

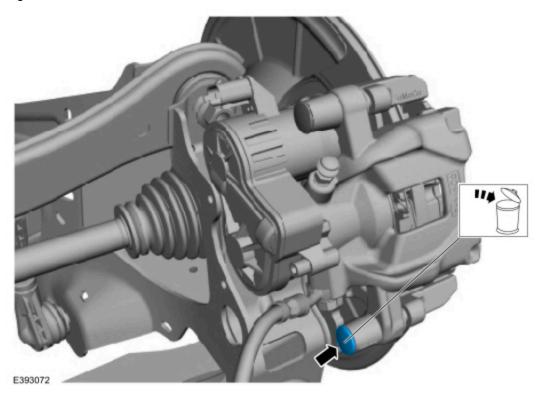
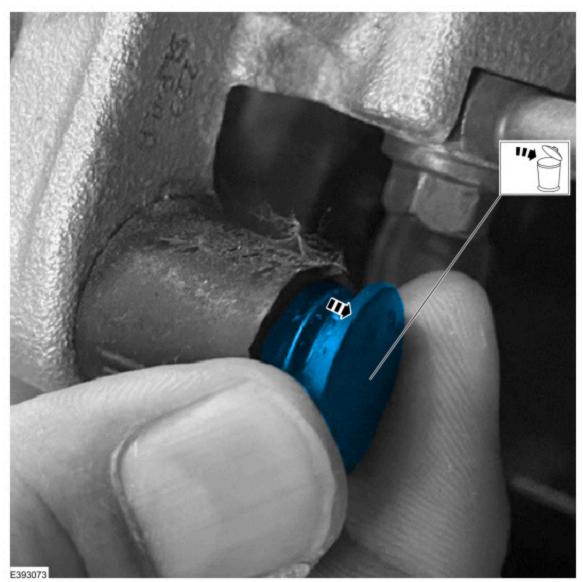
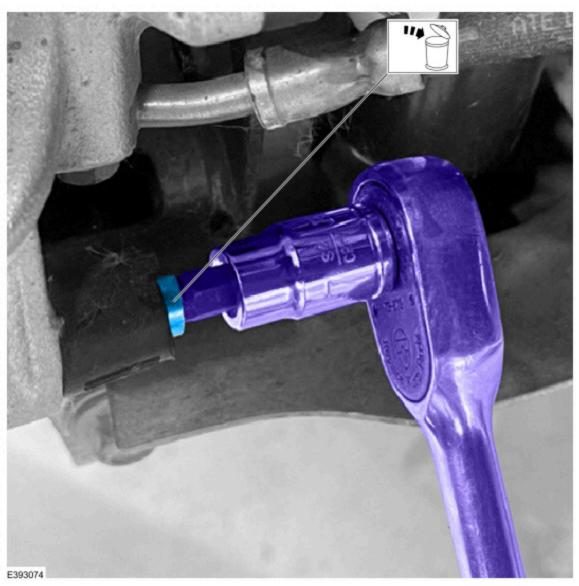
Figure 3

5. Remove and discard the brake caliper guide pin cap and guide pin on the opposite side of the bleeder. (Figures 3-5)

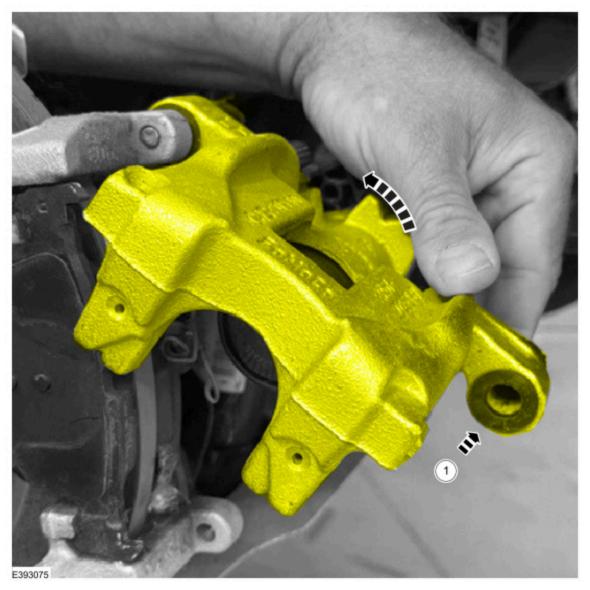
Figure 6

6. Loosen the upper guide pin and rotate the rear caliper upwards to access to the bushing housing. (Figure 6, Callout 1)

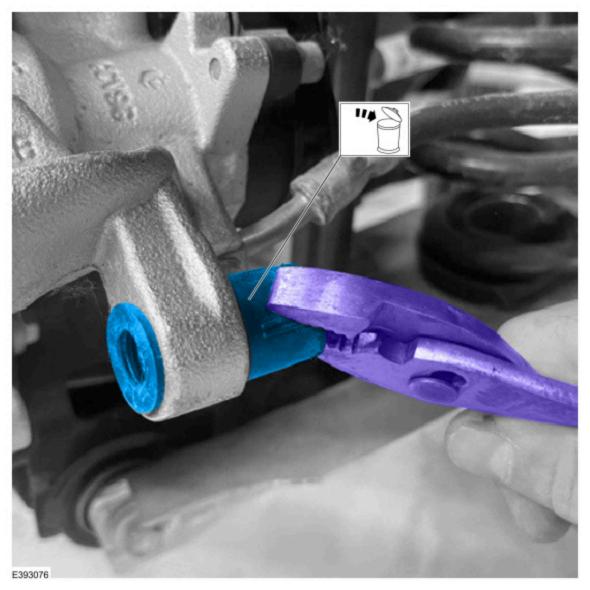
Figure 7

7. Using 6 inch slip joint pliers, remove and discard the standard bushing located on the opposite side of the bleeder. (Figure 7)

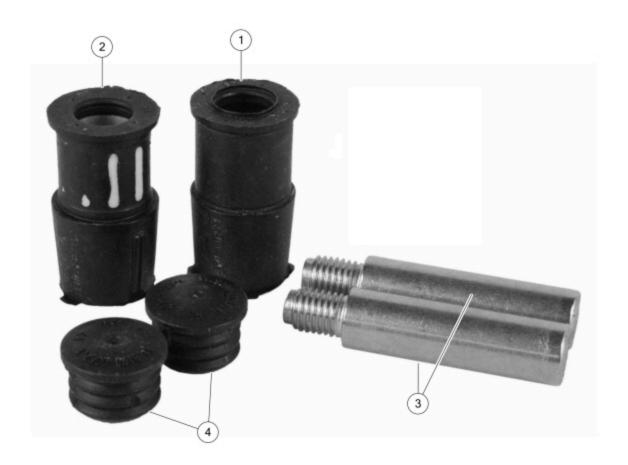
Figure 8

NOTE: The kit includes: (1) standard bushing (Figure 8, Callout 1), (1) reinforced bushing (Figure 8, Callout 2), (2) guide pins (Figure 8, Callout 3), (2) guide pin caps (Figure 8, Callout 4)

Item	Description		
1	Standard Bushing		
2	Reinforced Bushing		
3	Guide Pins		
4	Guide Pin Caps

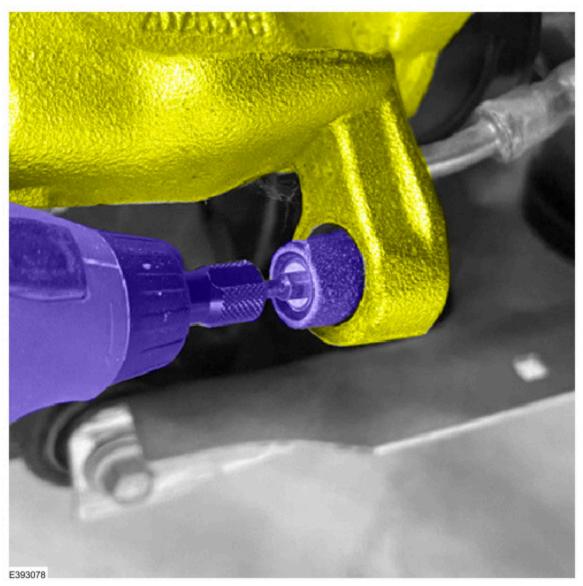
Figure 9

(1). Use a $\frac{1}{2}$ inch drum sander bit to clean the caliper bushing housing. (Figure 9)

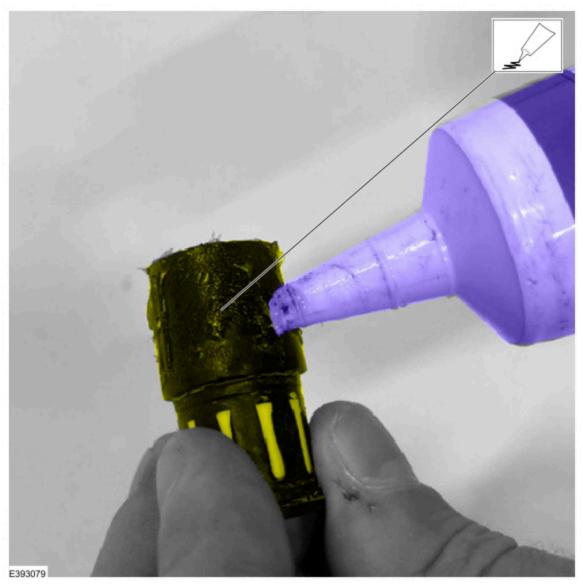
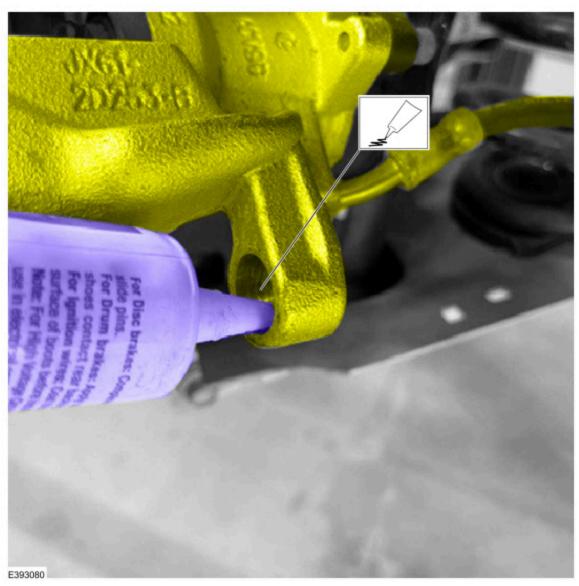
Figure 11

- (2). Use Motorcraft® Metal Brake Parts Cleaner to remove any brake dust from the bushing housing.
- (3). Lubricate the bushing and bushing housing with Motorcraft® Silicone brake caliper grease. (Figures 10-11) Figure 10

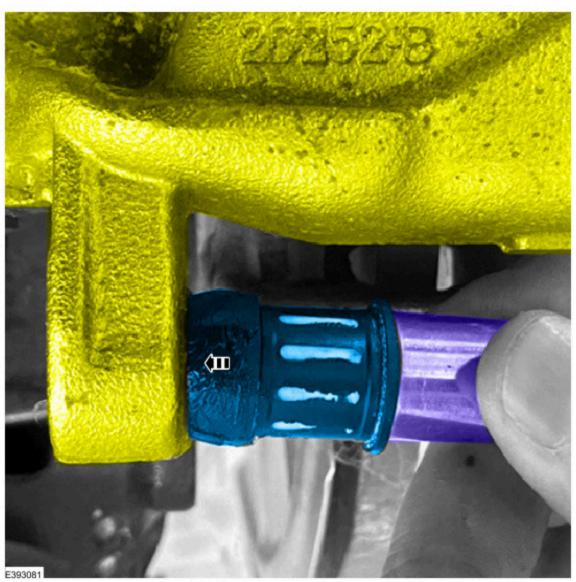
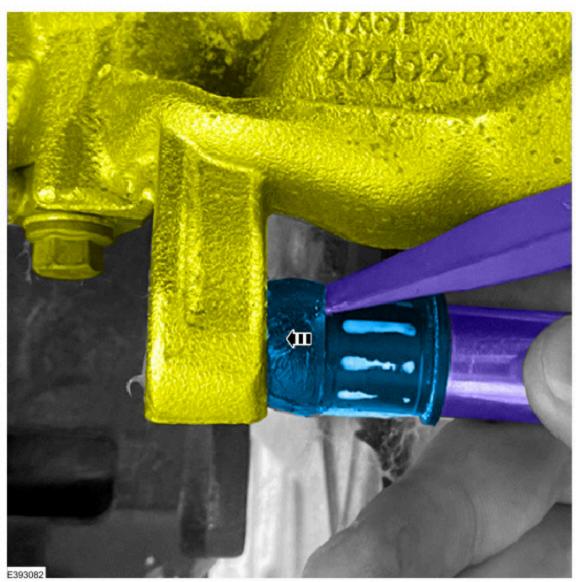
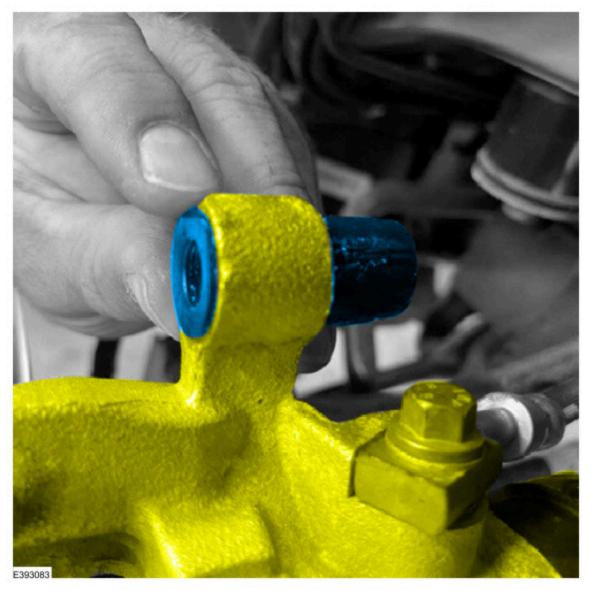
Figure 12

(4). Use an appropriate diameter socket, such as a 13 mm 3/8 drive chrome deep socket, to push the bushing into the caliper bushing housing. (Figures 12-14)

NOTE: Use a plastic trim tool to help guide the bushing into the housing.

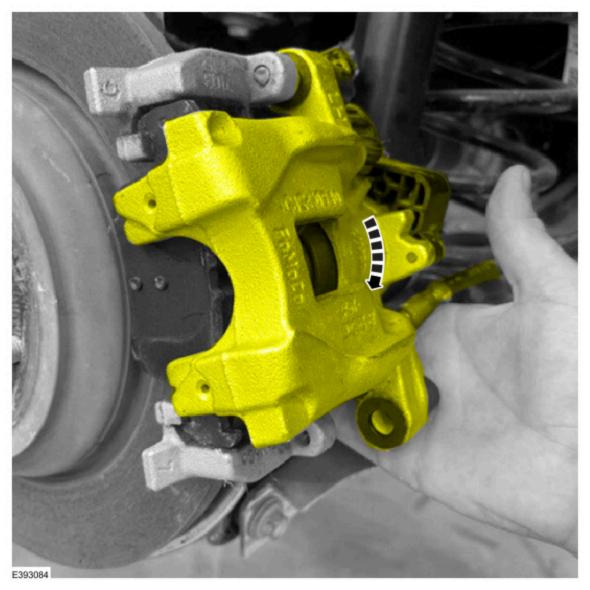
Figure 15

9. Position the rear caliper in place and reinstall the guide pin (Figure 15)

(1). Tighten the lower pin enough to rotate the caliper

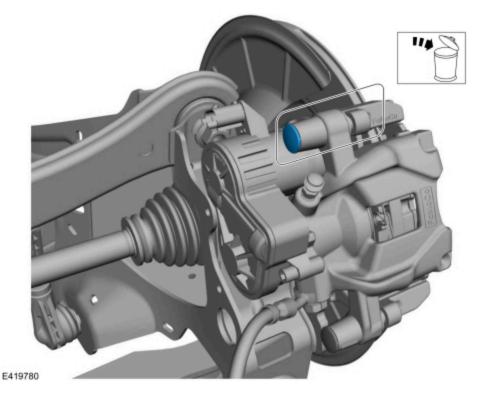
10. Remove and discard the upper brake caliper guide pin cap and guide pin beside the bleeder. (Figure 16) Figure 16

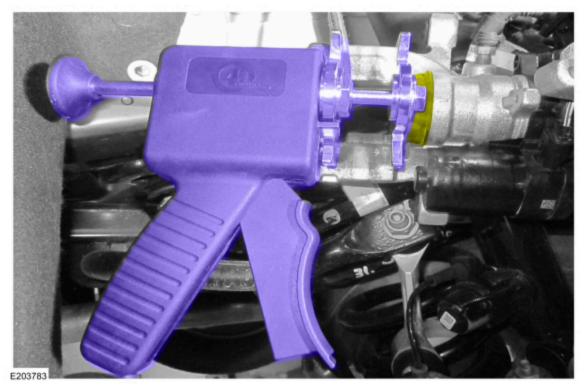
Figure 17

- **20.** Remove and discard the brake pads. Refer to the <u>WSM</u>, Section 206-04 Rear Disc Brake > Removal and Installation
- 21. Compress the brake caliper piston until the piston bottoms out in the brake caliper bore. (Figure 17)

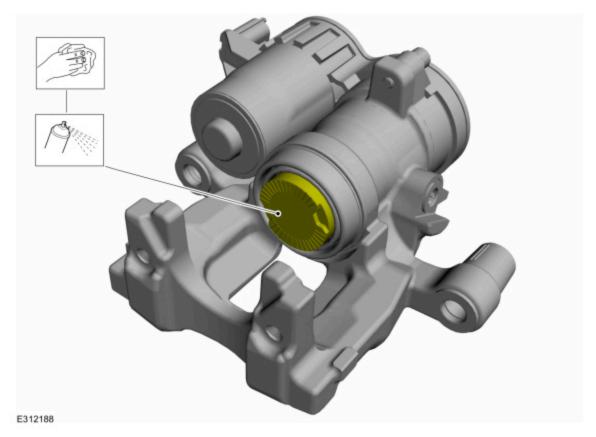
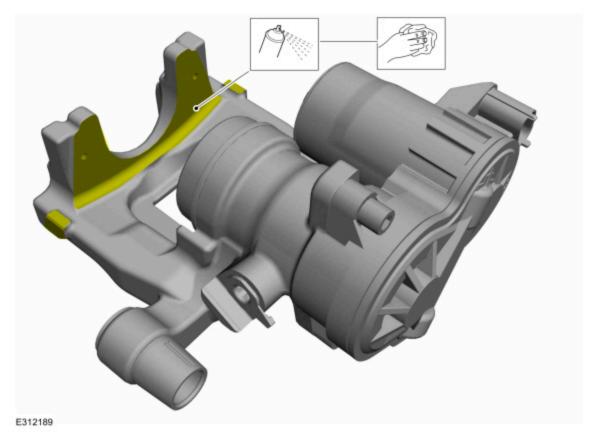
Figure 19

23. Use Motorcraft® Metal Brake Parts Cleaner and an abrasive pad (super fine grade) to clean the brake caliper. (Figure 19-20)

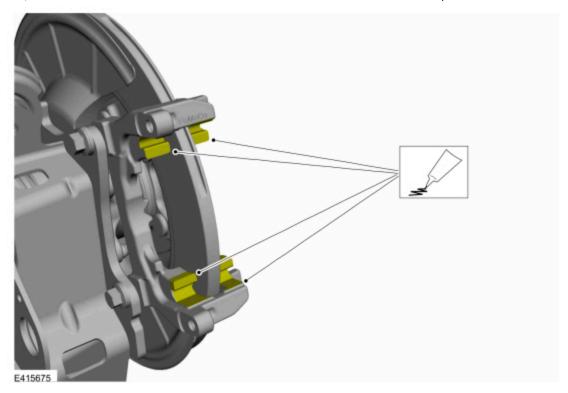
25. Apply Motorcraft® Silicone brake caliper grease to the anchor plate contact points. (Figure 21) Figure 21

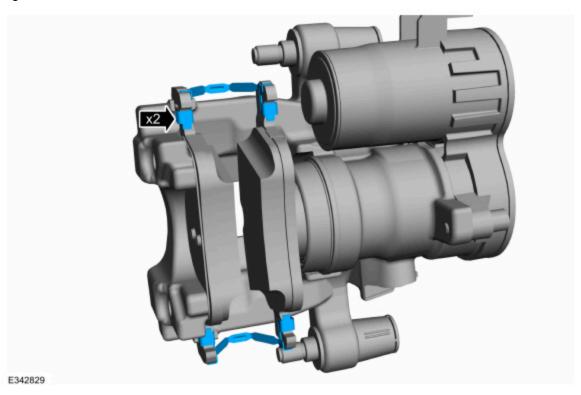
Figure 22

- 26. Install new brake pads in the caliper.
- 27. Position the brake pad clips. (Figure 22)

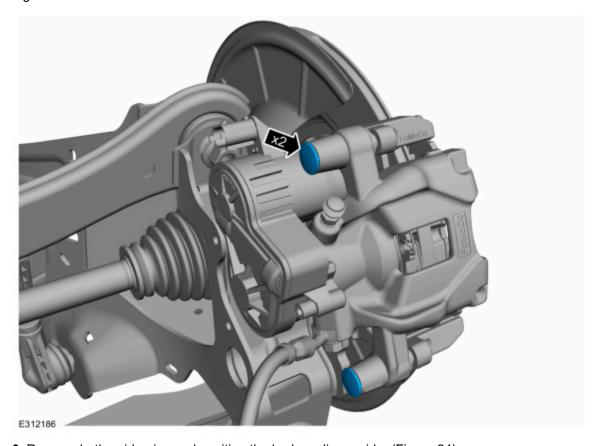
Figure 23

- Activate the brake service mode. Refer to the <u>WSM</u>, Section 206-00 Brake System > General Information > General Procedures.
- 2. Remove the wheel and tire. Refer to the WSM, Section 204-04A Wheels and Tires > Removal and Installation.
- 3. Remove the brake caliper spring.
- **4.** Disconnect the parking brake electrical connector.
- **5.** Remove both guide pin caps. (Figure 23)

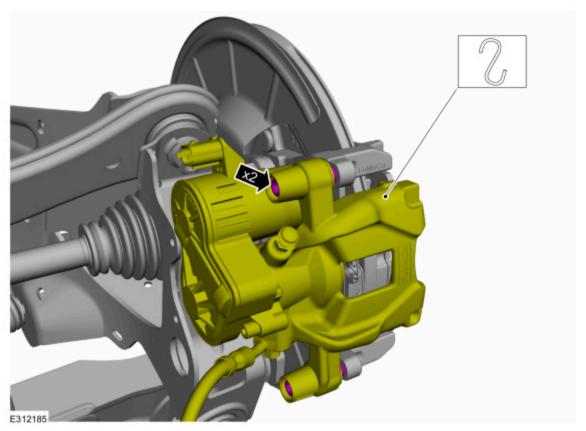
Figure 24

6. Remove both guide pins and position the brake caliper aside. (Figure 24)

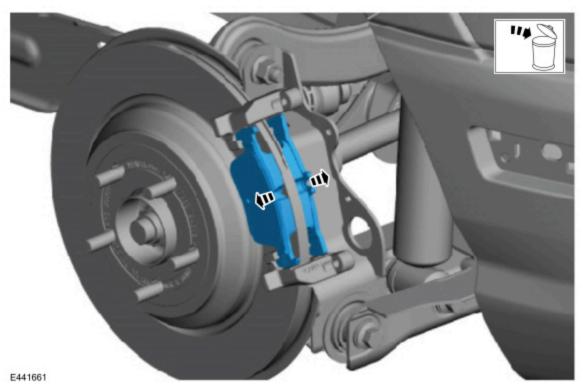
Figure 25

- **12.** Remove and discard the brake pads. (Figure 25)

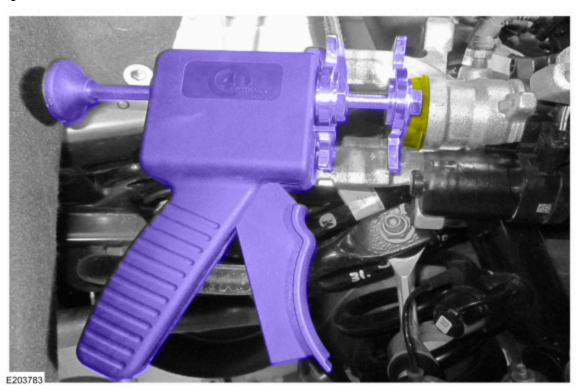
13. Compress the brake caliper piston until the piston bottoms out in the brake caliper bore. (Figure 26) Figure 26

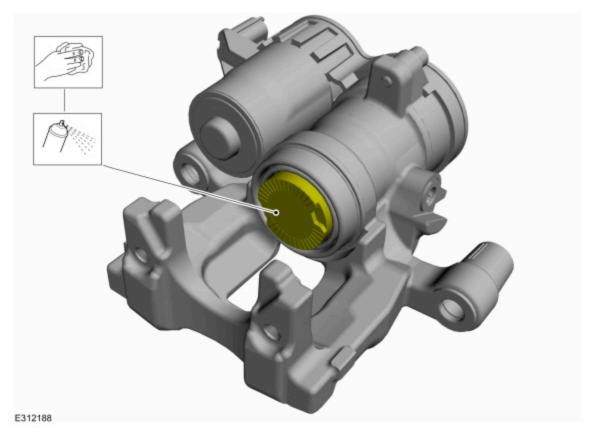
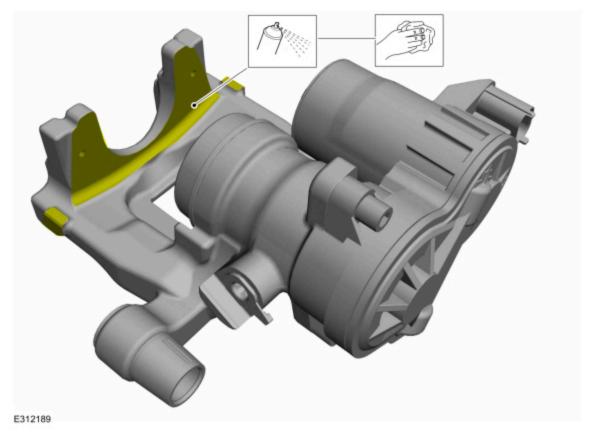
Figure 28

15. Use Motorcraft® Metal Brake Parts Cleaner and an abrasive pad (super fine grade) to clean the brake caliper. (Figure 28-29)

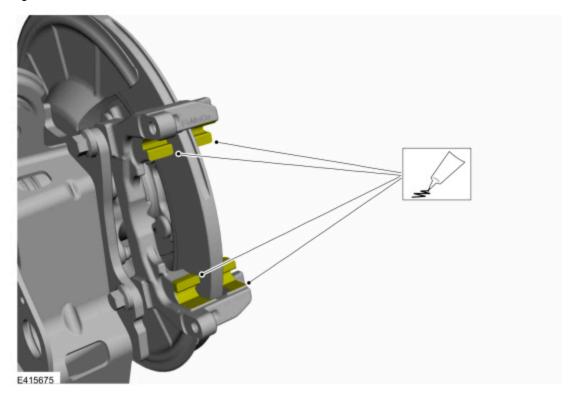
- **16.** Use compressed air to completely dry the contact areas.
- **17.** Apply Motorcraft® Silicone brake caliper grease to the anchor plate contact points (Figure 30) Figure 30

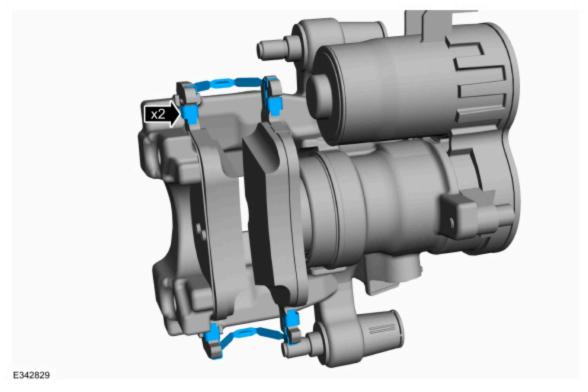
Figure 31

- 18. Install new brake pads in the caliper.
- 19. Position the brake pad clips. (Figure 31)
