Continental Tire Safety Recall

Code: 44CT

Continental Tire Safety Recall Information

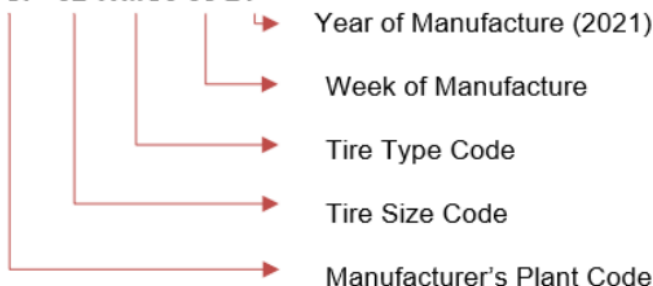
The Continental 255/35 R19 96H ProContact GX AO is identified as follows:

Product Line: ProContact GX AO

DOT TIN: CP32WMC9

Article No. 15573690000

CP 32 WMC9 38 21

- The DOT week number is read as follows:
 - First two numbers are the build week.
 - Second two numbers are the build year.
- The example shown has a build date of the 38th week of 2021.
- **NOTE:** A DOT date of 0324 has a build date of the 3rd week of 2024, and DOES fall in the affected date range (1921 – 3224).

Example of DOT Serial Number Identification:

The Continental 255/35 R19 96H ProContact GX AO is identified as follows:

Product Line: ProContact GX AO

DOT TIN: CP32WMC9

Article No. 15573690000

CP 32 WMC9 38 21
