**Volvo Car USA LLC**
**Technical Journal**

Technical Journal Title ICUP "Searching for GPS" message in DIM / CSD		Ref. No. TJ 36691.5.1	
Issuer (Dept.) Technical Service		Issue Date 8/27/24	Status Date 9/19/24
Car Market United States and Canada	Partner 3 US 7510 Volvo Car USA	Function Group 3900	
Function Description Media, navigation and communication		Page Page 1 of 4

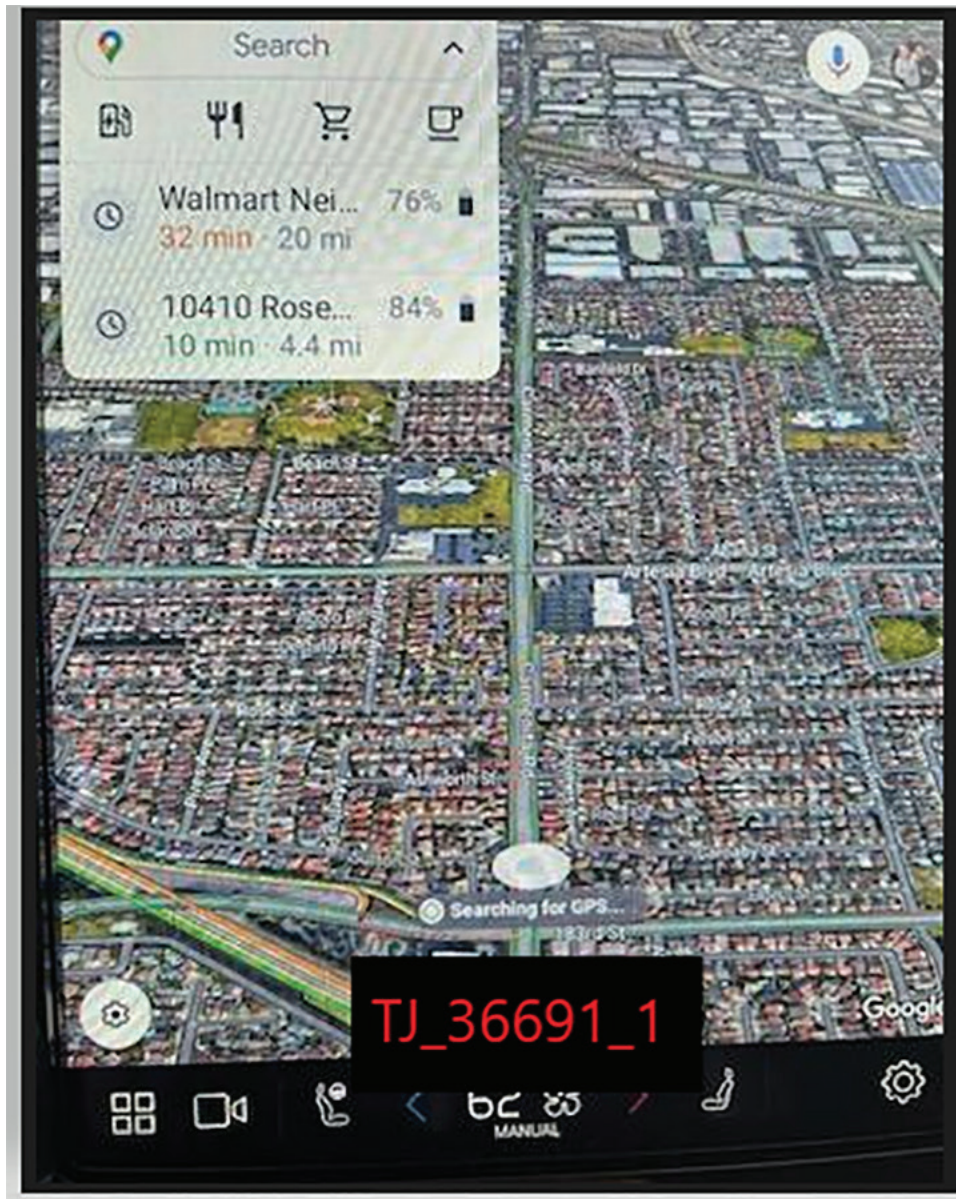
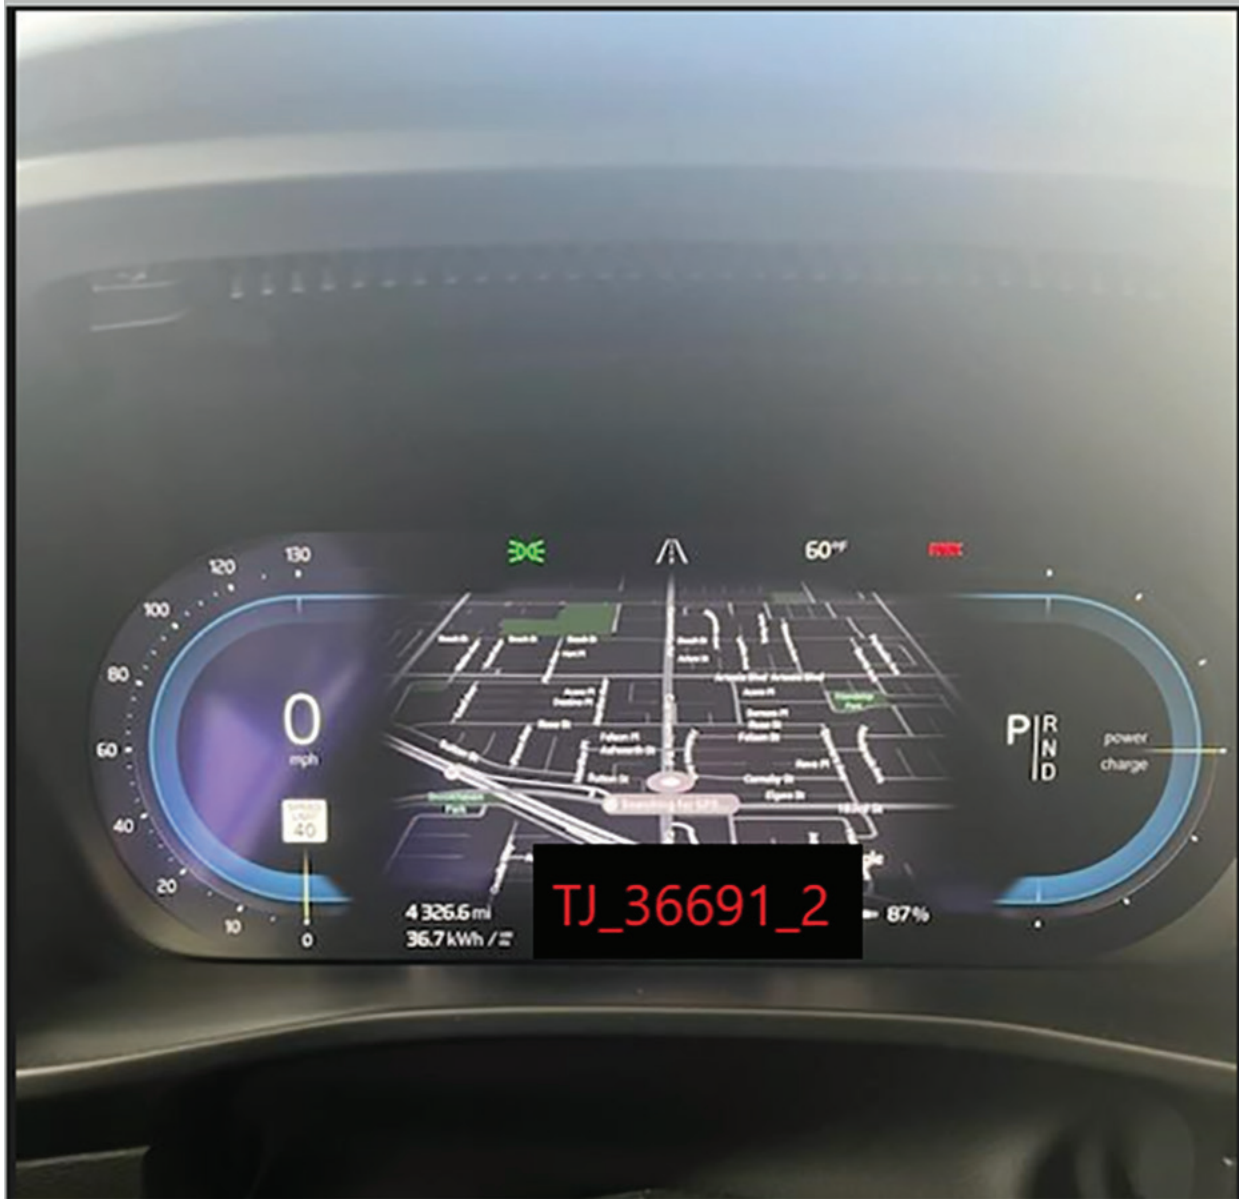
File Name	File Size
TJ_36691_1.PNG	0.4320 MB
TJ_36691_2.PNG	0.2862 MB

If the customer experiences a "Searching for GPS" message in the CSD and DIM during startup, while LTE connection is fully established (see attachment TJ\_36691\_1/2), then follow advice under "Service".

Do not replace any components for this issue.

\*An Improved IHU software (v2.13 SW) was introduced week 48 in 2023, which resolved this issue.
