Quality Inspection Request
SWITCH - HEADLAMP
Suspect Part Identification

03-Oct-2024

Part numbers : 68156066AC, 68156065AC, 68292842AC, 68292845AC, 68373903AB, 68146602AB, 68156061AD and 68401933AB

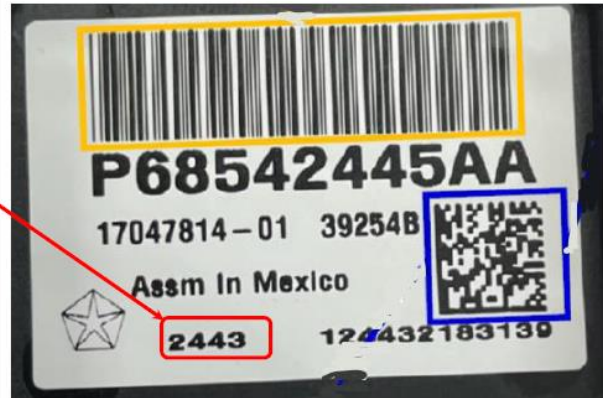
Julian date code location:

Julian date code shown

2443: DDDY

244th Day of 2023

1st September 2023

Part in picture shown is suspect.

Part in picture below is **suspect**

Suspect parts: Parts built before Julian date code **0094 (9th January 2024)** are suspect parts.

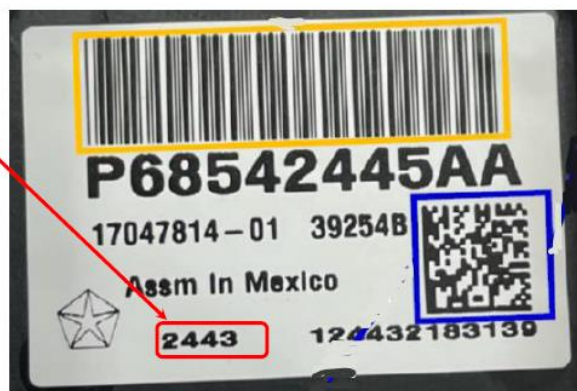
Emplacement du code de date Julien:

Code de date Julien affiché

2443 : JJJA

244e Jour de 2023

1er septembre 2023

La partie de l'image montrée est suspecte.

La partie de l'image ci-dessous est **suspecte**

Pièces suspectes: Les pièces construites avant le code de date julien **0094 (9 Janvier 2024)** sont des pièces suspectes.

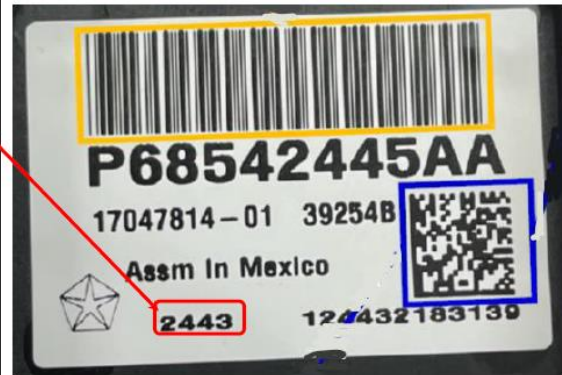
Ubicación del código de fecha juliana:

Se muestra el código de fecha juliano

2443 : DDDA

244e Jour de 2023

1 de septiembre de 2023

Parte de la imagen del paquete que se muestra es sospechosa.

Parte en el paquete se muestra a continuación es **sospechoso**

Piezas sospechosas: Las piezas fabricadas antes del código de fecha juliana **0094 (9 de enero de 2023)** son piezas sospechosas.
