Technical Journal Title Long Range PHEV ERAD Knocking Noise Repair Kit		Ref. No. TJ 36894.5.0	
Issuer (Dept.) Technical Service		Issue Date 10/8/24	Status Date 10/16/24
Car Market United States and Canada	Partner 3 US 7510 Volvo Car USA	Function Group 4632	
Function Description Electrical rear axis drive		Page Page 1 of 13

TJ Instruction VCC-528981-1

Title	ERAD bearing	Page	1 (10)
Action	Product fix	Operation number:	98298-2 97733-3

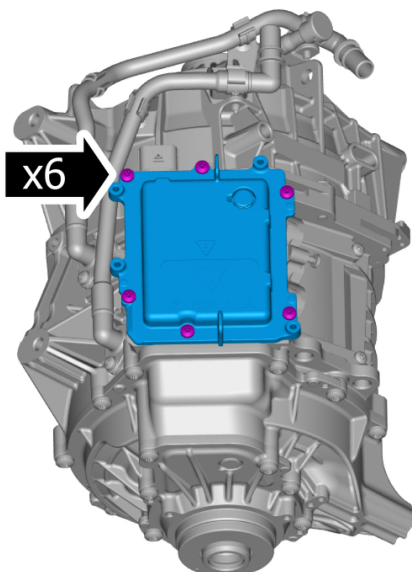
Remove the screws.

Remove the marked part.

High voltage wiring harness lid, ERAD ,
9 Nm

The top rectangular cover is removed first. A gasket for this cover is included in the kit, but it only needs to be replaced if the original one is damaged. Underneath this cover is a wire clip (also included in the kit) and two connectors that need to be disconnected.

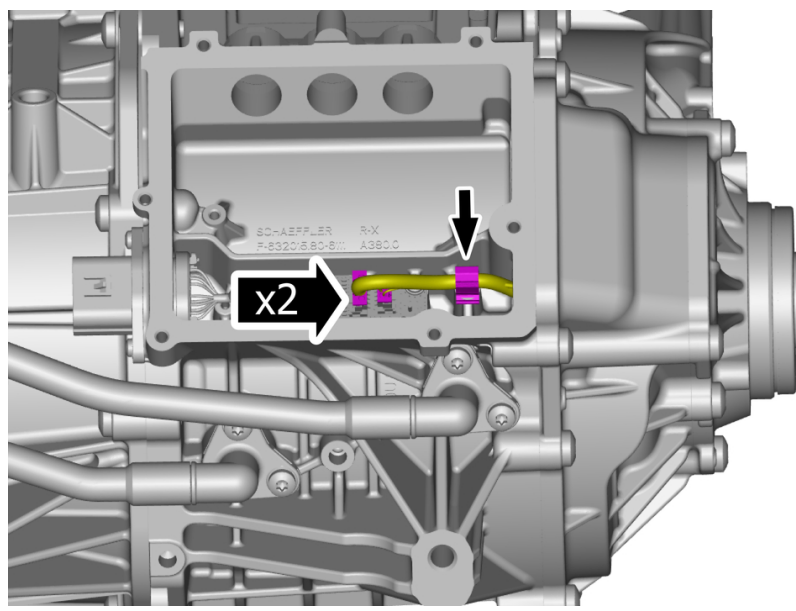
Disconnect the connectors.
Loosen the fastener.

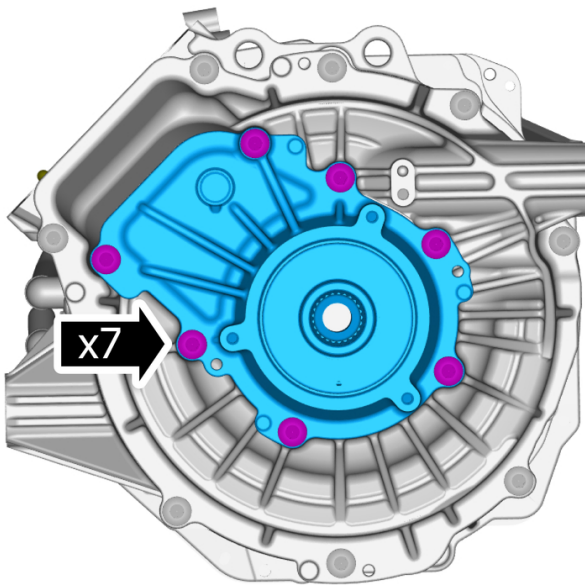
Caution! Take extra care when handling the components.

Remove the screws.
Remove the marked parts.

Inner shaft lid screw, ERAD , 23 Nm

Next, remove the smaller side cover, a gasket is included for this cover as well. Again, it is only necessary to replace if the original gasket is damaged.

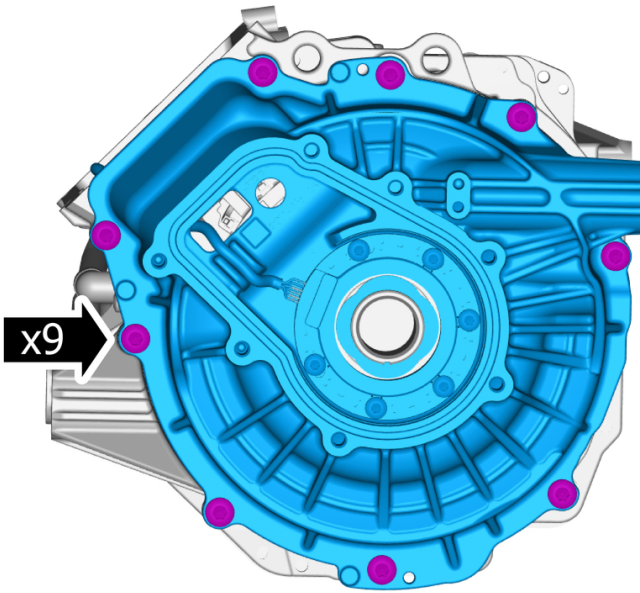
Caution! Take extra care when handling the component.

Remove the screws.
Remove the marked part.

Electric motor cover screw, ERAD , 23 Nm

Next, remove the larger side cover which the previous piece was bolted to. A gasket is included for this cover as well. Again, it is only necessary to replace if the original gasket is damaged.

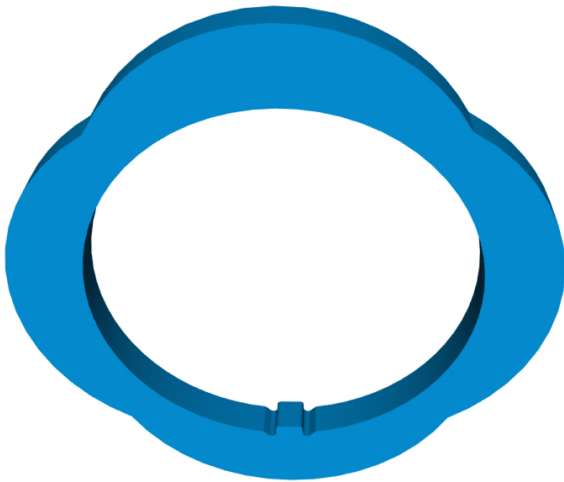
Caution! If the component is loose, a new component must be installed.

The following steps apply if damages are discovered

Note: This section is only followed if the bearing remains in the side cover and/or the 4 lobed clover resolver wheel was removed from the shaft or appears to be loose.

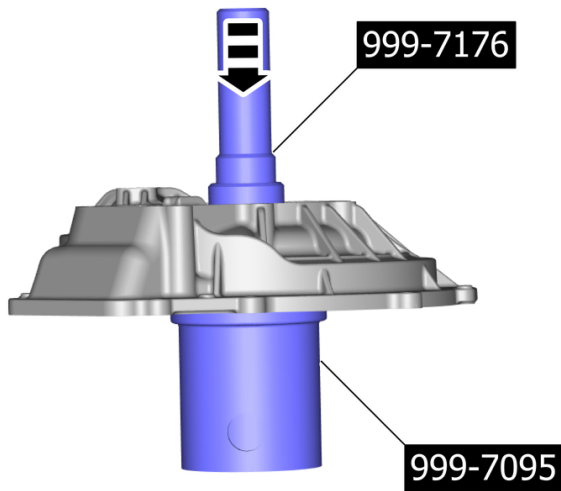
Install the Special tool.

Special Tool: T9997095, Socket

Special Tool: T9997176, Drift

Use: Hydraulic press

To remove the bearing from the side case, place the side casing in a hydraulic press. Support the bottom of the side case using special tool 999 7095. Press the bearing out of the cover using tool 999 7176 or equivalent.

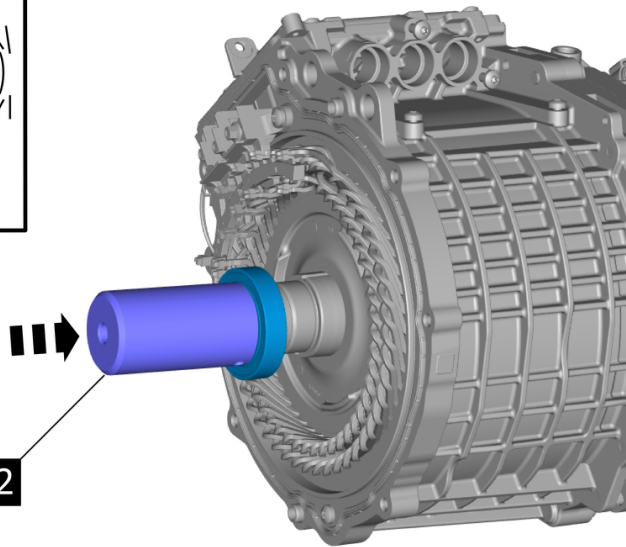
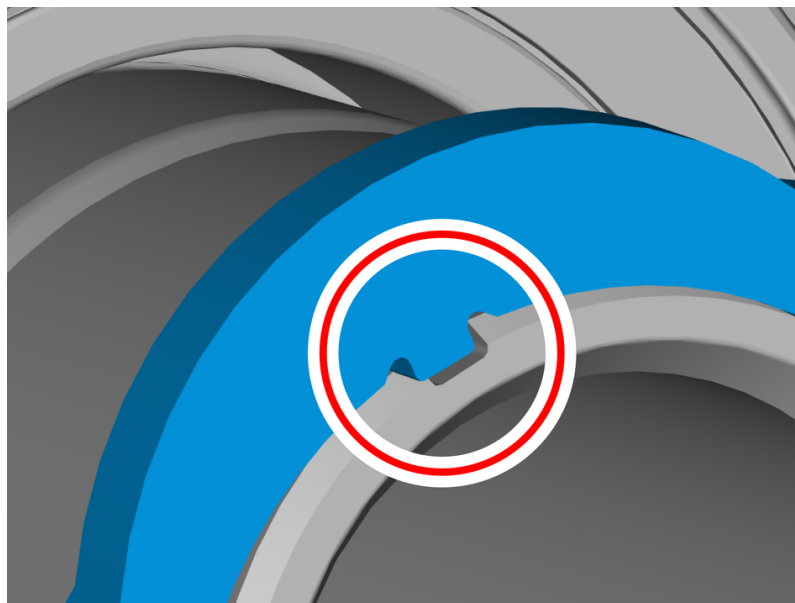
999-7542

Install the marked component.

Special Tool: T9997542, Counterhold

Use: Copper mallet

Install the new bearing on the shaft using special tool 999 7542.

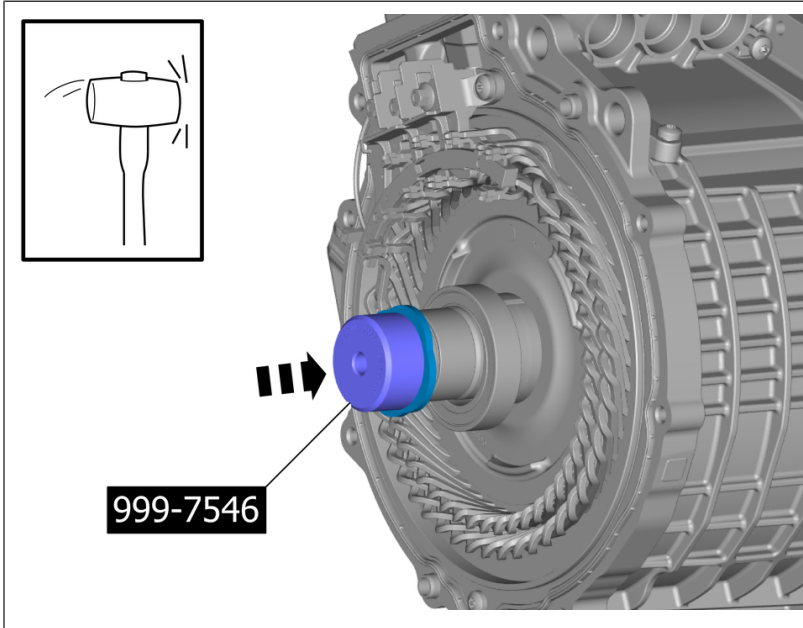
Install the marked component.

Special Tool: T9997546, Drift

Use: Copper mallet

Install the resolver wheel on the shaft using special too 999 7546.

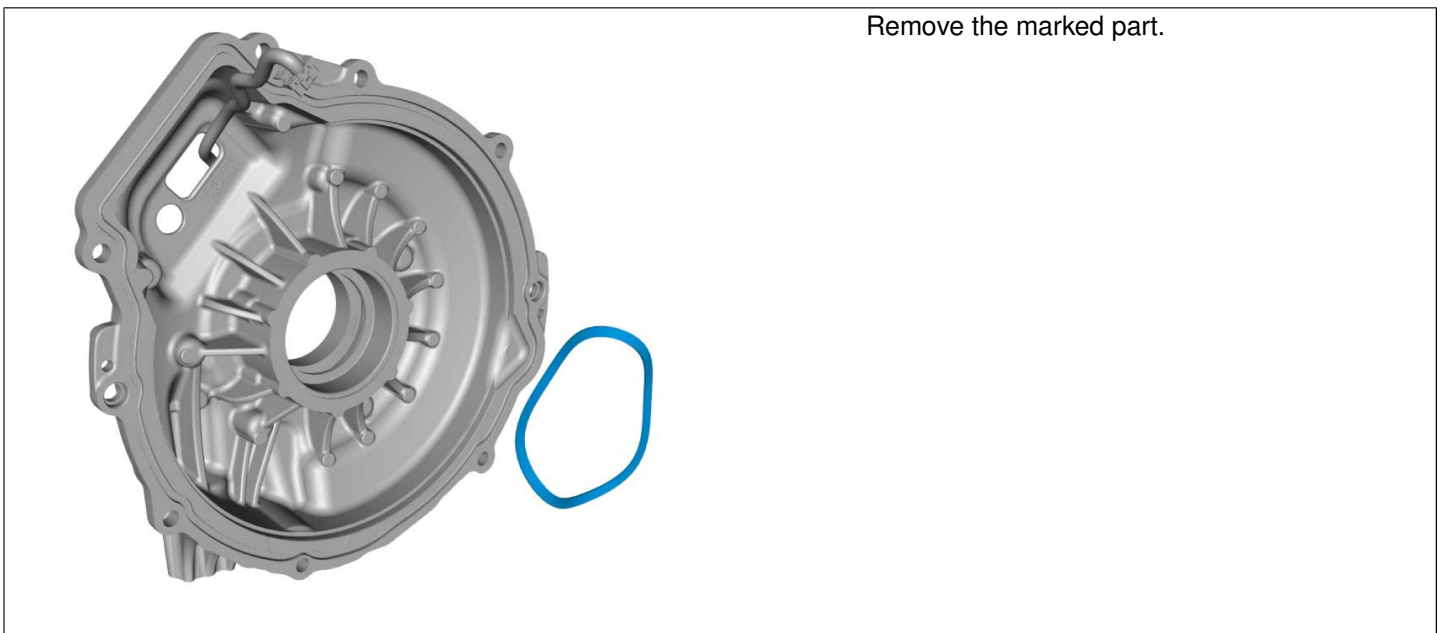
Remove the marked part.

Remove the "wave" type washer from the inside of the large side cover.

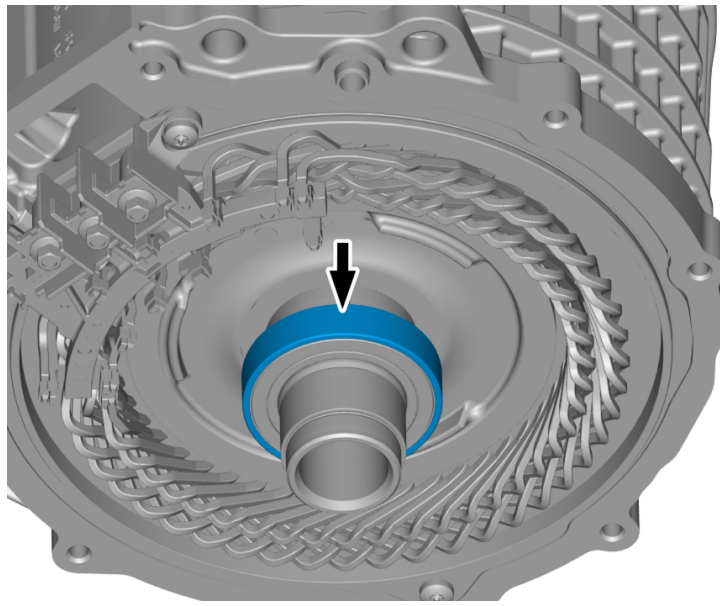
Caution! Make sure that the surface is clean and free of foreign material.

Clean the marked area.

Use: Abrasive cloth , 9511024

Using abrasive cloth (not included in the kit) clean any corrosion from the outside surface of the bearing. Ensure there are no bits of abrasive cloth left after cleaning.

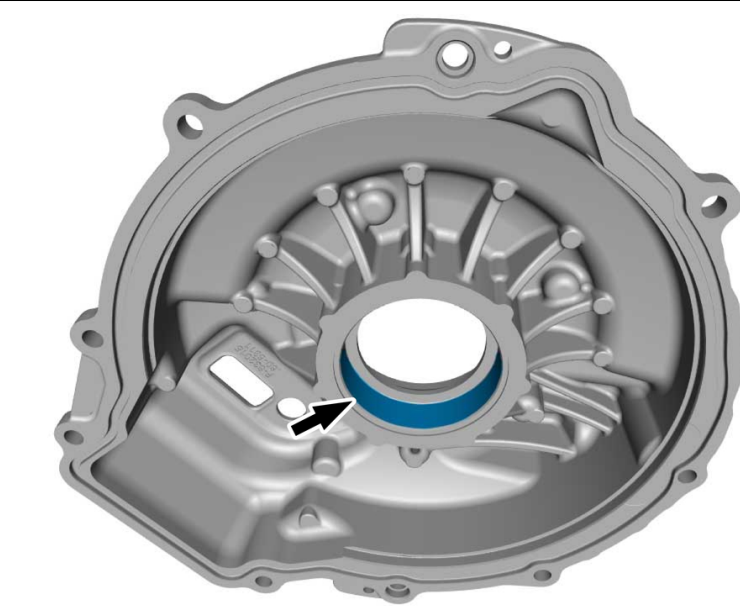
Caution! Make sure that the surface is clean and free of foreign material.

Clean the marked area.

Use: Abrasive cloth , 9511024

Repeat the process on the bearing mating surface inside of the large side cover.

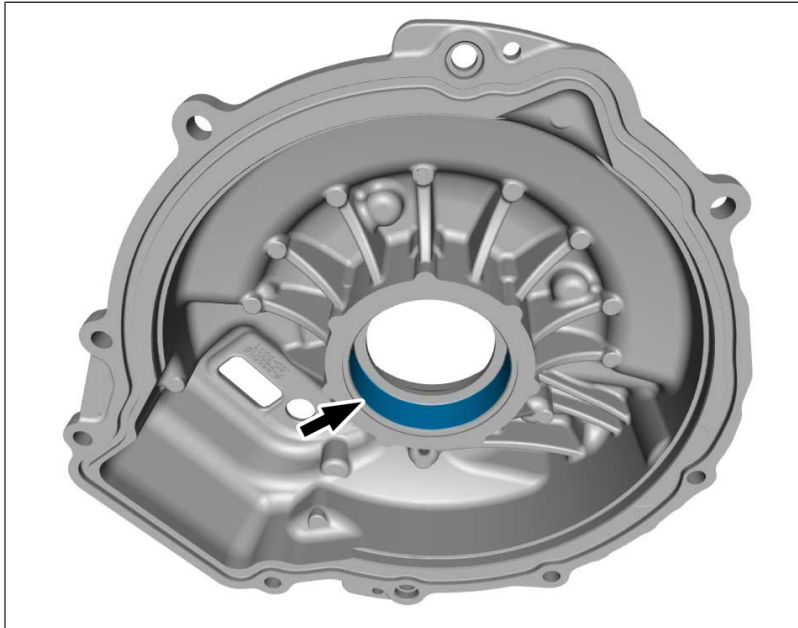
Apply grease on the area indicated.
Apply a thin and even layer.

Use: Splines grease , 1161748

Apply a thin and even layer of grease (not included in the kit) to both surfaces which were just cleaned.

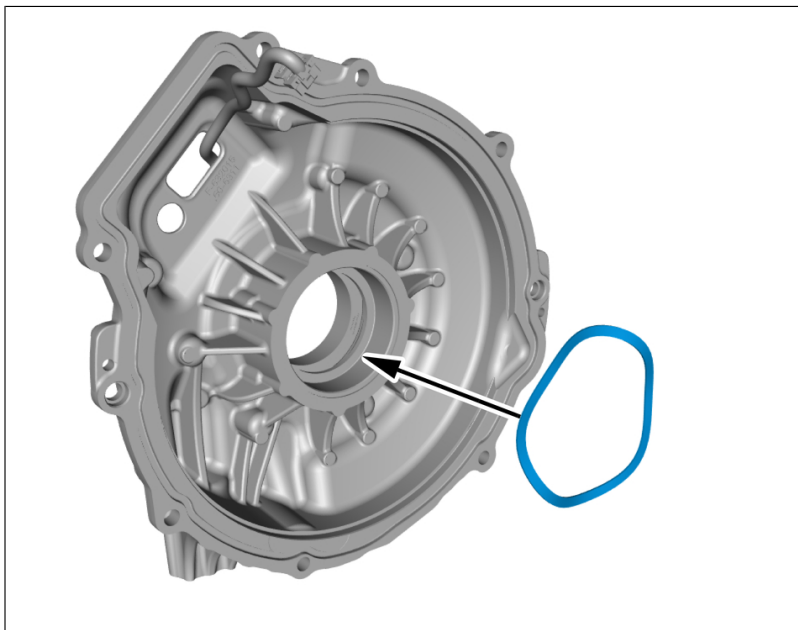
Install the marked component.

Reinstall the "wave" type washer on the inside of the large cover.
