Advanced Technical Information

Bulletin #: 2433

Porsche Mobile Charger Plus Supply Cable Initialization Failure

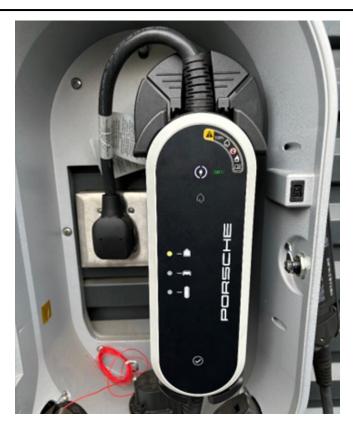
Phase 1: (~20 seconds)

The uppermost Charge Status LED illuminates solid white, while the top "House" LED will illuminate solid yellow for a few seconds as shown in figure 1.

While the Operating Instructions recommend removing and reinserting the power plug, this does not always remedy the condition. There is currently no known correlation of this condition to supply cable production date. If a PMC+ exhibits the described behavior with a certain supply cable, normal operation cannot be guaranteed with a power supply cable of later production date. Each cable must be physically tested with the customer's PMC+ at the Porsche Center to confirm functionality before returning the PMC+ and new supply cable to the customer.

This condition is not a fault of the temperature-sensing supply cable. New cables that do not work on the affected PMC+ devices demonstrating this condition will work normally on other part number variants with updated software. If the PMC+ continues to display this behavior with all available supply cables after multiple outlet plug-in cycles, it should be replaced.

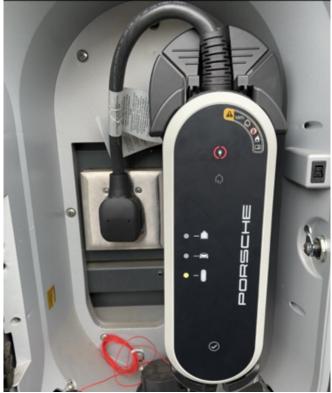
Phase 2: (indefinite)

The uppermost Charge Status LED illuminates solid red, and the bottom "Charger" icon LED flashes yellow as shown in figure 2 as long the unit remains plugged into an outlet.
