# Technical Service Bulletin

## 92 Q8 e-tron washer fluid reservoir leaking

92 24 41 2075757/1 October 28, 2024.

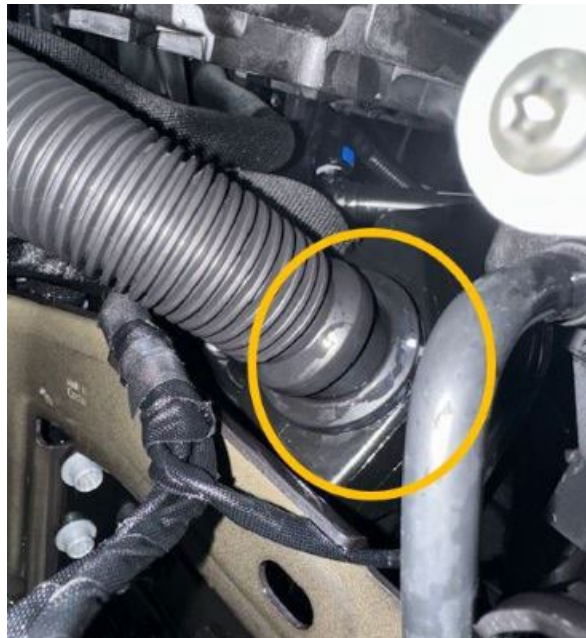
Filler connection not fitted correctly.

Filler hose not fitted correctly.

*Figure 1. Filler hose not fitted correctly.*

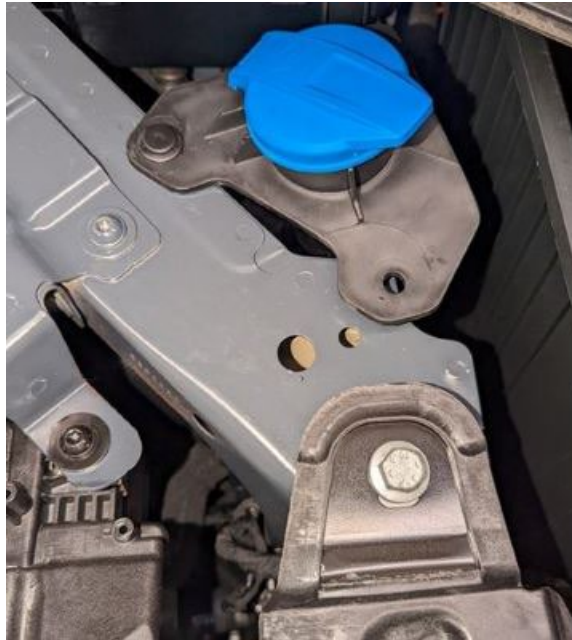
*Figure 2. Removing filler connection.*

1. Remove filler connection for washer fluid as specified in repair instructions.

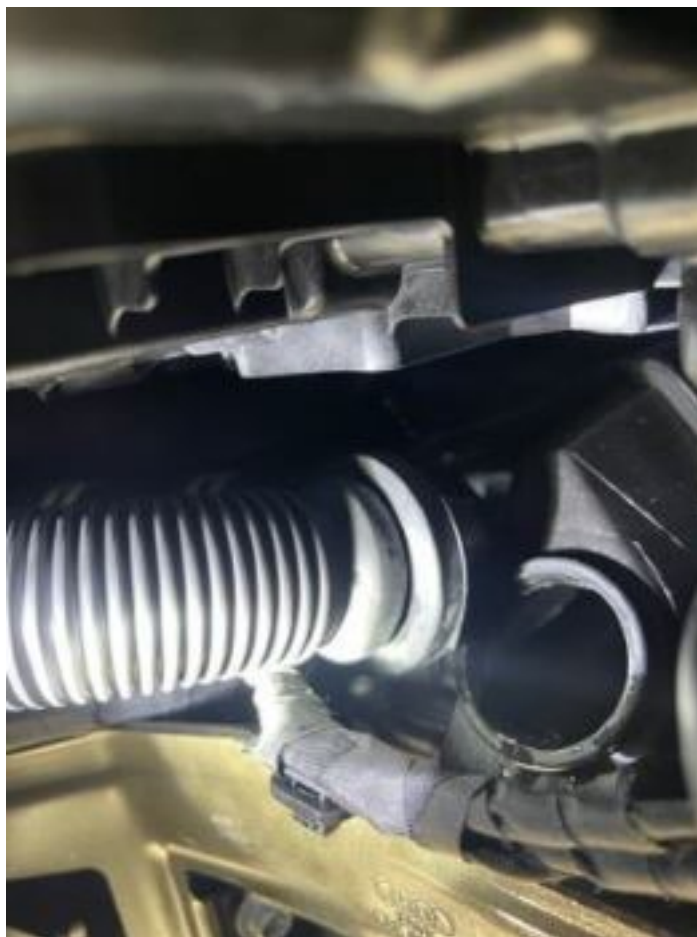
**Figure 3.** Detaching filler connection.

2. Pull filler neck out of washer fluid reservoir.

3. Check whether seal (8T0955465A) is OK and replace if necessary.

Assembly is performed in reverse sequence. Ensure that seal is not squeezed when fitting filler connection.
