48-23-01 - Travel Assist Currently Not Available

Hardware-related deviation of the sensor mat (“hands on detection”) in the steering wheel and software-related deviation in the steering wheel touch detection control module -**J1158**.

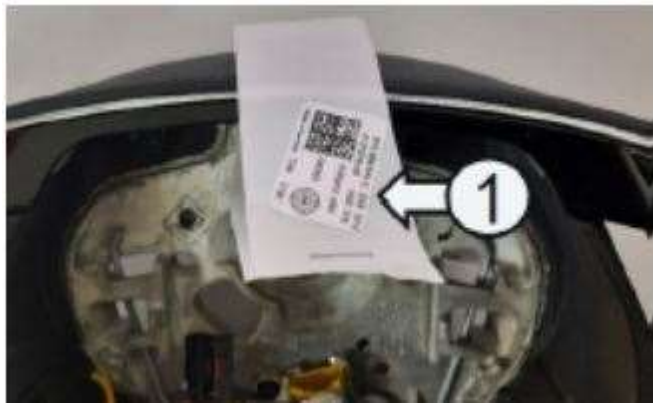
Figure1: New Label/Sticker

The new steering wheel will have the supplied label/sticker (see figure 1) that will need to be applied to the trim panel on multifunction button set, (see figure 2).

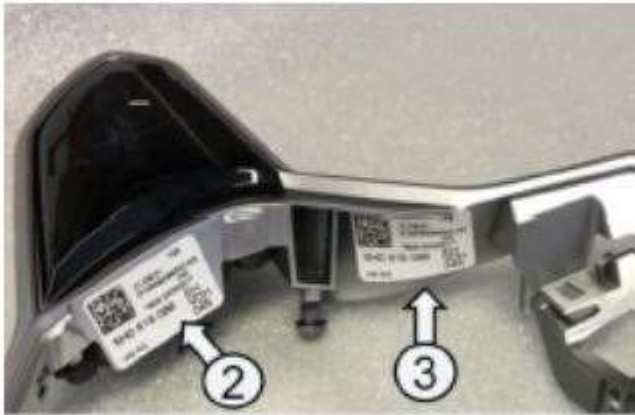
Figure 2.

The old label (see Figure 2) must not be covered up.

Position of old (2) new (3) label on trim panel.
