Technical Service Bulletin (TSB)
Rear Damper Noise

REFERENCE:	TSB: 17-003-24 GROUP: 17 - Rear Suspension	Date:	October 29, 2024	REVISION:	—
VEHICLES AFFECTED:	2024 (B1) Jeep Renegade (Brazil) This bulletin applies to vehicles built on or after March 02, 2024 (MDH 0302XX) and on or before July 21, 2024 (MDH 0721XX).			MARKET APPLICABILITY:	
				<input type="checkbox"/> NA	<input type="checkbox"/> CH
				<input type="checkbox"/> EE	<input type="checkbox"/> IAP
				<input checked="" type="checkbox"/> SA	<input type="checkbox"/> MEA
CUSTOMER SYMPTOM:	Customers may experience the following: <ul style="list-style-type: none"> Noise from rear while driving. 				
CAUSE:	Rear Damper

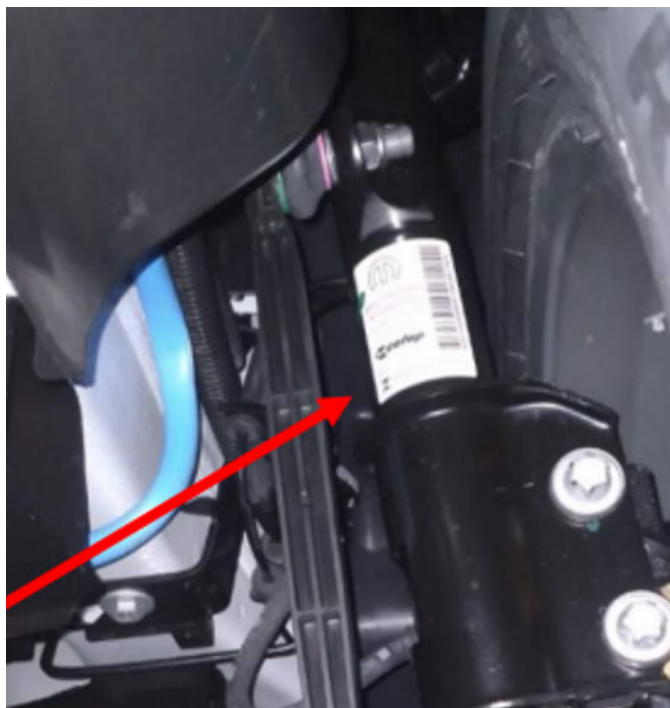
Fig. 1
Rear Damper Label

1. Raise the vehicle. Refer to the detailed service procedures available in DealerCONNECT/Service Library under: 04 - Vehicle Quick Reference / Hoisting / Standard Procedure.
2. Inspect the part number label(s) on the rear dampers [Fig. 1](#), [Fig. 2](#).

3. Is the part number on either of the dampers 30323?
 - YES>>> Proceed to [Step 4](#).
 - NO>>> This bulletin does not apply. Use Inspection LOP (17-27-01-XX). Perform further diagnosis.
4. Replace one or both rear dampers. Refer to the detailed service procedures available in DealerCONNECT/ Service Library under: Service Info> 4420A30 - Amortecedor da Suspensão Traseira (Um Lado) - Remoção/Recolocação. Alinhamento a Parte.
5. Perform all wheel alignment. Refer to the detailed service procedures available in DealerCONNECT/ Service Library under: Service Info> 4450A10 - Alinhamento das Rodas Dianteiras - Controle com Aparelhagem Óptica, Compreende Eventual Regulagem.

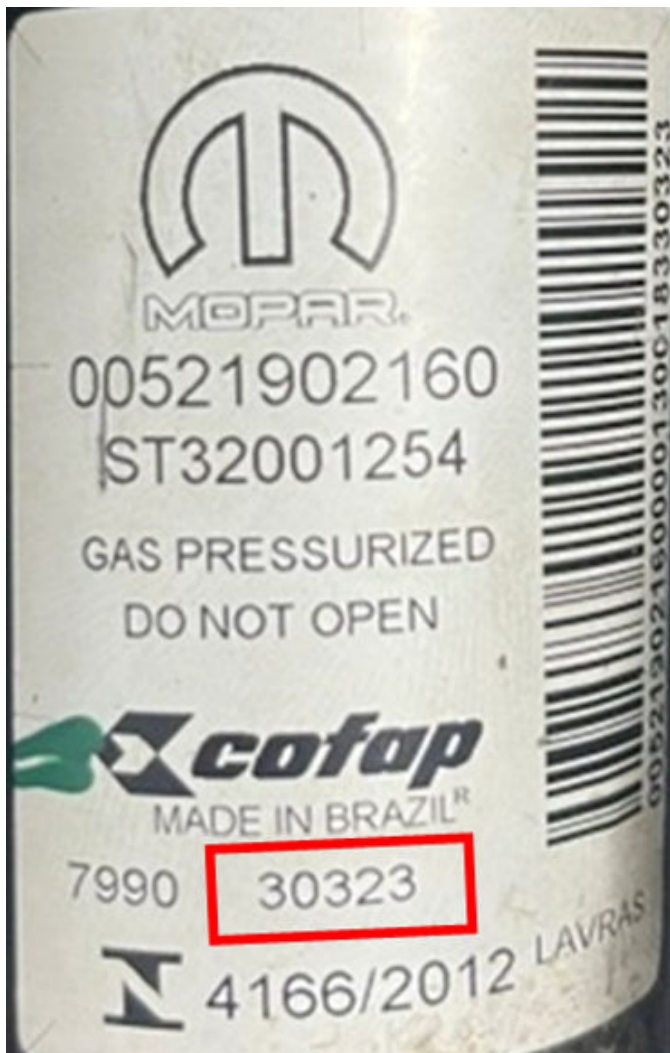
Fig. 2

Rear Damper Part Number
