2010-2011MY  
Forte & Forte Koup (TD)  
w/2.4L MPI

PI2102Y/Z (Rev 2, 11/07/2024)

ENGINE REPLACEMENT INSTRUCTIONS  
FOR DTC P1326 (PI2102Y/Z)

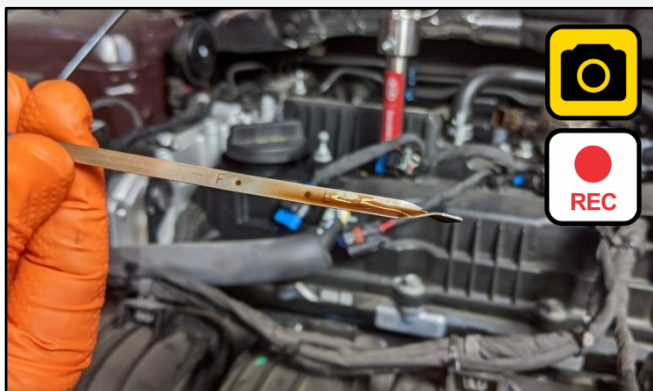
1. Start video showing vehicle and move in towards the dash VIN tag.
2. Measure and record oil dip stick level.
3. Note oil dip stick reading on the RO.
4. Take a picture of the oil reading on dipstick.

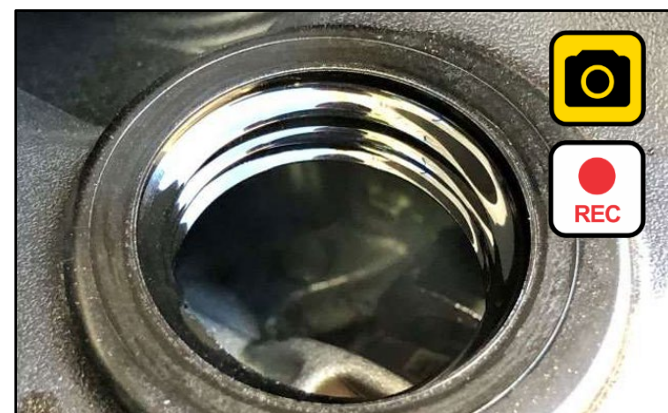
**Oil Level Measurement: (Main Flowchart → PWA Request) NO OIL READING ON DIPSTICK**

1. Remove oil filler cap, remove oil drain plug and drain oil into the measuring container SST067BUCK and check oil level.
2. Record oil level reading on the RO.
3. Take photo of the drained oil container using KDS and attach to warranty claim PWA request.

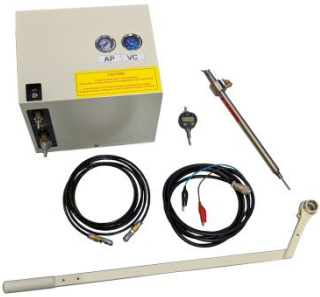
| Tool Name | Tool Part No. | Figure | Comments |
|---|---|---|---|
| Bearing Clearance Tester Kit | KQ231 2T110QQK | | Auto-shipped to Dealers<br>For troubleshooting assistance contact the GITA Support Line at: (888) 542-4371.<br><br>For replacement parts, contact Snap-On Tools at: (888) 542-1011. |

If DTC P1326 is present, first perform the bearing clearance inspection with the Engine Bearing Clearance Tester device (SST KQ231-2T110QQK). This device checks the rod bearing clearance by placing air and vacuum into the cylinder block. Measure the bearing clearance and follow the instructions in this bulletin. Refer to the flow chart found on pages 2-4, then follow the appropriate procedure as outlined in this bulletin. Before conducting the procedure, verify the vehicle is included in the list of affected VINs.

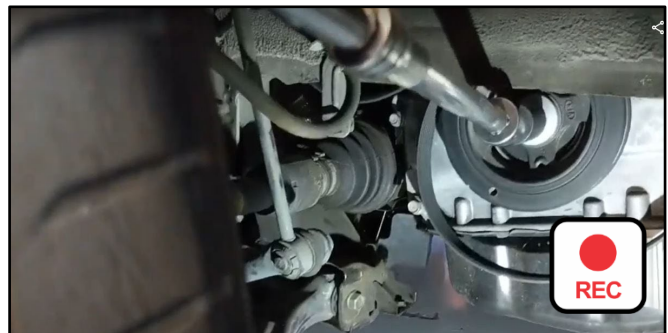
**Prepare the vehicle prior to the video by removing the spark plugs and drive belt as well as setting the torque wrench to 94 lb.ft.**

5. Show the removed drive belt and attached torque wrench to crank bolt.
