# Service Bulletin

Bulletin No.: 16-NA-003

**Subject:** Chirp, Squeak Noise from Rear of Vehicle

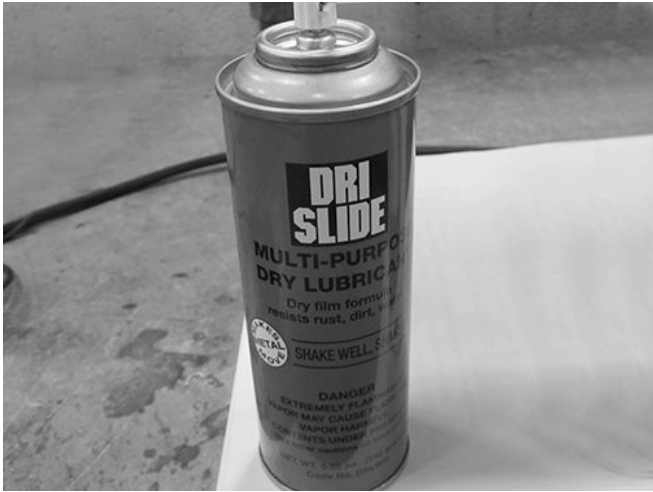
4340714

**Important:** Regardless the noisy valve location, lubricate ALL exhaust valves on the system.

Generously lubricate the forward, and rear if equipped, exhaust valves following the steps below:

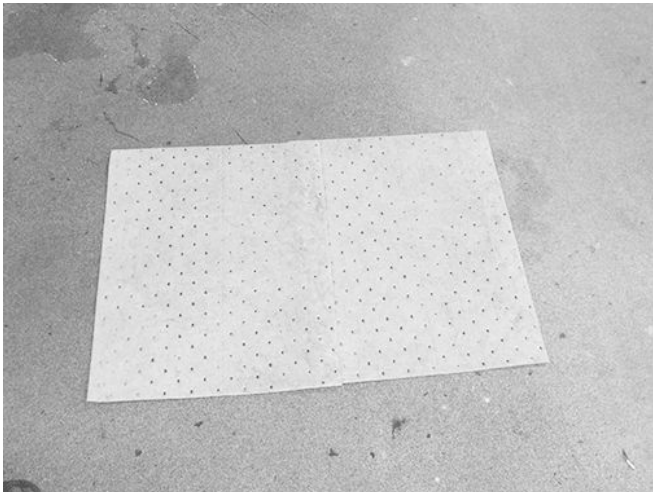
4340724

1. Fully raise the vehicle.

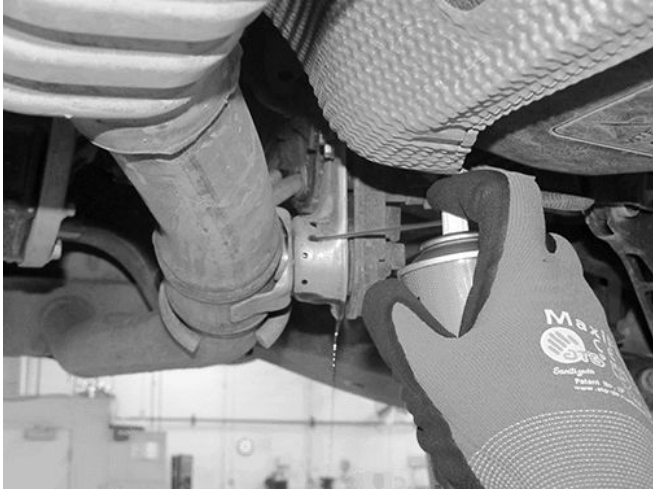
4340727

2. Position a drop cloth below the valve being lubricated.

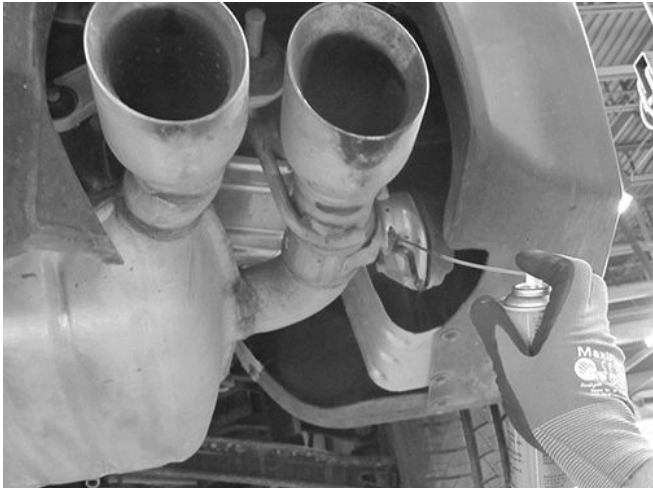
4340730

3. Apply DRY SLIDE Multi-Purpose Dry Lubricant, P/N 1052948 (in Canada, use 89021511), into the valve by inserting the nozzle into the slot on the valve. Liberally apply a generous amount of the lubricant.

4. Move the drop cloth to and repeat application at both, or all four valve locations, depending on the exhaust system.
5. With all valves lubricated, command the flow control functioning numerous times on all valves, to work the lubricant into the valve.
6. During the flow control functioning, also verify the squeak/chirp noise has been eliminated.
