# Service Bulletin

Bulletin No.: 22-NA-198

**Subject: Information on Dimpling of Front Fascia Due to Incorrect Front Splitter Fasteners Installed at Pre-Delivery Inspection (PDI)**

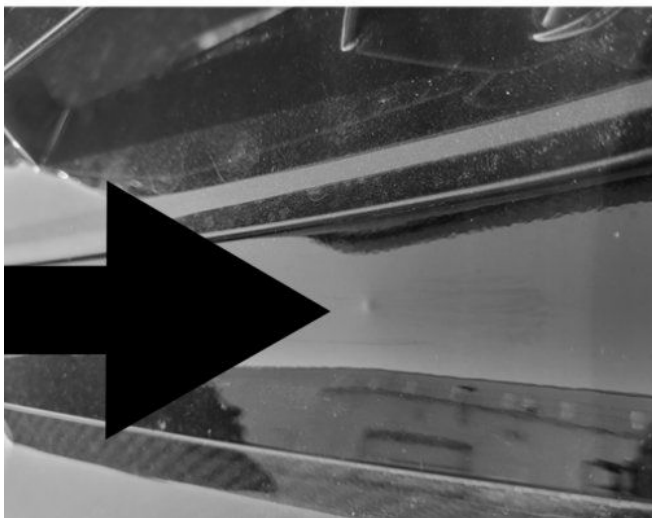
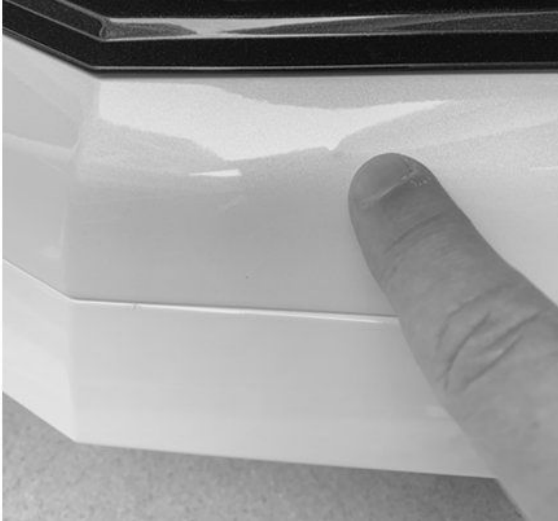
6163496

There are four long fasteners included in the front splitter kit. They should **NOT** be used due to the longer fasteners possibly creating a dimple on the front fascia.

During the installation of the front splitter kit, it is important to install using the correct fasteners.
