TECHNICAL SERVICE BULLETIN

ISSUE DATE:	7/12/2022
SERVICE BULLETIN SUBJECT:	Four-Position Switch Knob Retrofit
VINs or MODELS AFFECTED:	Service Specified Buses
COMPLETE BY:	Next Service Opportunity
SERVICE BULLETIN #:	SC-22-87
LABOR OPERATION CODE:	DE50Z

FOUR-POSITION SWITCH KNOB RETROFIT

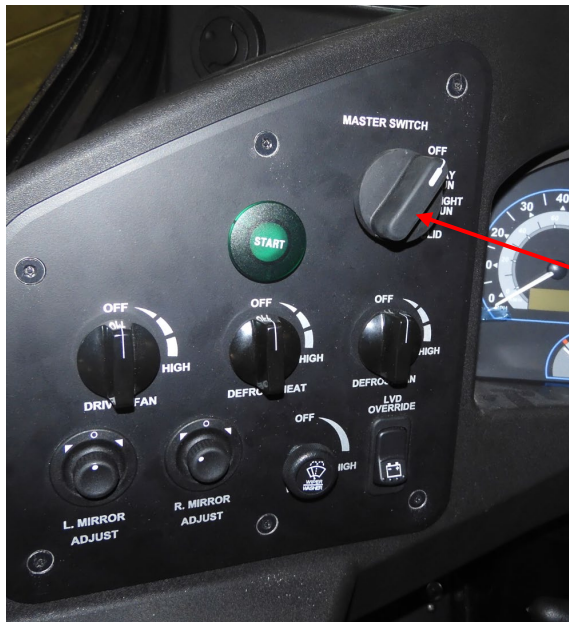
1. Perform the Proterra approved Lockout/Tagout procedures to make the bus safe for work.
2. Using a 1/16-inch Allen Wrench, remove the Knob from the Four-Position Switch shown in the following photograph.

4. Replace the Knob that was removed with the new Knob (**170-2501**). The new Knob is retained by a spring clip, so no tools are required to replace it.
5. Remove the Lockout/Tagout devices and return the bus to service.

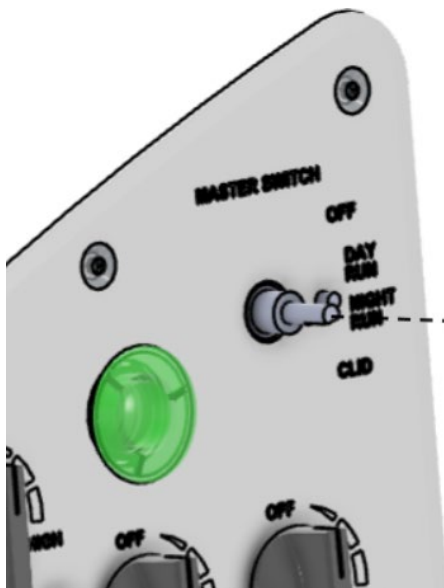
3. Remove the Spacer that was underneath the Knob.
