# TECHNICAL SERVICE BULLETIN

<b>ISSUE DATE:</b>	6/22/2022
<b>SERVICE BULLETIN SUBJECT:</b>	Backup Alarm Reposition Retrofit
<b>VINs or MODELS AFFECTED:</b>	Service Specified Buses
<b>COMPLETE BY:</b>	Next Service Opportunity
<b>SERVICE BULLETIN #:</b>	SC-22-74
<b>LABOR OPERATION CODE:</b>	EA60Z

## **BACKUP ALARM REPOSITION RETROFIT**

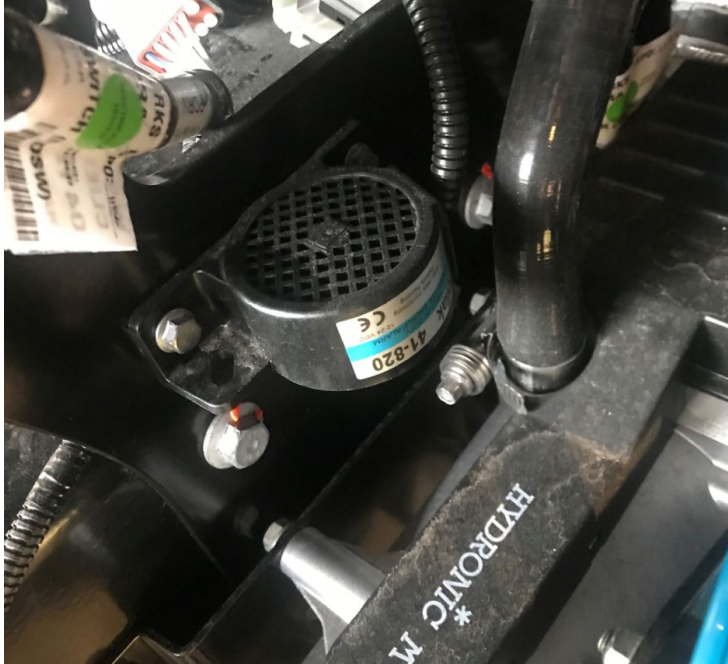
1. Perform the Proterra approved Lockout/Tagout procedures to make the bus safe for work.
2. Working on the streetside rear of the bus near the air compressor, locate the Backup Alarm shown in the following photograph.

3. The Backup Alarm shown in the photograph is upside down. The openings in the housing allow water to enter the device and damage it.
4. If the openings in the Backup Alarm are facing down, this process is complete. Remove the Lockout/Tagout devices and return the bus to service.
5. If the Backup Alarm is upside down, use a 10mm Ratchet/Socket to remove the Backup Alarm and reverse it so that the openings in the housing are down.
6. Using a Calibrated Torque Wrench with a 10mm Socket, **torque the fasteners to 53 inch-pounds.**
7. Using Orange Torque Stripe Paint, mark the properly torqued fasteners.
8. Remove the Lockout/Tagout devices and return the bus to service.
