# HYUNDAI

## Technical Service Bulletin

GROUP <b>CAMPAIGN</b>	NUMBER <b>24-01-069H</b>
DATE <b>NOVEMBER 2024</b>	MODEL(S) <b>SANTA FE (MX5A)</b>

**SUBJECT:** ECU SOFTWARE UPDATE FOR DTC P060547  
(SERVICE CAMPAIGN 9B2)

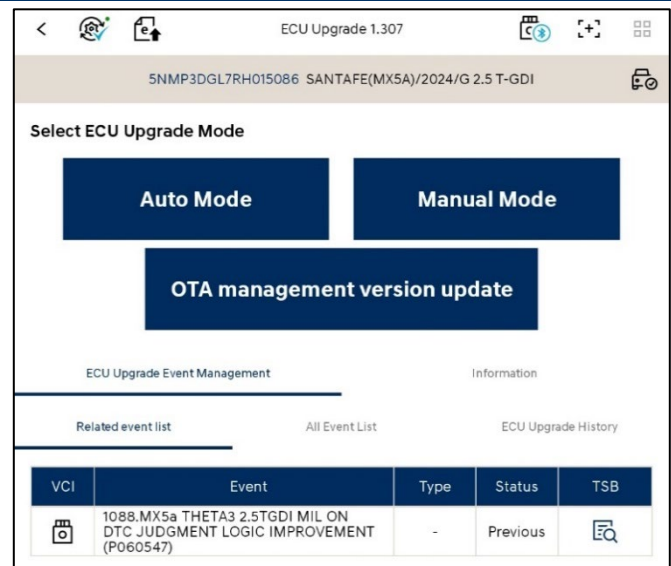
1. Perform the ECU update in Auto Mode.

Use the **ID Check** to verify the ROM ID before updating the software.

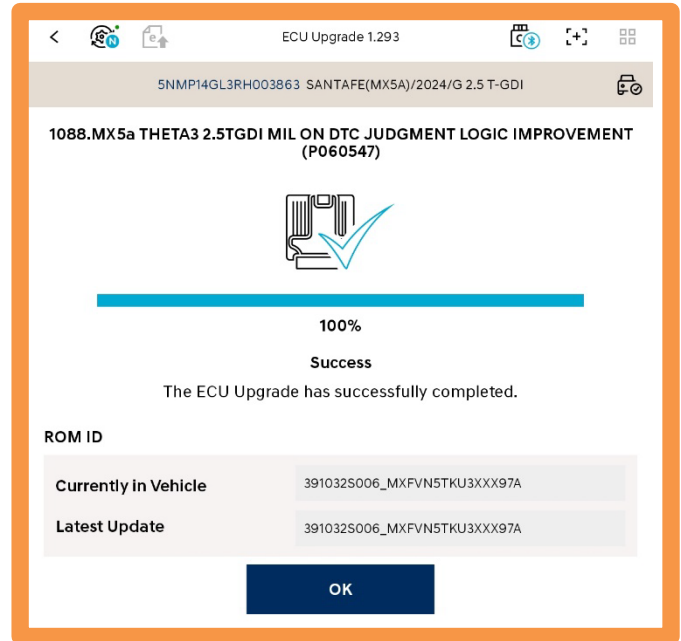
Take a screenshot of the ECU update complete screen using your tablet and upload to STUI.

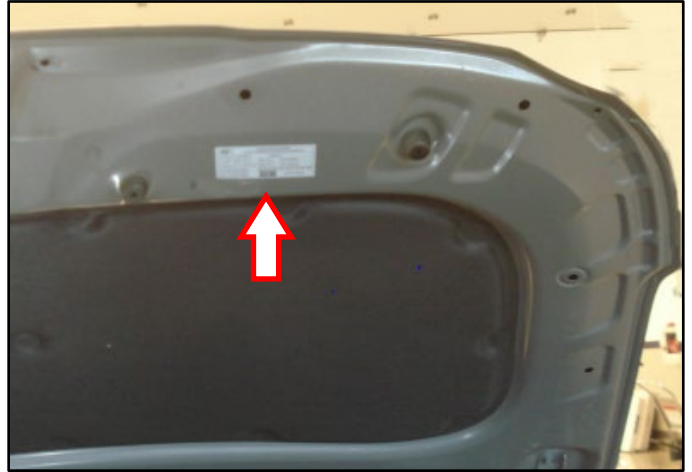
1. Fill in the Dealer Code and Date on the Campaign Sticker, and apply adjacent to the existing Emission Label, on the underside of the hood, as shown.

Be sure to clean the mounting surface to ensure proper label adhesion.
