## ENGINE COOLANT EXPANSION TANK - LEAKING BLEED SCREW

### Range Rover

- 25MY Range Rover
- 25MY Range Rover Sport

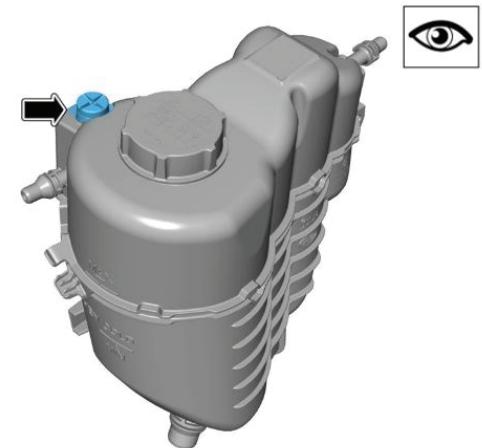
- Small engine coolant leak can be found coming from the engine coolant expansion tank bleed screw.

- After performing a engine coolant pressure test, engine coolant can be seen leaking from the bleed screw follow the steps below.

1. Remove the bleed screw.
2. Lubricate the o-ring with engine coolant.
3. Install the bleed screw and tighten to 3Nm
