# Technical Service Bulletin

<b>Subject:</b>  CHECK ENGINE LIGHT ON WITH DTC P0126:00	<b>Bulletin No.:</b> 01-005/24
	<b>Last Issued :</b> 11/04/2024

## APPLICABLE MODEL(S)/VINS

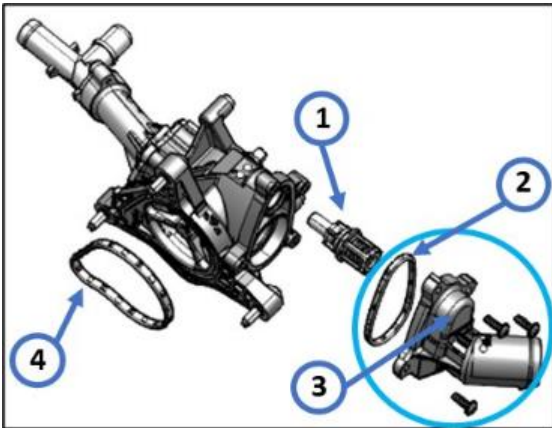
1. Verify customer concerns and check the coolant temperature in the freeze frame data.
  - If it is at around 40-80 °C {104-176 °F} proceed to step 2.
  - If it is not at around 40-80 °C {104-176 °F}, this Service Information is not applicable. Diagnose according to the instruction on MGSS online.
2. Remove the coolant control valve according to the instruction on MGSS:
  - Mazda3 (COOLANT CONTROL VALVE REMOVAL/INSTALLATION)
  - Mazda6 (COOLANT CONTROL VALVE REMOVAL/INSTALLATION)
  - CX-3 (COOLANT CONTROL VALVE REMOVAL/INSTALLATION)
  - CX-5 (COOLANT CONTROL VALVE REMOVAL/INSTALLATION)
  - CX-30 (COOLANT CONTROL VALVE REMOVAL/INSTALLATION)
3. Remove thermostat cover and thermostat cover gasket from coolant control valve.

1. Thermostat
2. Thermostat cover gasket
3. Thermostat cover
4. Water outlet gasket

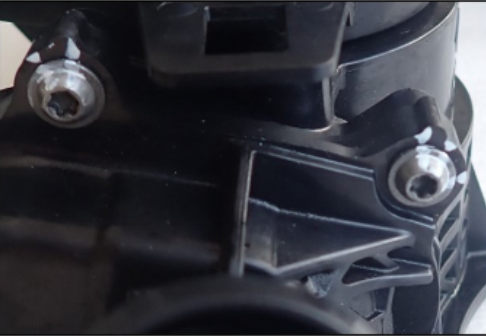
a. Mark the four (4) screws and the respective holes before loosening them to ensure that the screws are placed in their original holes when reinstalling.

**NOTE:** If the screws are not reinstalled in their original holes, the holes may become deformed.

**Marking Example 1:** Draw lines over the screws and the thermostat cover as shown above.
