# Service Bulletin

Bulletin No.: 21-NA-089  
Date: October, 2024

**Subject:** Rapid Rear Brake Pad Wear

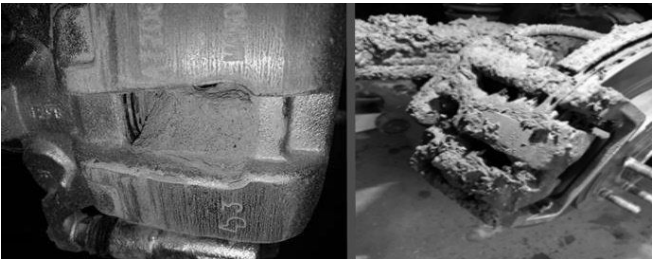
| Cause | <p>5793579</p> <p>This condition may be caused by the rear caliper being packed with dirt, mud or debris deposited in the rear brake calipers, which causes the brake pads to be held against the rotor.</p> |

| Correction | <p><b>Important:</b> Installation of these calipers is a customer paid expense.</p> <p>If mud has been found to be the cause of this condition, replace the rear caliper with a shield version to prevent mud packing.</p> <ul style="list-style-type: none"> <li>- For the 2021 model year, an updated shielded rear brake caliper was released as a dealer installed option under the RG1 designation.</li> <li>- These calipers can be installed on any 2019-2021 LD 1500 pickup that was not built with this option.</li> </ul> <p><b>Note:</b> Inform the customer if the brakes are not cleaned after off-road use, the accumulated dirt, mud and debris can cause the brake pads to wear which is not covered by warranty.</p> |
