Technical Service Bulletin

57 Noises from door arrester when opening or closing door

57 24 70 2074129/3 November 27, 2024. Supersedes Technical Service Bulletin Group 57 number 24-46 dated June 21, 2024 for reasons listed below.

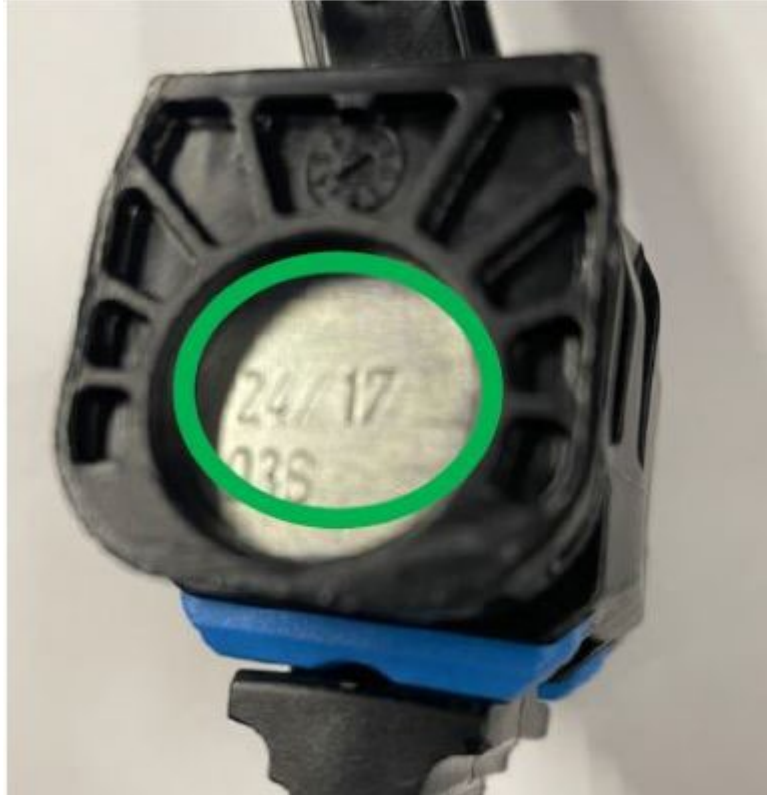
The improved door arrester can be identified by production date and part version number. This information is stamped into the part with a date structure production year / production week (YY / WW) where the first two characters are the last two numbers of the year, and the second two numbers are the calendar week of that year). In the example in Figure 1 the production date is week 17 of 2024. The three characters beneath the date is the part version number. In this case the part is version '03S'.

Figure 1. Replacement part with production date 24/17 (year 2024 / week 17) and component version 03S.

Please check the current version of the replacement part. It must have a **production date of week 17/2024 or later** and a **component version of 03S or higher** (Figure 1).
