**Case Number:** S2405000002

**Symptom/Vehicle Issue:** Brake Light Switch Service Information.

# BRAKE LAMP SWITCH

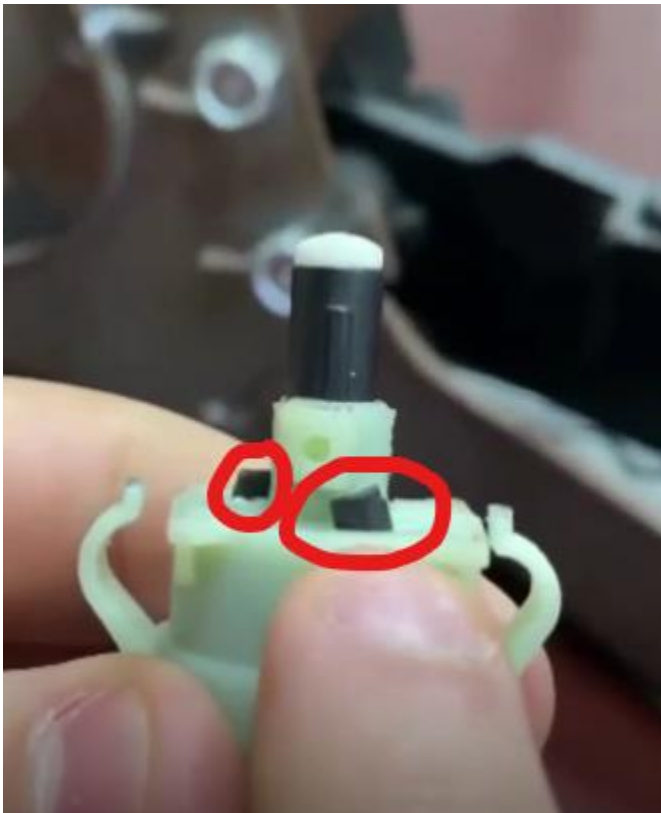
\* Check if tabs (small plastic pieces positioned beside the plunger) are damaged or broken. See the below figure red circled plunger tabs. Note the red circled tabs are cocked sideways- "Not OK". Green circle shows "OK" part.

Not OK.

**NOTE:** If damage to the switch is present for any reason, the switch is to be replaced. If a switch is removed and the plunger length differs from a new switch, the switch should always be replaced and not reinstalled. The nominal height for a new switch (tip of the plunger to the body of the switch) is 16.9 mm (0.67 inch).

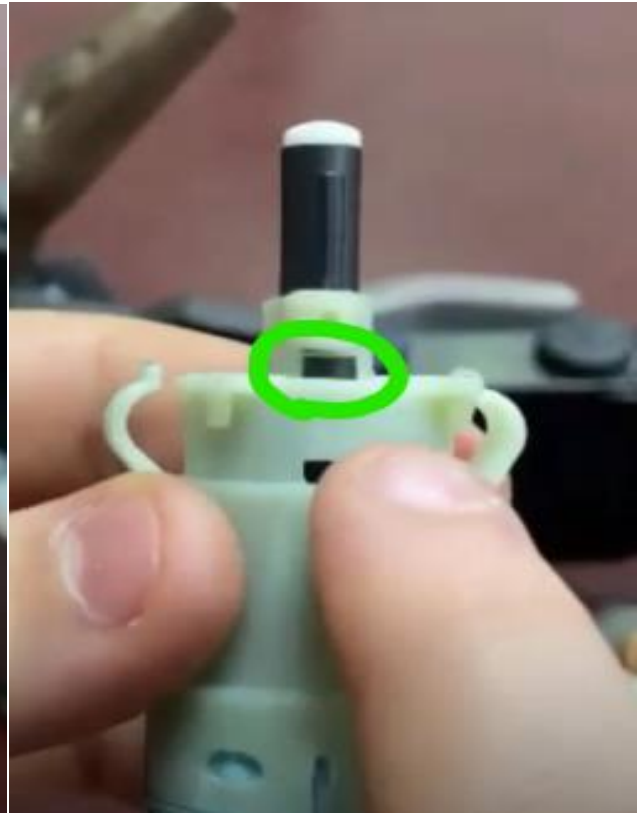
OK.
