Technical Service Bulletin (TSB)
Dual EVAP System Extreme Duty Vapor Canister Filter Kit

REFERENCE:	TSB: 25-009-24 GROUP: 25 - Emissions Control	Date:	December 5, 2024	REVISION:	25-001-21
VEHICLES AFFECTED:	<p>**2010 - 2024** (DS) RAM 1500 Pickup **2019 - 2025** (DT) RAM 1500 Pickup **This bulletin applies to vehicles equipped with a 3.6L V6 24V VVT Engine (Sales Codes ERG or ERB) or a 5.7L V8 HEMI MDS VVT Engine (Sales Codes EZL or EZH).**</p> <p>NOTE: This applies to only the gasoline engine powered vehicles used in severe/extreme duty conditions.</p>			MARKET APPLICABILITY:	
				<input checked="" type="checkbox"/> NA	<input type="checkbox"/> IAP
				<input type="checkbox"/> EE	<input type="checkbox"/> MEA
				<input type="checkbox"/> SA	<input type="checkbox"/> CH
CUSTOMER SYMPTOM:	<p>Customers operating fleet or severe/extreme duty gasoline vehicles in continuous dusty driving conditions can plug the single OE filter system and may experience a Malfunction Indicator Lamp (MIL) illumination. Upon further investigation the technician may experience a Malfunction Indicator Lamp (MIL) illumination and the vehicle may exhibit/set one or more of the following Diagnostic Trouble Code

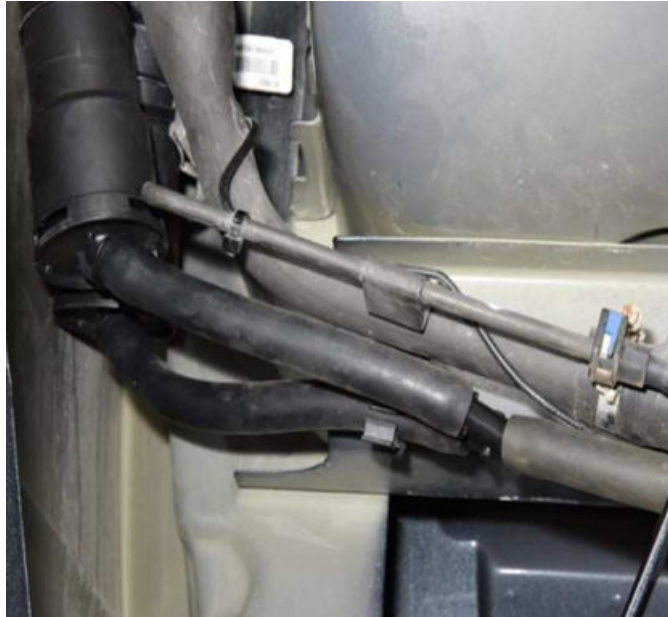
Fig. 1
Dual Vapor Canister Filter Kit

CAUSE:	Single vapor canister filter

This Information Only bulletin is to make technicians aware that an EVAP dual vapor canister filter kit (**Mopar part #68478013AA**) is available in place of the OEM single vapor canister filter.

A dual vapor canister filter kit should be used in this situation [Fig. 1](#). Refer to the detailed service procedures available in DealerCONNECT> Service Library under: Service Info>25 - Emissions Control / Evaporative Emissions / Filter, Vapor Canister / Removal and Installation.
