Subject: REVISION: N242451390-01 – Service Update  
First Responder Emergency Cut Loop Label Removal  
Population Expansion

Models: 2025 Cadillac Escalade IQ  
2024-2025 Chevrolet Silverado EV  
2022-2025 GMC HUMMER EV Pickup  
2024-2025 GMC HUMMER EV SUV  
2024-2025 GMC Sierra EV

## N242451390 First Responder Emergency Cut Loop Label Removal

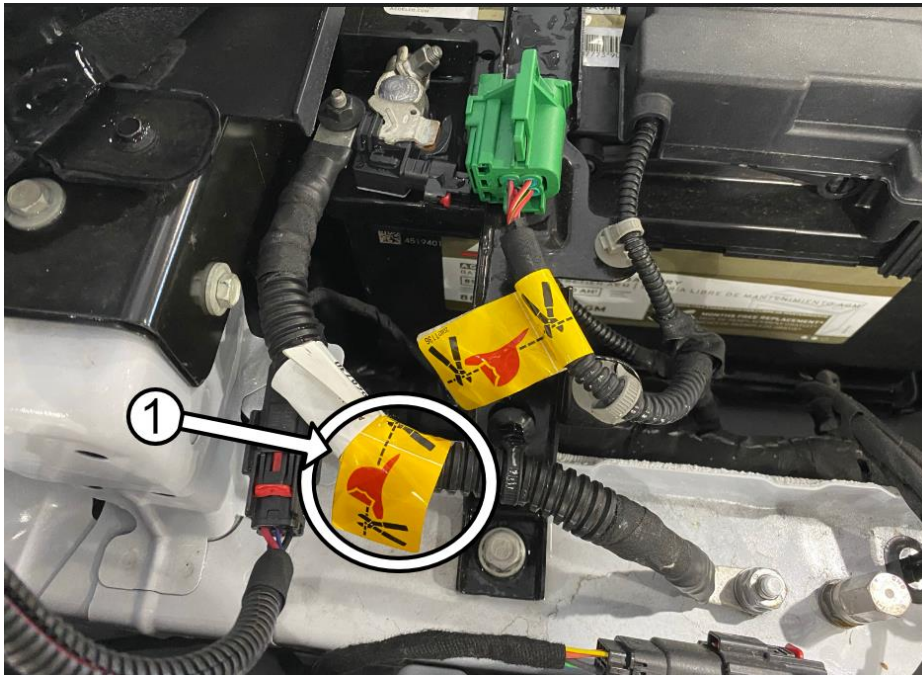
6692423

**Note:** GMC HUMMER EV shown.

2. Using a sharp cutting tool, remove the First Responder Emergency Cut Loop label (1) from the 12V Battery Negative Cable.
3. Install the Right Front Compartment Rear Sight Shield. Refer to *Front Compartment Rear Sight Shield Replacement - Right Side* in SI.

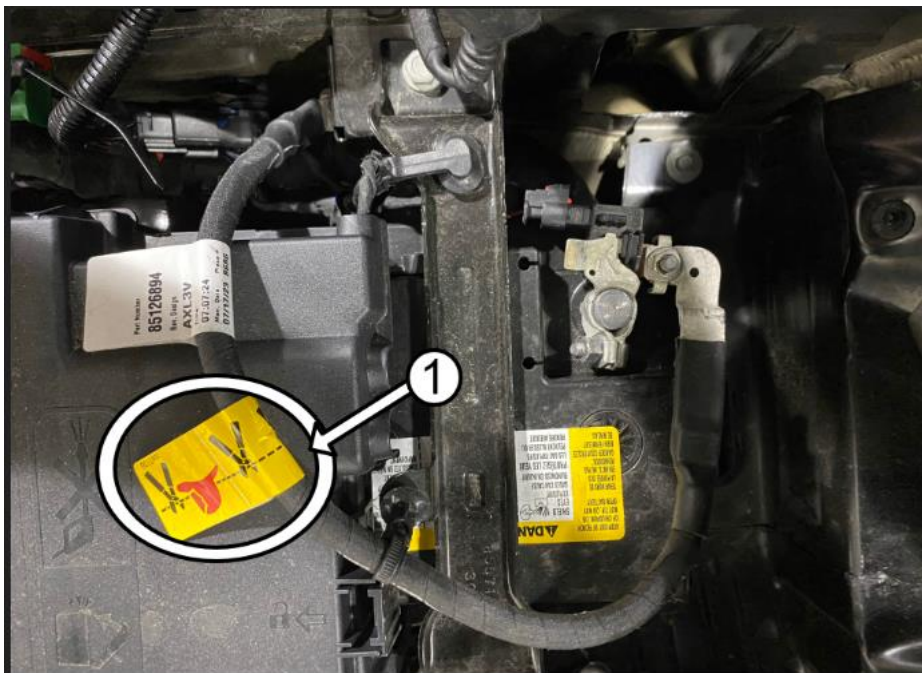
6692425

**Note:** Chevrolet Silverado EV shown. Can be used for GMC Sierra EV also.

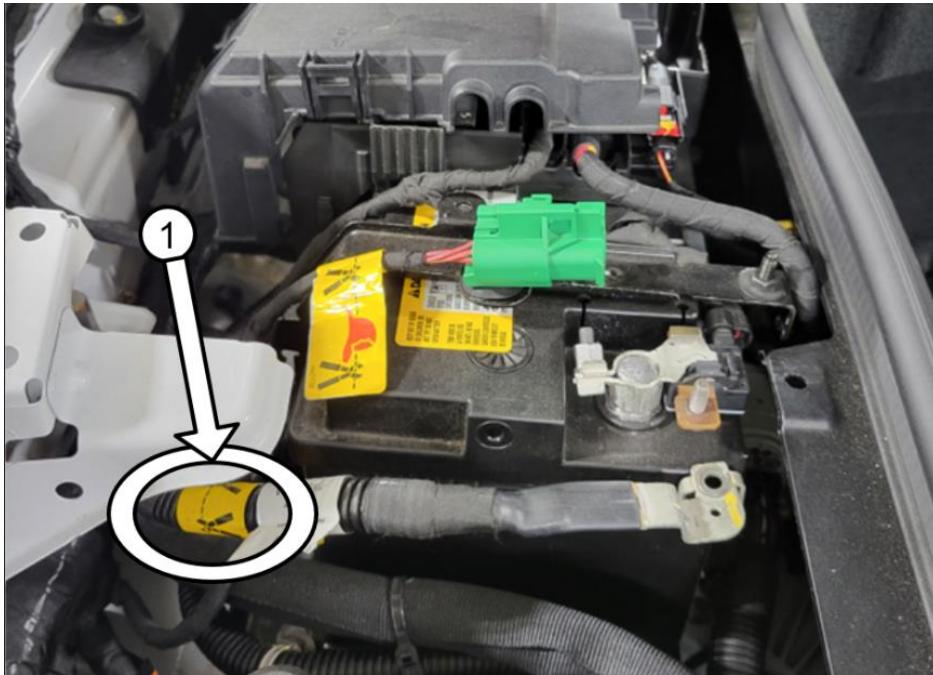
**Note:** Cadillac Escalade IQ shown.

**Important:** DO NOT remove the High Voltage Service Lockout Emergency Cut Loop Label.

**Caution:** Use caution to avoid damaging the 12V Battery Negative cable conduit.
