TECHNICAL SERVICE BULLETIN

Luggage Compartment Scuff Plate To Luggage Compartment Side Trim Panel Gap

24-2422

Ford 2024 Mustang

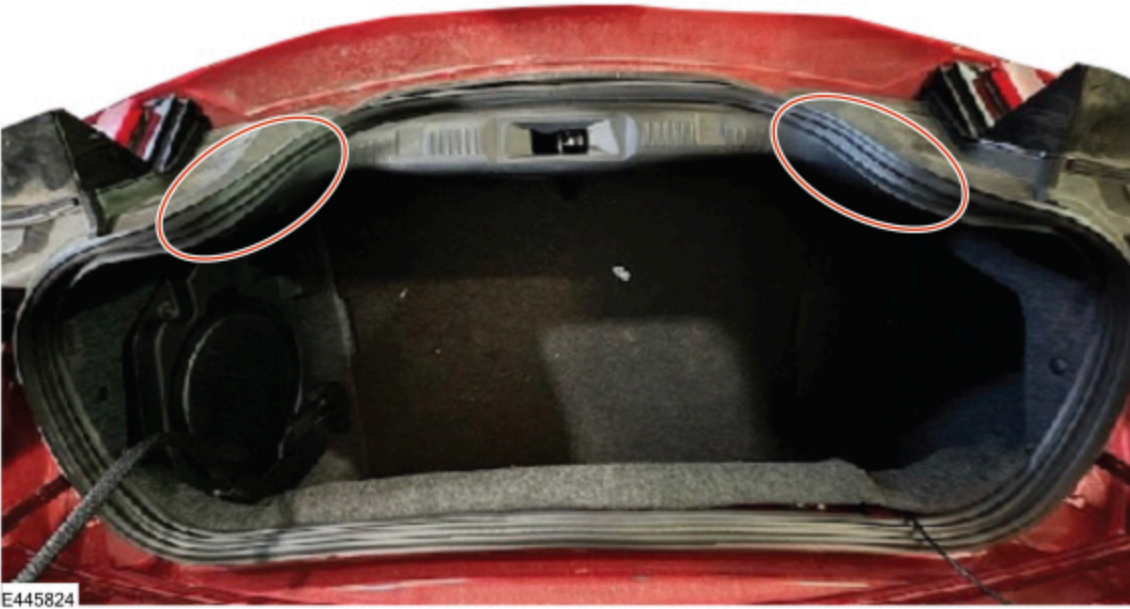
Figure 1

1. Does the luggage compartment scuff plate to luggage compartment side trim exhibit a gap similar to Figures 1-2? (Right side shown in figure 2, Left side similar)

- (1). Yes - proceed to Step 2.
- (2). No - this article does not apply.

2. Remove the luggage compartment scuff plate by unscrewing the thumb nut type retainers. (Figure 3)

3. Install the new luggage compartment scuff plate.
