MAS004483 RU 24-45

Rapid Update 775 Maserati Levante and Ghibli – DMTL pipe connection check

DATE: December 11, 2024

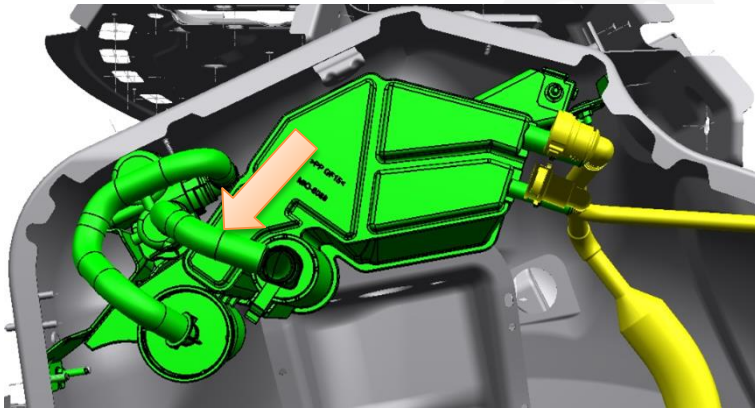
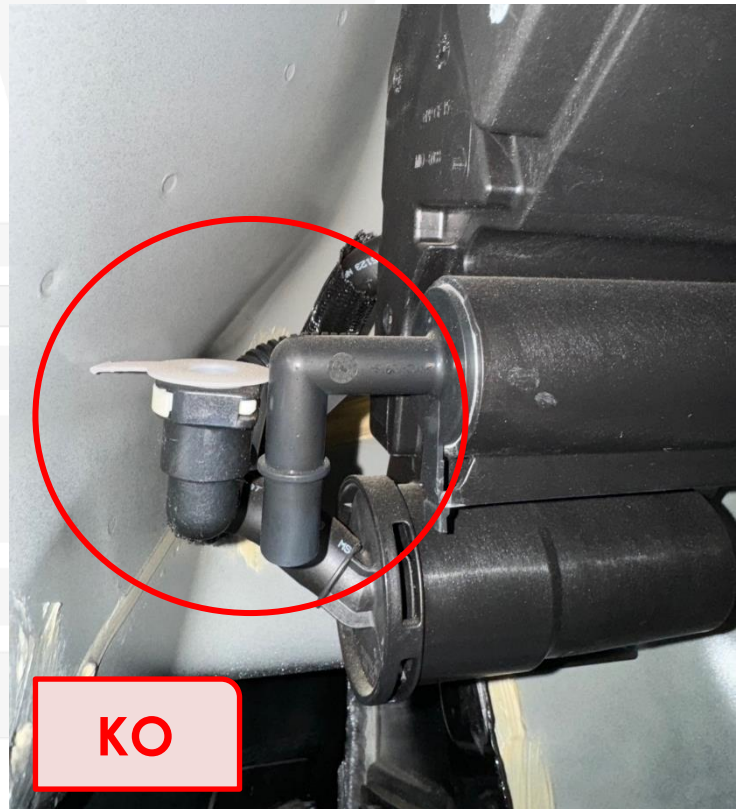
1. Always check ModisCS+ to see if the vehicle is involved in this action and if it has not been previously performed.
2. Proceed to remove the right rear wheel and the wheel guard following the instructions in the workshop manual:
 - a. **9.13.005 - REAR RH WHEEL COMPARTMENT FRONT GUARD - Removal/refitting or replacement**
3. Identify the pipe from the fuel vapor filter to the diagnostic pump (DMTL) and check that the Quick Connector is **correctly engaged** on the vapor filter, checking that there are no foreign bodies on the pipe (see for example protective caps).

4. Repair any non-conformities and reassemble the dismantled components by proceeding in reverse order to the disassembly procedure.
5. Procedure complete.
