Technical product information

Topic	Brake noise identification
Market area	Bentley: worldwide (2WBE), China 796 VW Import Comp. Ltd (Vico), Beijing (6796)
Brand	Bentley
Transaction No.	2074951/2
Level	EH
Status	Approval
Release date

New Continental GT / C and New Flying Spur

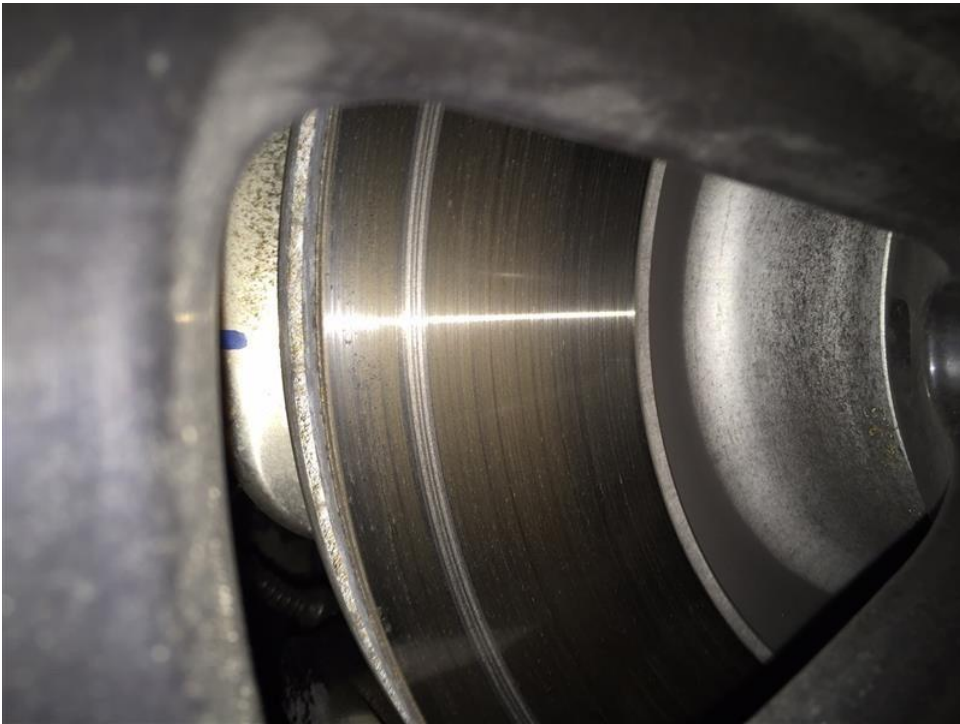
Figure 2

- Discs have a groove in them (Figure 2)

1) Check the overall condition of the brakes to determine if the brake noise can be attributed to one of the causes listed in the *Technical Background* section of this TPI. If the noise is not a result of one these causes, proceed with point 2

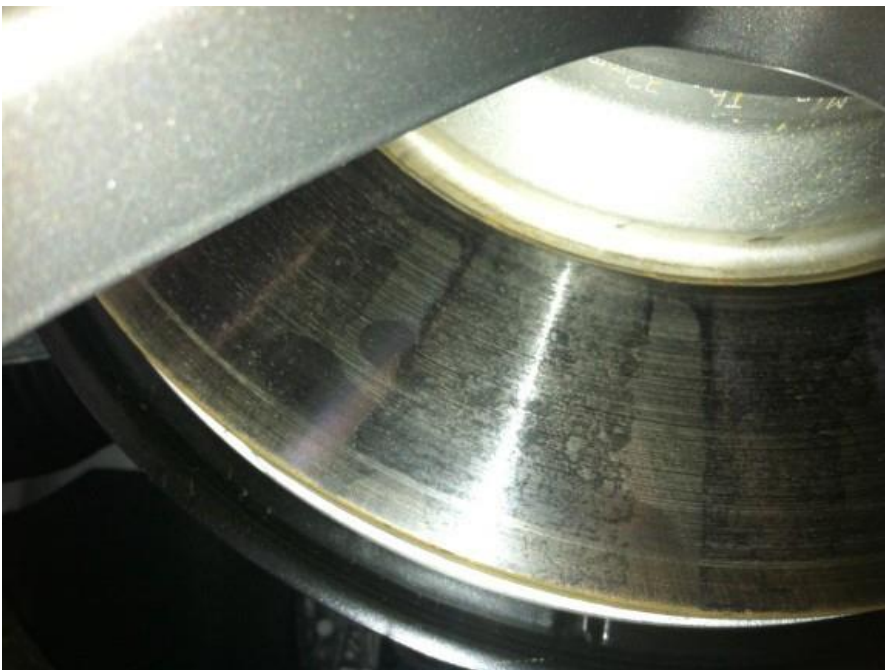
Figure 3

- There is chemical contamination on the braking surface of the disc due to a wheel or tyre cleaner being sprayed directly onto the disc (Figure 3)

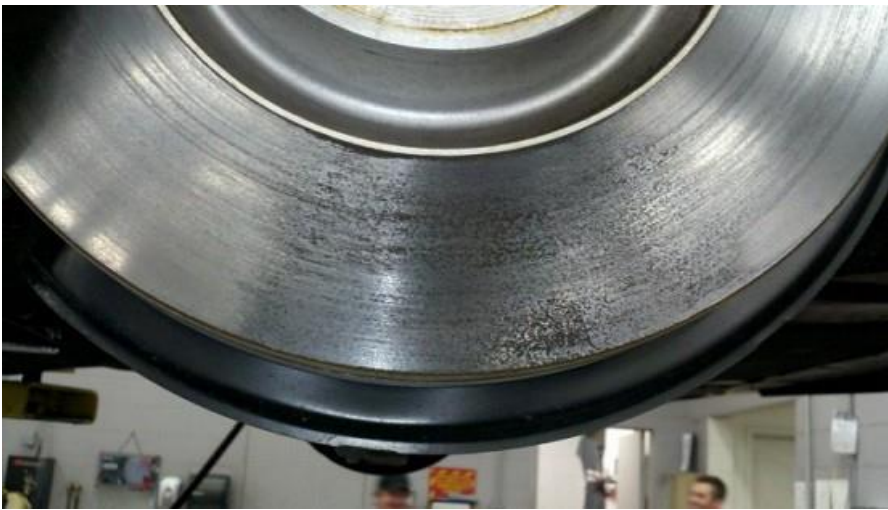
Figure 4

- There are 'pad marks' on the brake disc as a result of the brake pad material transferring to the discs. This can occur when a vehicle has been stood for long periods of time in a wet or snowy environment (Figure 4)
