Technical product information

Topic	Speaker Replacement - Diagnostic checks
Market area	Bentley: worldwide (2WBE), China 796 VW Import Comp. Ltd (Vico), Beijing (6796)
Brand	Bentley
Transaction No.	2075127/2
Level	EH
Status	Approval
Release date

New Continental GT / C and New Flying Spur

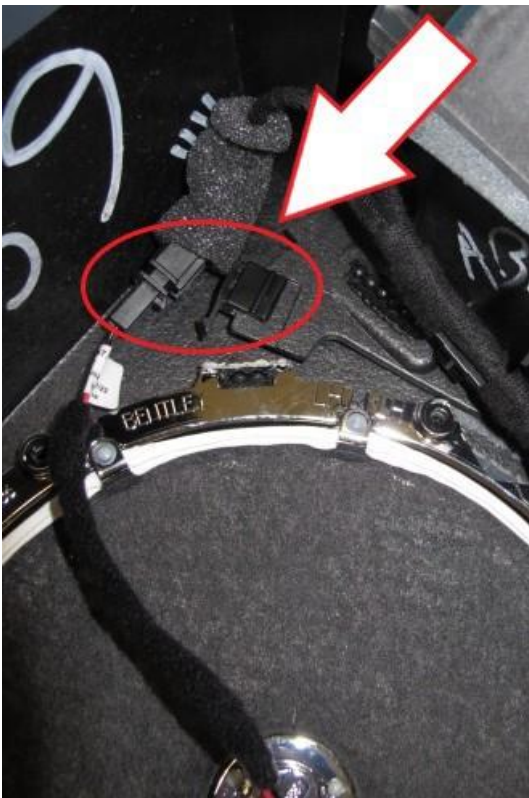
1. Remove the door pad and retest the speaker (door mounted when possible) to the same audio level. If the noise or distortion disappears then check the door pad and its mounting points for a poor fit or loose components *For example: Speaker connector not secured correctly (Figure 1)*
- In the event the issue is as shown in Figure 1 (or similar) reconnect the insecure connection and retest
