87-24-02 - ID.4 - Cleaning the Refrigerant Circuit R1234YF

Release date: 12/9/2024

Technical Background

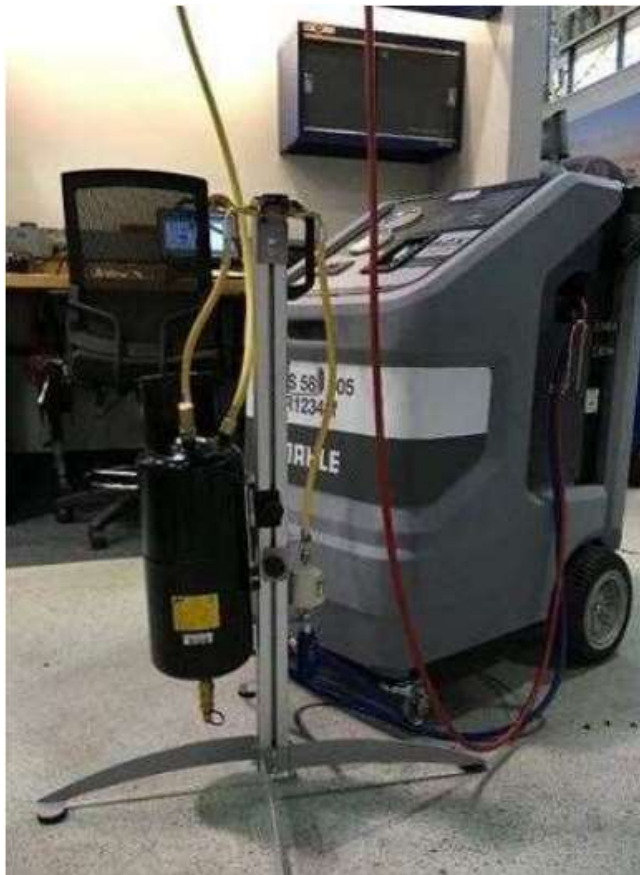
Figure 1. The VAS581005 Air Conditioning Service System with Flushing Device.

Use an approved R1234yf servicing machine and the R1234yf Flush Kit RTI360831840 (Figure 1).

Used for effective refrigerant handling and air conditioning circuit flushing after air conditioning component failure.

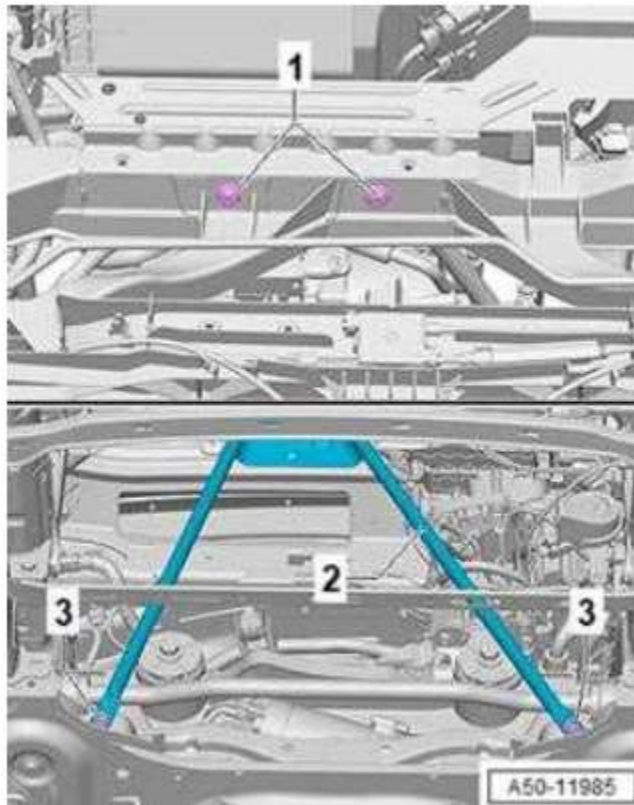
Figure 2. Lock carrier brace

4. Remove the lock carrier brace.

Remove the front underbody trim panel. Refer to ⇒ Body Exterior; Rep. Gr.66 [Underbody Trim Panel; Front Underbody Trim Panel, Removing and Installing] .

Remove the bolts -1- from the lock carrier.

Remove the bolts -3-.

Remove the connecting piece -2- downward.

(Figure 2)

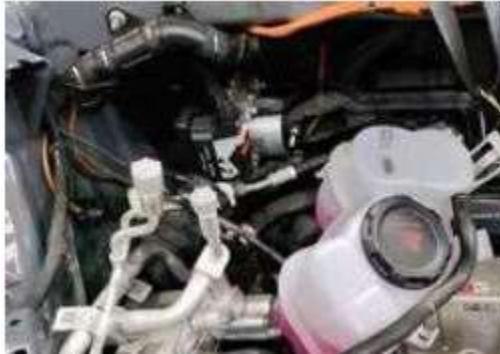
Figure 4. Coolant reservoir set aside.

6. Support the hood using suitable tools and equipment.

Release the coolant reservoir and set it away from the lock carrier. (Figure 4)

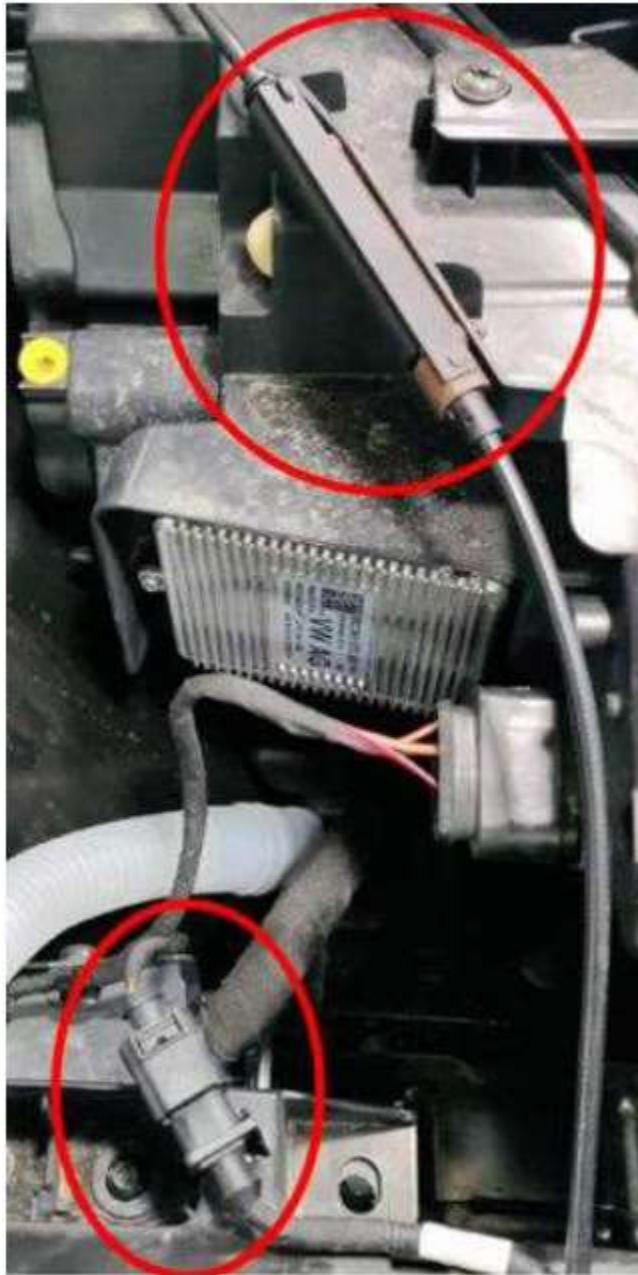
Figure 5. Disconnect hood switch and hood cable.

7. Disconnect the hood release cable and 2 pin hood switch connector F266. (Figure 5)

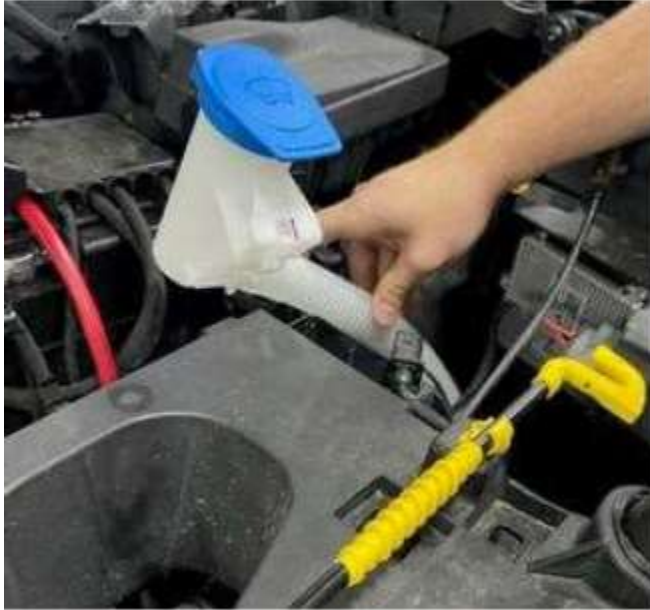
Figure 6. Set aside washer solvent filler neck.

8. Disconnect and set aside the washer solvent filler neck. (Figure 6)

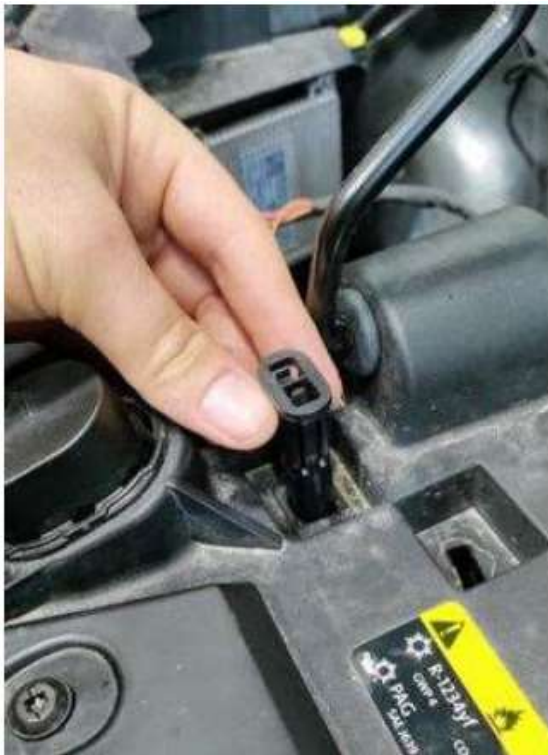
Figure 7. Remove radiator module bracket.

9. Remove the radiator module bracket. (Figure 7)

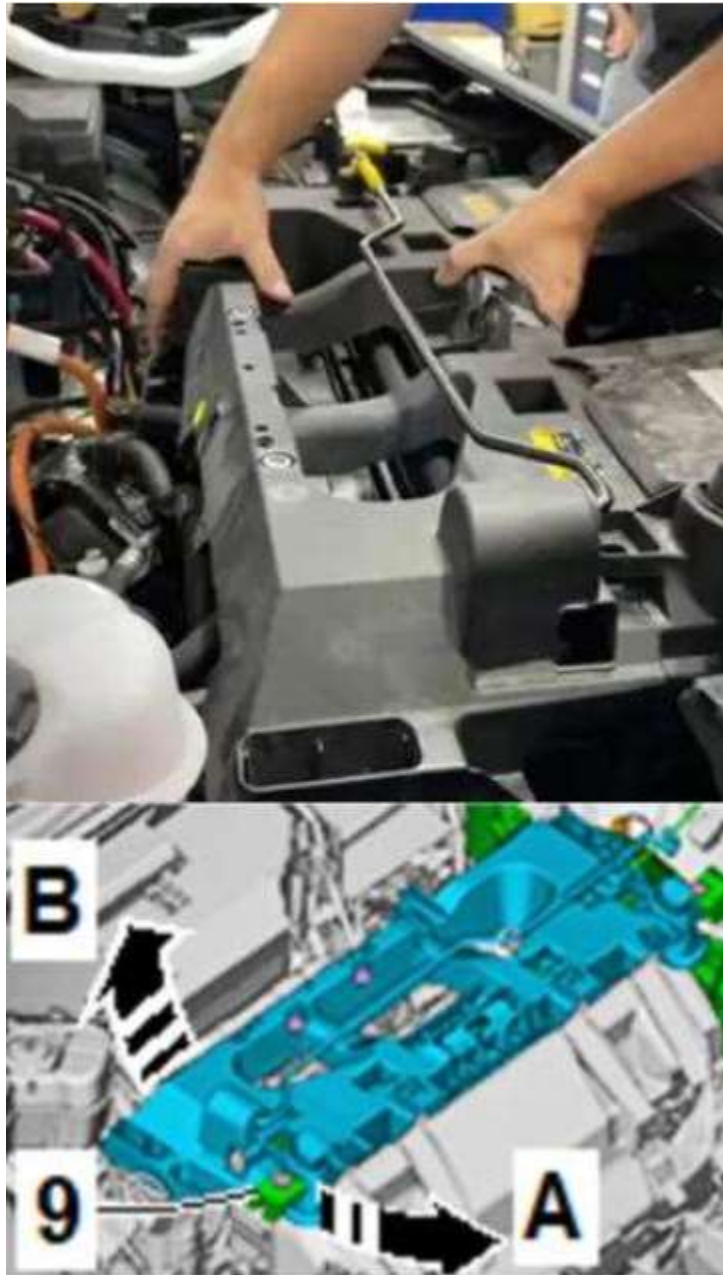
Figure 10. Lock carrier removal

12. Perform the following steps below to remove the lock carrier. (continued)

(Figure 10)

Pivot out the lock carrier -1- in the direction of -arrow A- under the tab -9-.

-Remove the lock carrier -1- in the direction of -arrow B-.

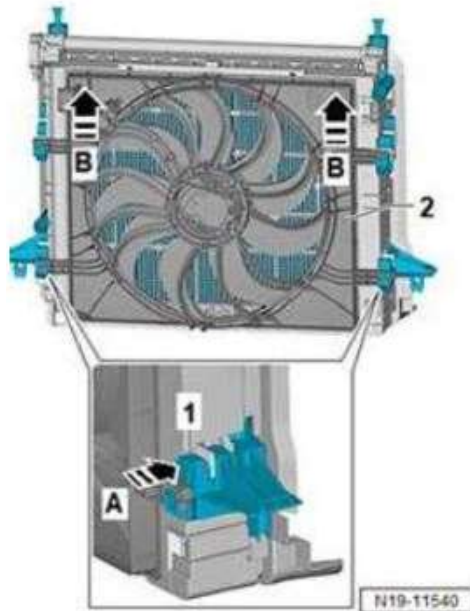
Figure 11. Release the fan module

13. Release the radiator fan module.

Disconnect the connector for the Radiator Fan - VX57 - -arrow-.

Push in the left and right tabs -1- for the fan shroud in the -direction of the arrow A-. (Figure 11)

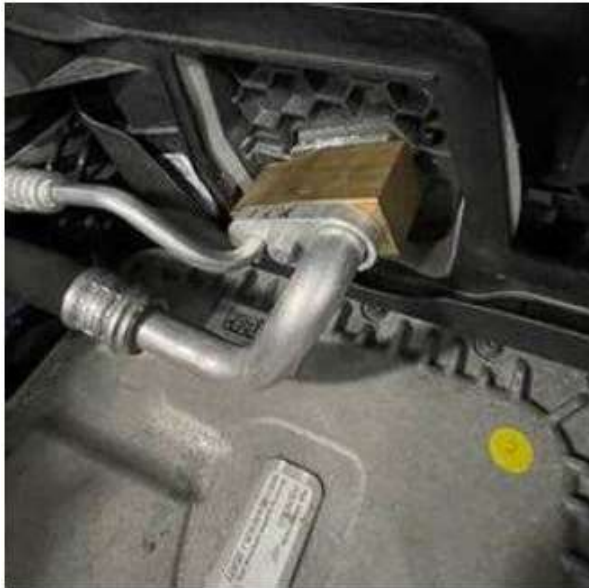
Figure 15. Installation of front expansion valve bypass adaptor VAS 6338/38.

17. Remove expansion valve and install flush plate VAS 6338/38. (Figure 15)

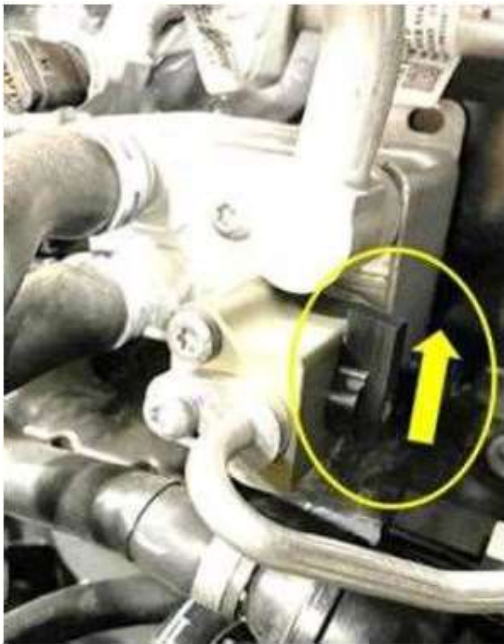
Figure 16. Installation of A/C Line connection block adaptor VAS 6338/80.

18. Remove expansion valve N636 and install adaptor VAS 6338/80 (Figure 16)

At this time place the bypass adaptor in the closed position as shown in Figure 16.

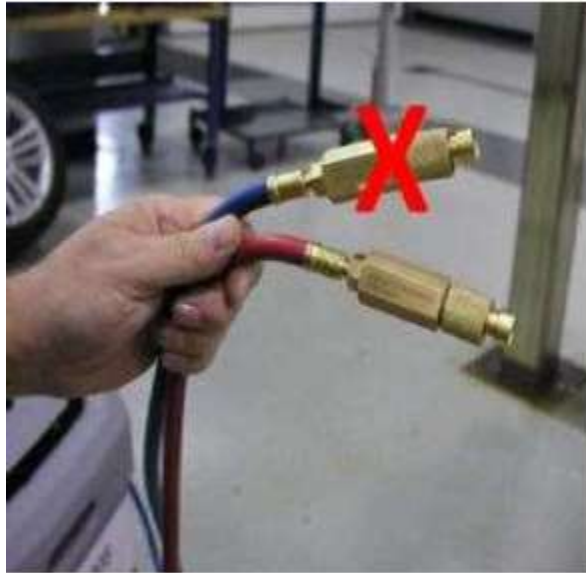
Figure 17. A.C hose adaptor 6338/44.

19. Remove A/C Recovery machine high side coupler from hose.

Install flush adaptor VAS 6338/48 to high side A/C recovery machine hose. (Figure 17)

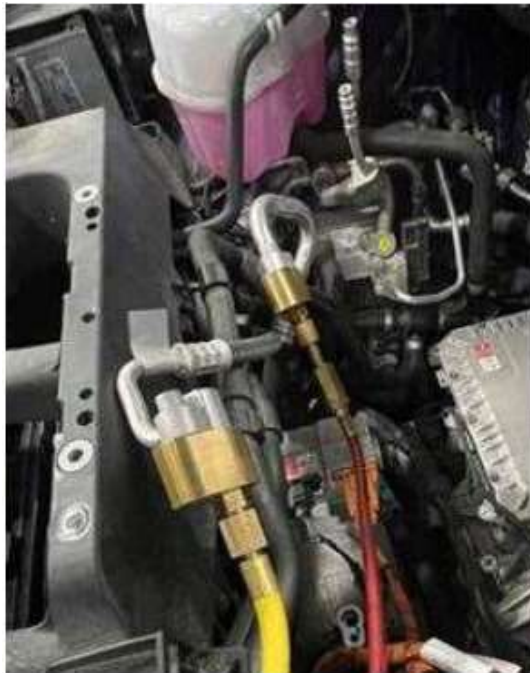
Figure 18. Installation of VAS 6338/3 and 6338/12.

20. Disconnect A/C compressor hoses from the compressor.

Install flush adaptor VAS 6338/3 on the high side compressor hose.

Install flush adaptor VAS 6338/12 on low side compressor hose.

Attach high side A/C Recovery machine hose with VAS 6338/48 fitting to low side compressor hose adaptor VAS 6338/12.

Attach the Yellow recovery tank hose to high side adaptor VAS 6338/3.

(Figure 18)

This connection strategy allows for a system flush in the opposite direction of the normal refrigerant flow.
