STAR ONLINE PUBLICATION

Case Number: S2523000001

Symptom/Vehicle Issue: C00C4-97 And Or C00C5-97 - Rear Radar Module Component Or System Operation Obstructed Or Blocked.

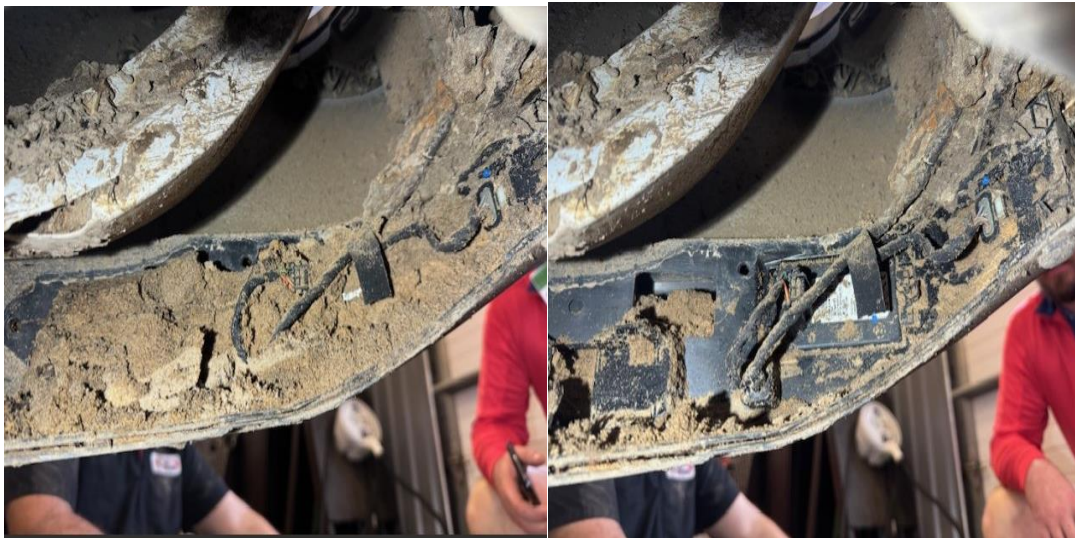
Left Rear Radar Module Shield Removed Showing Dirt Packing Condition.

Discussion: In addition to performing standard diagnostics, it may be necessary to disassemble and clean behind the rear radar(s) shields and attachment brackets. Road debris including mud, dirt, snow and slush could pack around the rear bumper area causing the diagnostic trouble codes (DTCs) C00C4-97 and or C00C5-97 to set. Refer to Service Library 08 - Electrical / 8B - Driver Assistance / Assistance System Components / RADARS / Removal and Installation.
