TECHNICAL SERVICE BULLETIN

24-2444

Illuminated Airbag Warning Indicator Lamp With DTC B0004:1A, B0013:1A, B1405:1A, And/Or B1408:1A Stored In The RCM

Ford 2024 Ranger	Built on 01-Apr-2024 and through 16-Jul-2024
---------------------	--

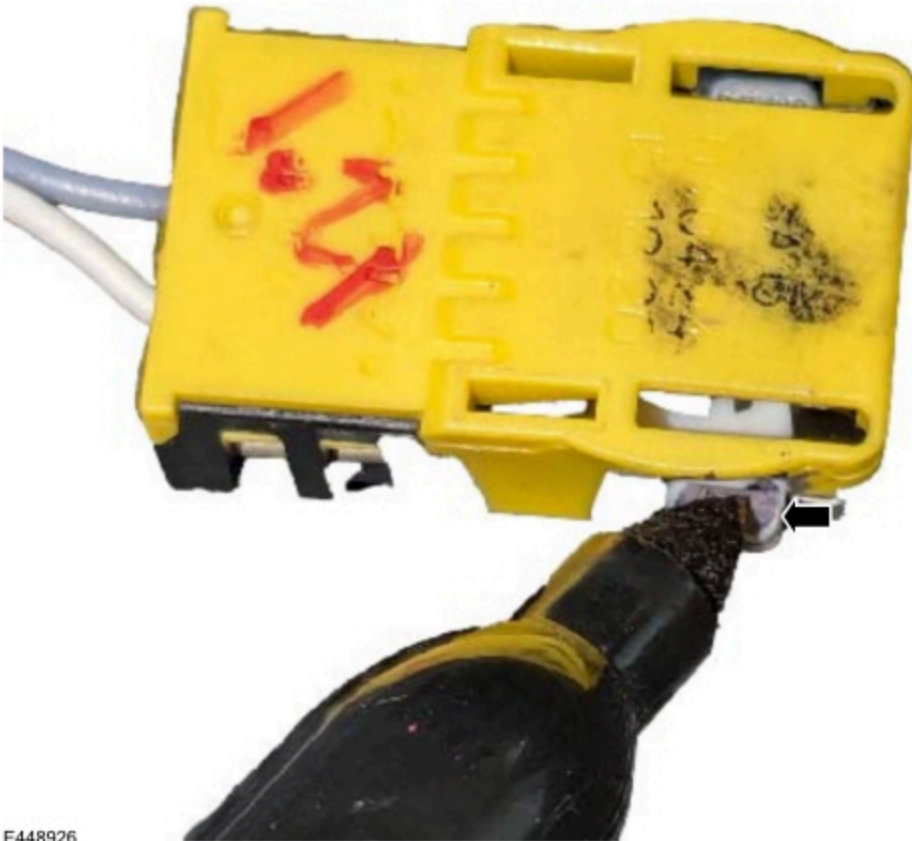
1. Gain access to and disconnect all four of the following airbag connectors: passenger side air curtain connector C9032, driver side air curtain connector C9031, passenger knee airbag connector C2433, driver knee airbag connector C2432. Refer to WSM, Section 501-20B Supplemental Restraint System.
2. On each of the 4 airbag connectors, identify the moulding number on the locking tab. This will be located on the right side ear of the locking tab as shown in Figure 1.

3. Do any of the four locking tabs have the numbers 02, 03, 09, 11 or 14 stamped on them or are any of the connectors damaged?

(1). Yes - replace the affected connector(s) with a service replacement pigtail. Refer to WSM Section 501-20B.

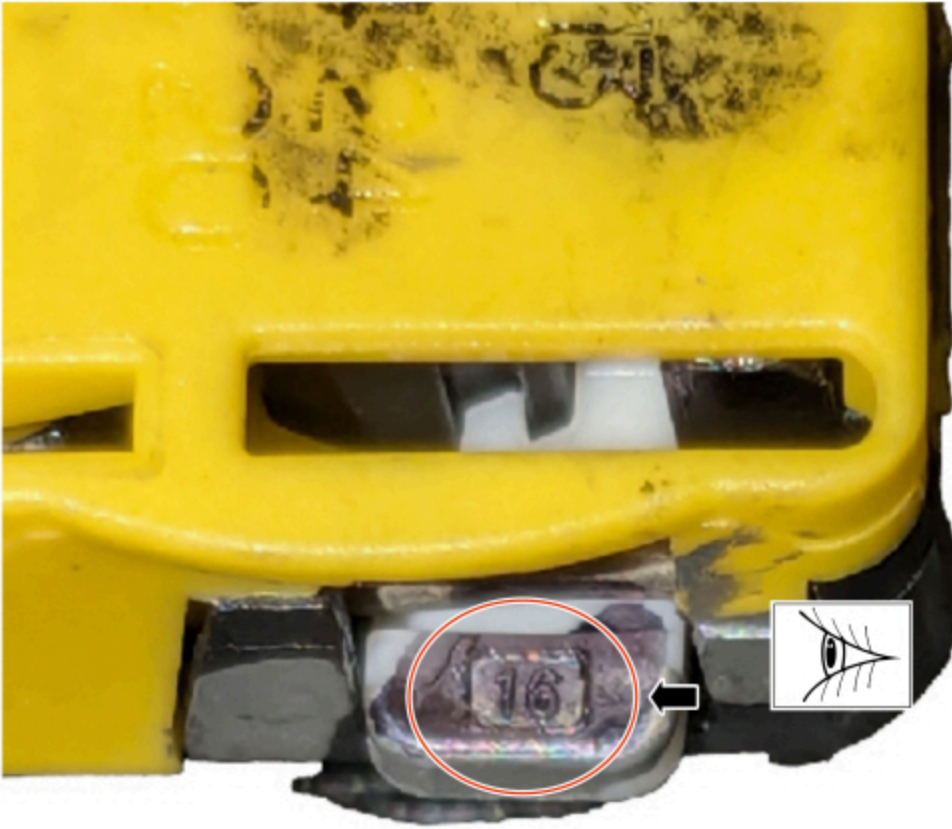
E448927

- (1). Using a black permanent marker, color the locking tab similar to Figure 2. The use of a magnifying glass or quality camera can make it easier to see the number.
