SIB 01 18 24

F3X F90 G20 G3X G12 TCU EMERGENCY BATT EXT LTD WTY (ELW) 6
YRS W/O MILEAGE LIMIT

Component-Specific Extended Limited Warranty (ELW)

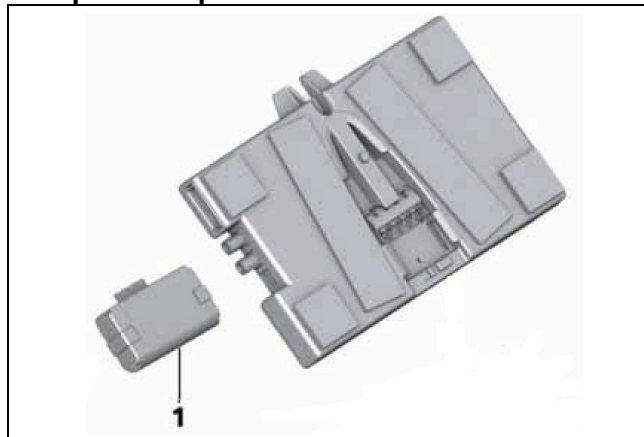
For the eligible vehicles, BMW of North America, LLC (BMW NA) is extending the coverage for the vehicle's **Telematics Control Unit's (TCU) Emergency (Backup) Battery (Item # 1)** to:

The vehicle's Telematics Control Unit's Internal Emergency (Backup) Battery may not meet BMW's operational standards because it may have faulty cells and/or its overall performance in varying outside temperature conditions may be less than what is optimally required.

Should a situation like this occur, it may affect the operation of the vehicle's Telematics system. If that should happen, the vehicle's monitoring system will generate and show the corresponding Check Control Messages (CCM) in the vehicle's display, for example:

If a vehicle listed above arrives at your center with the issue described in this Service Information Bulletin, perform the corresponding diagnosis and when applicable, replace the Telematics Control Unit's internal emergency battery as instructed or as determined by the diagnosis.
