SIB 51 31 24  
REAR SPOILER CLEAR COAT DELAMINATING

## REAR SPOILER CLEAR COAT DELAMINATING

| E-Series | Model Description |
|---|---|
| G30 | 5 Series Sedan |

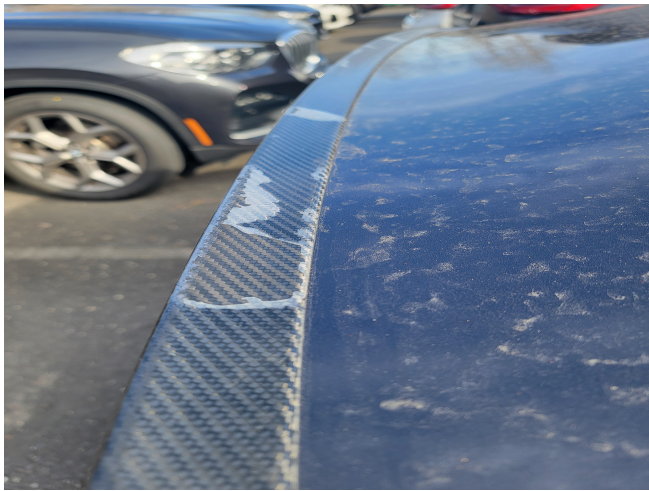
The clear coat on the carbon fiber M Performance rear spoiler is delaminating.

The clear coat did not adhere/bond to the spoiler correctly in the manufacturing process.

Replace the rear spoiler.

1. Verify the customer's concern.
2. Replace the carbon fiber M Performance rear spoiler.
