## Creaking noise on front axle when driving slowly and turning-in slightly

Topic number	LI33.20-P-078406
Version	3
Function group	33.20 - Wheel location, wheel hubs
Date	1/28/25
Validity	Vehicles with bolt in wheel bearing/hubs and vehicles in model series 192 / 232 up to VIN vehicle identification end number:  Model series 192: xxx xxx xx 002 876  Model series 232: xxx xxx xx 022 312  MODEL 166  MODEL 231  MODEL 292  MODEL 222  MODEL 217
Reason for change	Update validity description

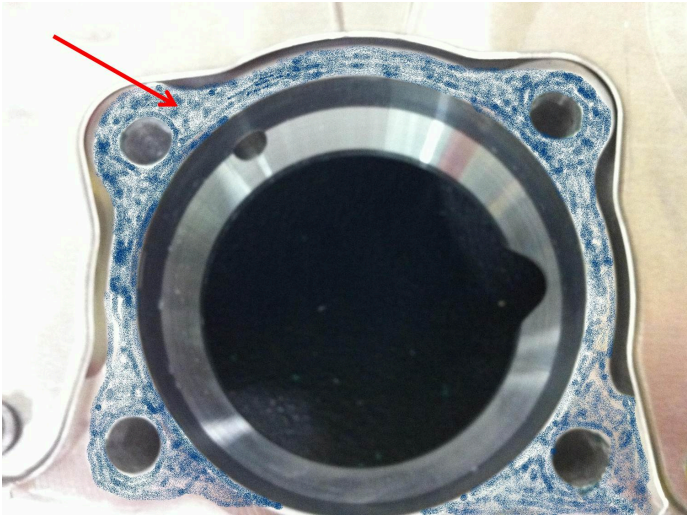
Attachments	
File	Description
<a href="#">2.jpg</a>	Molykote on steering knuckle

1. Clean contact surfaces of wheel bearing and steering knuckle with brake cleaner (see areas marked blue in pictures "2.jpg" and "3.jpg").

3. Thinly coat contact surfaces of wheel bearing, steering knuckle, and axle mating face with Molykote (annular joint grease) (see areas marked blue in pictures "2.jpg" and "3.jpg").
