# TECHNICAL SERVICE BULLETIN

<b>ISSUE DATE:</b>	9/8/2021
<b>SERVICE BULLETIN SUBJECT:</b>	Rooftop Coolant Hose Retrofit
<b>VINs or MODELS AFFECTED:</b>	Service Specified Buses
<b>COMPLETE BY:</b>	Next Service Opportunity
<b>SERVICE BULLETIN #:</b>	SC-21-123
<b>LABOR OPERATION CODE:</b>	CC57Z

## ROOFTOP COOLANT HOSE RETROFIT

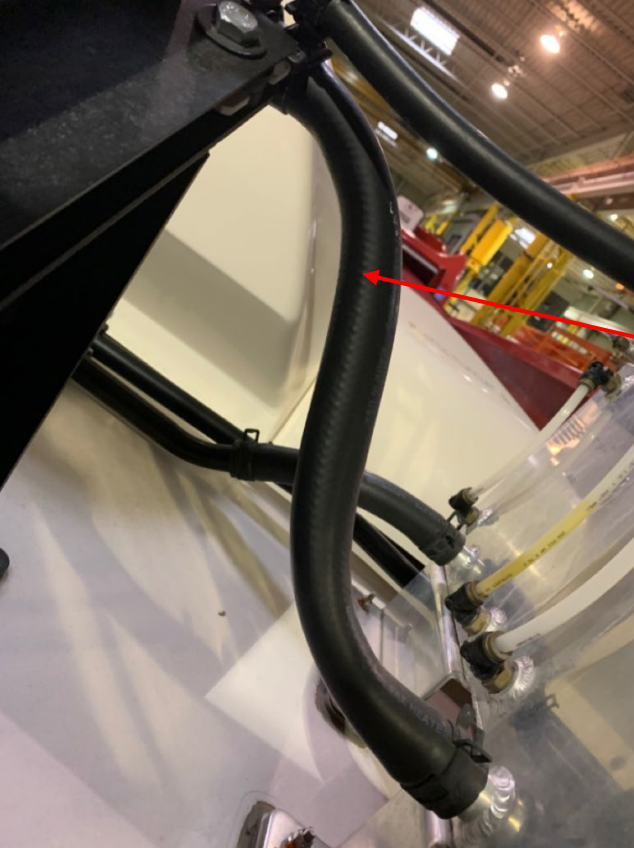
1. Complete the Proterra approved Lockout/Tagout procedure to make the bus safe for work.
2. Follow all the Proterra and Transit Agency specific safety requirements for safely working on top of a bus.
3. Place the Catch Pan below the hose shown in the following photograph. This hose connects the top of the 3-Fan Radiator and the rearmost Expansion tank.

Hose to be  
Removed

4. Using Hose Clamp Pliers, disconnect the top end of the hose shown in the previous photograph.
5. Twist the top end of the removed hose so that the coolant from the Expansion Tank can drain into the Catch Pan.
6. Allow all the Coolant in the Expansion Tank to drain into the Catch Pan.
7. Using Hose Clamp Pliers, remove the clamp from the bottom end of the Hose.
8. Remove the Hose and discard it along with the removed Hose Clamps.
9. Place each of the Worm Drive Hose Clamps (044137) onto the new Hose (038666).
10. Connect the new Hose (038666) to the 3-Fan Radiator and the Expansion Tank.

11. Using a 4mm Ratchet/Socket, secure the Hose (038666) using the Worm Drive Hose Clamps (044137).
12. Remove the Cap from the Expansion Tank.
13. Using a Clean Funnel, return the coolant to the Expansion Tank from the Catch Pan.  
**Note:** If the coolant is contaminated, it must be replaced with new coolant.
14. Replace the Cap on the Expansion Tank.
15. Using Shop Towels, clean up any spilled coolant.
16. Remove the Lockout/Tagout devices and return the bus to service.
