## Weatherstripping Loose or Not Set

Year	Model	Trim Level	VIN Range
2022–25	Civic (4-door)	ALL	2HGFE2F***H500011–2HGFE2F***H548360
2022-25	Civic (5-door)	ALL	19XFL2H***E000028–19XFL2H***E009401

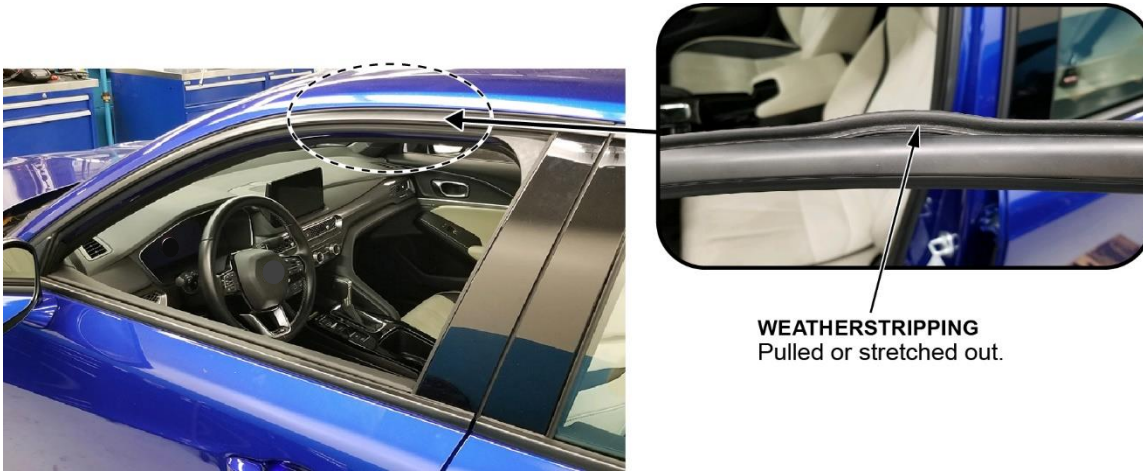
The door weatherstripping is loose or not set at the top of the door frame.

The customer may grab the top of the door sash (to assist while entering and exiting the vehicle) and dislodge the seal.

If the weatherstripping is pulled out of the sash and is undamaged, continue to the REPAIR PROCEDURE section in this bulletin to replace the weatherstripping on all doors.

NOTE: If the weatherstripping is damaged, this procedure does not apply.

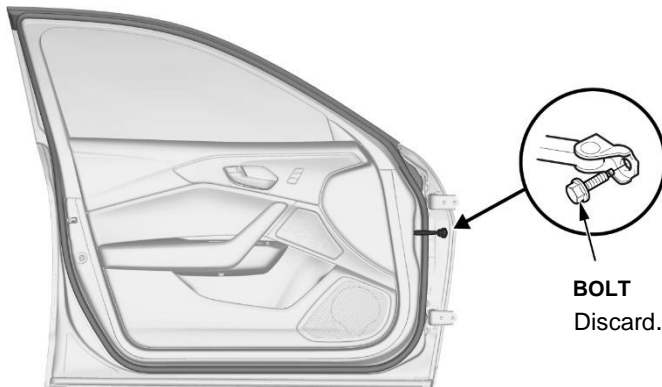
2. Remove the bolt from the door checker. Discard the bolt.

NOTICE: With the door-checker bolt removed, the door can overextend and cause damage to the door. Use care around the door until the new door-checker bolt is installed.

3. Complete the removal of the weatherstripping, then discard it.
4. Starting at the front of the door, install the new weatherstripping in the reverse order of removal.
5. Install the new door-checker bolt then tighten to the specification, **29 N·m (21 lb-ft)**.
6. Clear the weatherstripping contact areas around the door of any dirt or debris.

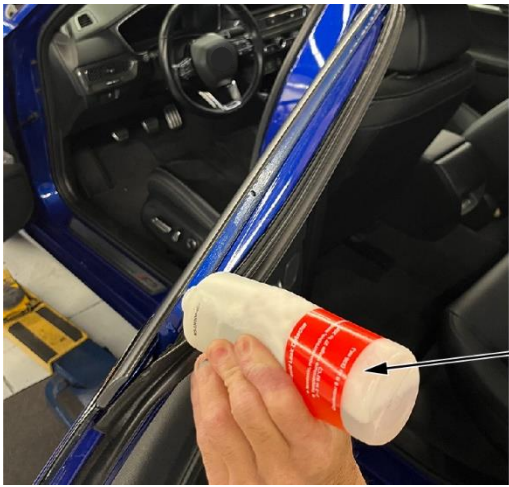
**SOAP AND WATER**  
Place solution in  
channel and on  
weatherstrip.

7. Apply a soap and water solution to the channel on top of the door frame and the weatherstripping to aid installation.

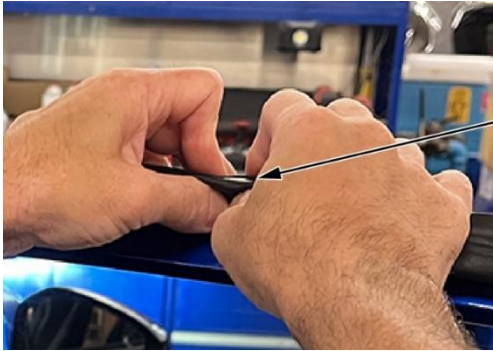
Pinch to aid in placing  
edges into the channel.

8. Install the new weatherstripping starting at the top of the door, then work around the door until the weatherstripping is fully installed.

- If the door checker is in the way of installing the weatherstripping, remove the door checker bolt then continue the REPAIR PROCEDURE at step 4.
- Pinch the weatherstripping to aid in installing its upper and lower edges into the channel of the door frame.

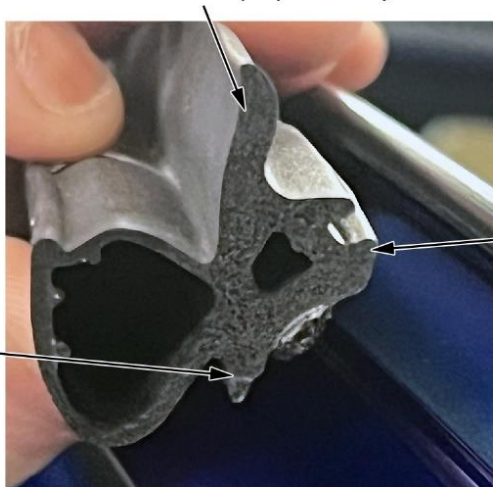
**CROSS-SECTION**  
For illustration purposes only.

**LOWER EDGE**  
Ensure lower edge  
is inside channel.

**UPPER EDGE**  
Ensure upper edge  
is inside channel.

**NOTE:** Ensure both edges of the weatherstripping are firmly installed into the channel of the door frame.

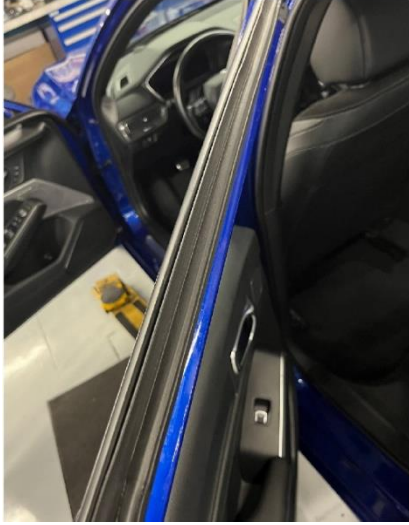
**CORRECT** ✓

NOTE: Be sure the weatherstripping is straight once installed.
