Turbo Compound Inspection/Replacement

Model Years	Models
2022-2025	VN

Volvo Trucks has identified that certain VN model trucks equipped with a D13 Turbo Compound (TC) engine may be at risk of TC unit failure due to an under-torqued idler gear bracket. TC units with the serial numbers listed in the table below are suspected to be affected, which could result in failure and potential engine damage. For impacted vehicles, please refer to the instructions provided below.

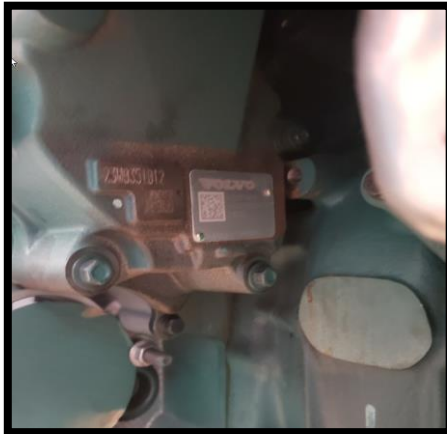
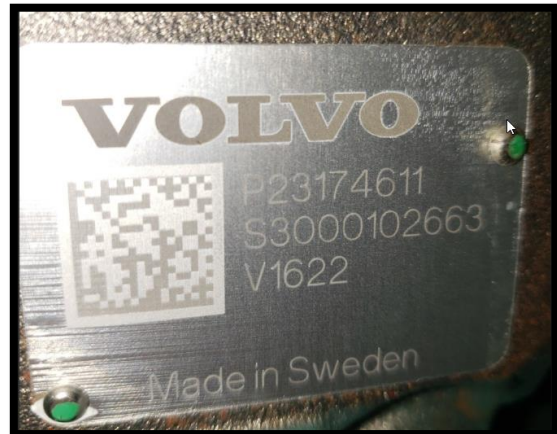
1. Park the vehicle on level surface.
2. Apply the parking brake.
3. Place the gear lever in neutral.
4. Install the wheel chocks.
5. Locate the serial number tag on the lower side of the TC unit.

6. Compare the serial number on the TC unit tag to the listed serial numbers listed above.
 1. If the serial number on the TC unit does not match the listed ones above, no further action is needed, and the truck can be released back into service.
 2. If the serial number on the TC unit is on the list above continue to **step 7**.

7. Follow operation (**2921-03-02-01 Turbo compound, Replacement**) in Impact to replace the TC unit with a new one.
8. After repair is complete return the truck to service.
