# Technical Service Bulletin

<b>Subject:</b>  <b>SEAT WARMER DOES NOT OPERATE WHEN TURNING IGNITION ON WHILE CABIN TEMPERATURE AND/OR SEAT IS WARM</b>	<b>Bulletin No.: 09-005/25</b>
	<b>Last Issued : 01/21/2025</b>

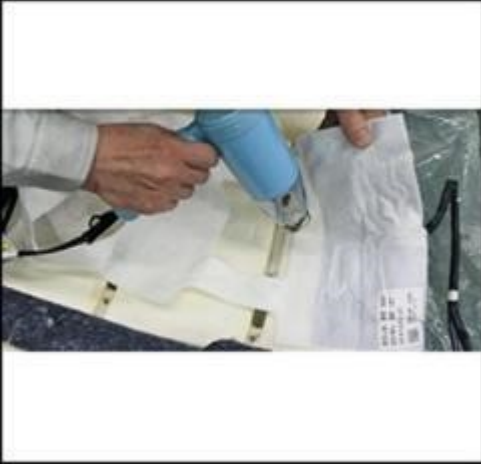
a. Remove the heater mat gently while using a hair dryer or an iron to warm up the adhesive parts (1).

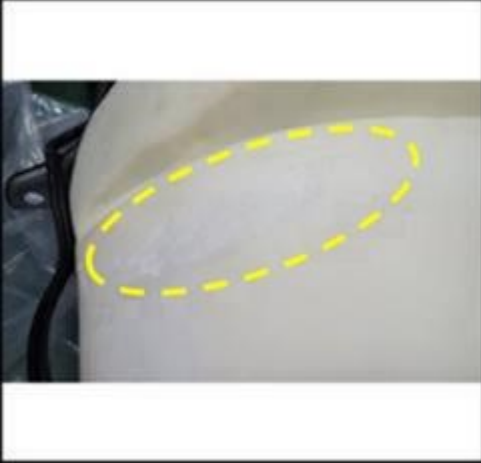
**NOTE:** If the adhesive surface is not warmed up sufficiently, the urethane pad may be damaged (example image below).

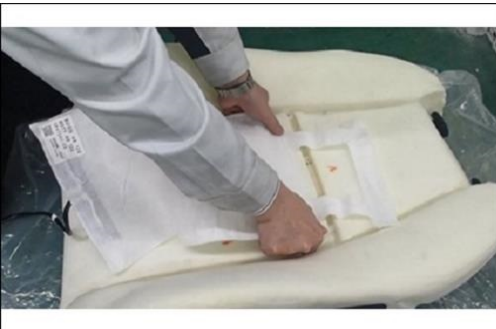
**NOTE:** Location of the markings of the urethane pad

c. Remove the three release papers on the seat warmer unit, and then apply it to the the urethane pad according to the markings on the pad (Refer to the procedure below).

**NOTE:** Align with the seat warmer and the markings on the urethane pad.

**Marking A:** DO NOT cover the marking with the adhesive tape on the seat warmer unit.

**Marking B:** Apply the edge the adhesive tape of the set warmer unit on the marking.
