## INFORMATION BULLETIN

| <b>SERVICE BULLETIN SUBJECT:</b> | TRW Steering Column Lubrication Information Bulletin |
| <b>SERVICE BULLETIN #:</b> | SC-20-148 |

### **TRW STEERING COLUMN LUBRICATION INFORMATION BULLETIN**

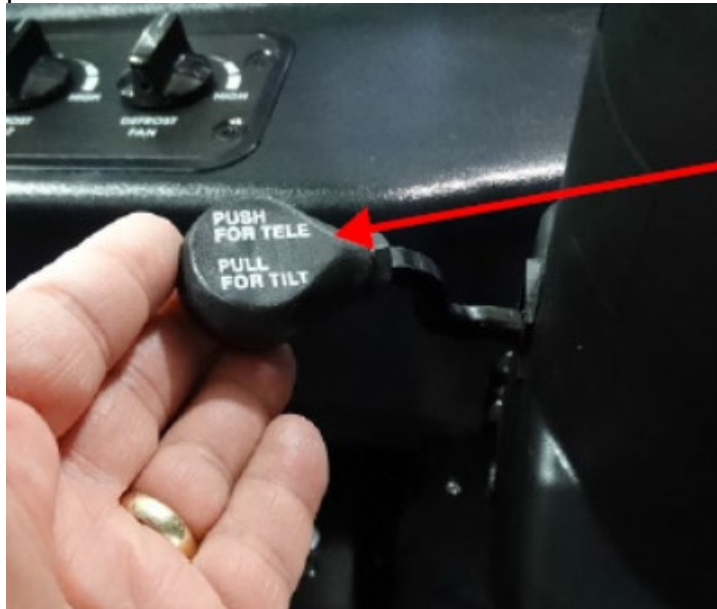
Steering Wheel  
Adjust Lever

1. Complete the Proterra approved Lockout/Tagout procedure to make the bus safe for work.
2. Access the steering column in the Driver's Work Place.
3. Using the steering column controls, fully telescope the steering wheel to its fully extended position.

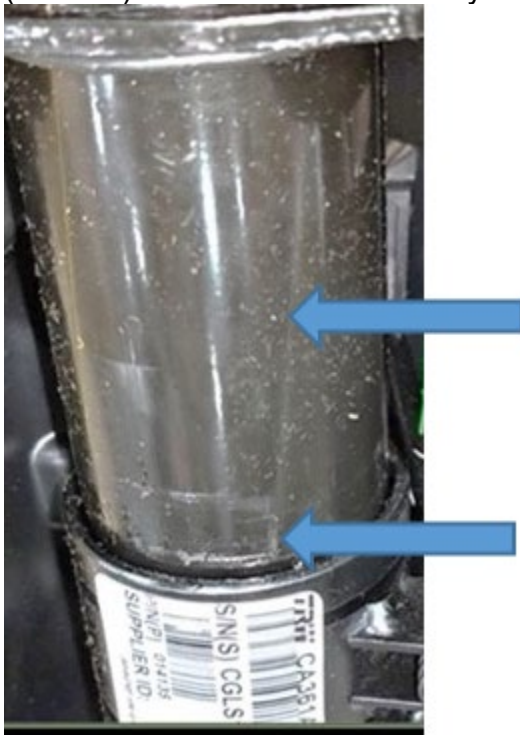
4. Using a T-30 Torx Driver, remove any panels necessary to access the steering column.
5. Using Tri-flow Industrial Lubricant or WD-40 Gel, generously lubricate the Steering Column (014135) in the location shown by the blue arrows.

6. Cycle the steering wheel up and down several times.
7. Repeat the application of the lubricant as necessary until the steering wheel telescopes smoothly and easily.
8. Using Shop Towels, clean up any excess lubricant.
9. Using a T-30 Torx Driver, replace any panels that were removed.
10. Remove the Lockout/Tagout devices and return the bus to service.
