TECHNICAL UPDATE: FUEL TANK FILLER NECK

Models affected: Speed 400, Scrambler 400 X

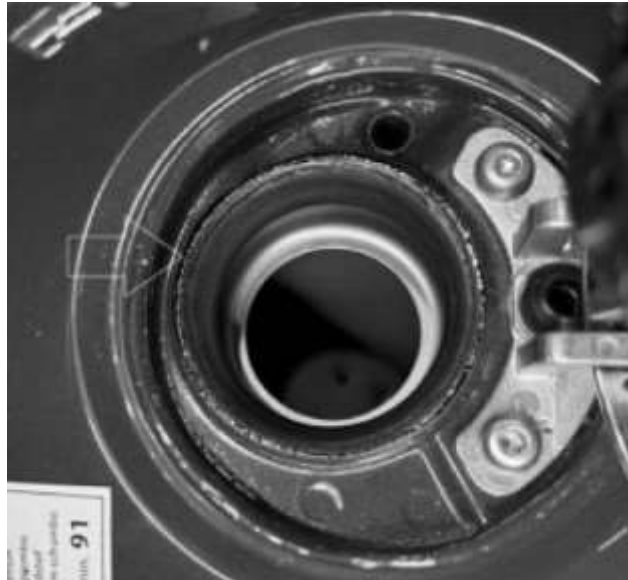
What is the nature of concern? The fuel tank filler neck may appear rusty.

What is Triumph doing? We have investigated the concern and found that the fuel cap seal is leaving a residue which looks like rust, though is not actually rust. A revised seal will be released soon.

What do I need to do? Clean the area and inform customers as necessary.
