STAR ONLINE PUBLICATION

Case Number: S2508000009

Symptom/Vehicle Issue: Flashing Odometer, No Diagnostic Trouble Codes (DTCs)

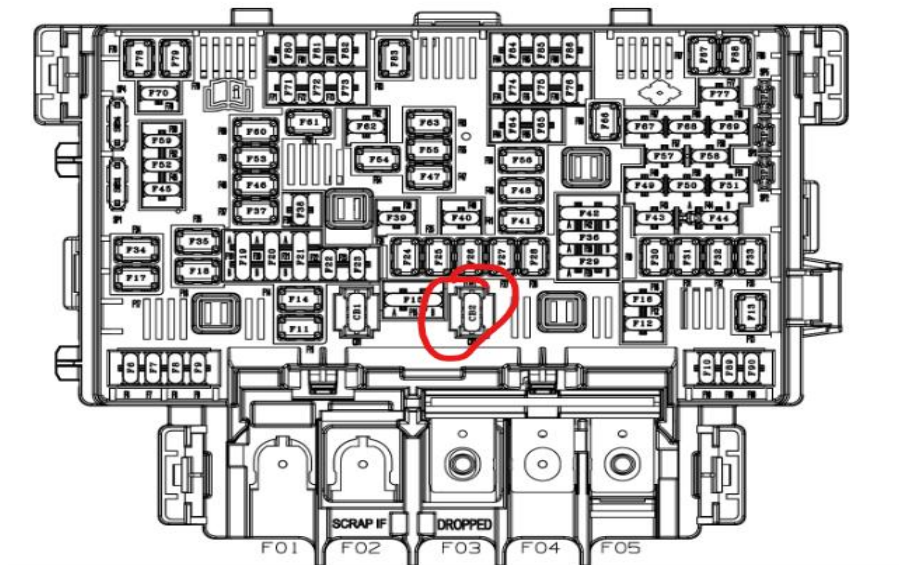
Discussion: Vehicles may exhibit Odometer Flash concern indicating a proxi misalignment or issue with Proxi with other Electronic Control Units (ECUs) misalignments. In some cases, some vehicles may have Fuse CB2 installed in error.

Inspect the rear Power Distribution Center (PDC) for the SPAAK module fuse as highlighted. Remove the fuse CB2 perform a key cycle to confirm if the odometer behavior has been resolved. If no change, use the scan tool to perform the Proxi alignment found in the guided diagnostics folder after the fuse has been removed to complete.
