Campaign No. 2024100008, November 2024

Revision A, February 6, 2025

SUBJECT: **Model AMG GLB 35 (247 platform)**  
**Model Year 2024 – 2025**

## **Replace B-Pillar Identification Label**

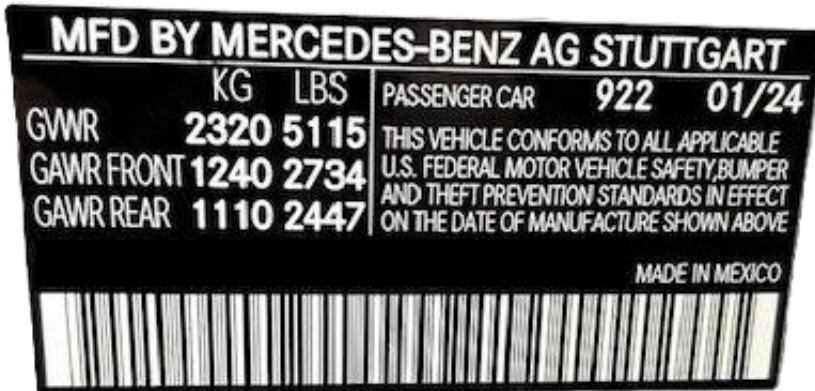
Figure 1 – B-Pillar Identification Plate

Mercedes-Benz AG, the manufacturer of Mercedes-Benz vehicles, has determined that on certain MY 2024-2025 AMG GLB 35 (247 platform) vehicles, the B-pillar identification label might not contain the vehicle's correct rear gross axle weight rating. An authorized Mercedes-Benz dealer will replace the identification label on the B-Pillar.

1. Replace identification plate (**Figure 1**) on driver's side B-pillar.
  -

Lightly heat identification plate with a commercially available heat gun.
  -

Carefully remove identification plate with a suitable aid.
  -

Utilize long wedge (W115 589 03 59 00) or a comparable non-marring plastic wedge.
  -

Clean bonding surface with alcohol based cleaner to remove residual adhesive.
