SIB 77 02 25

SERVICE SOLUTION: R 1300 GS Adventure Luggage Stains

Model	Model Description
KA2	R 1300 GS Adventure

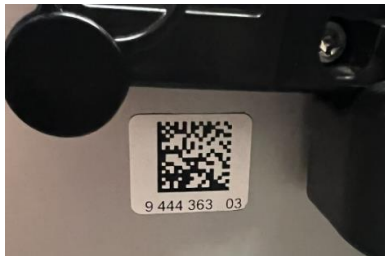
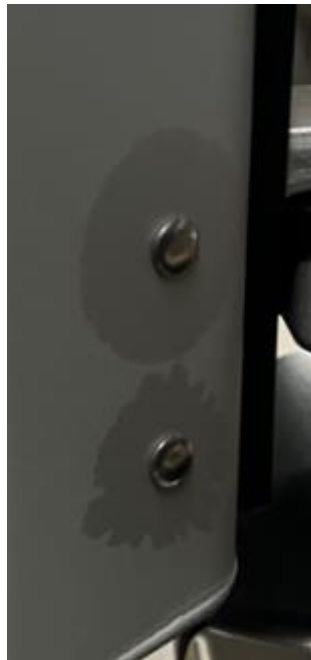
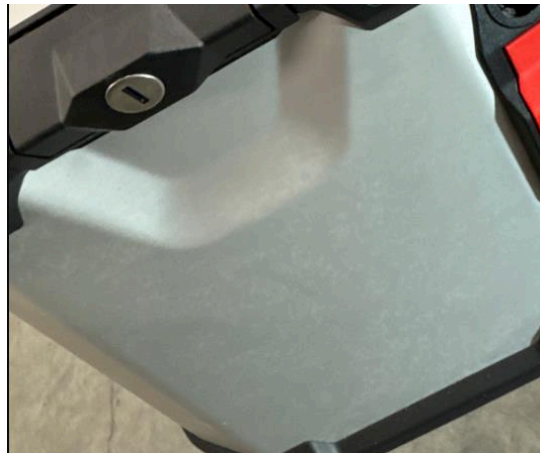
There are stains on the surface of the luggage caused by the heat treating and anodizing surfaces.

For any complaint submit a TSARA case with pictures of the complaint and QR code for quality purposes. (Examples below).

Then clean the surface of the luggage with an acid free and alkali free cleaner. (e.g. WD-40)
