## eP4/eM2 Compressor Discharge Line Freeze-Up

Service Bulletin TSB-13-007-FTL

Publish Date: 12/18/2024

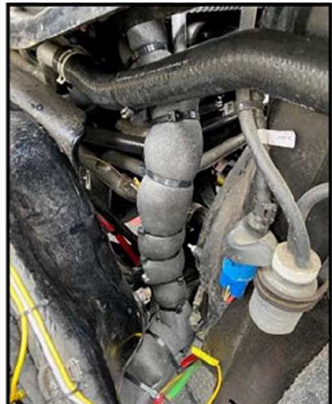
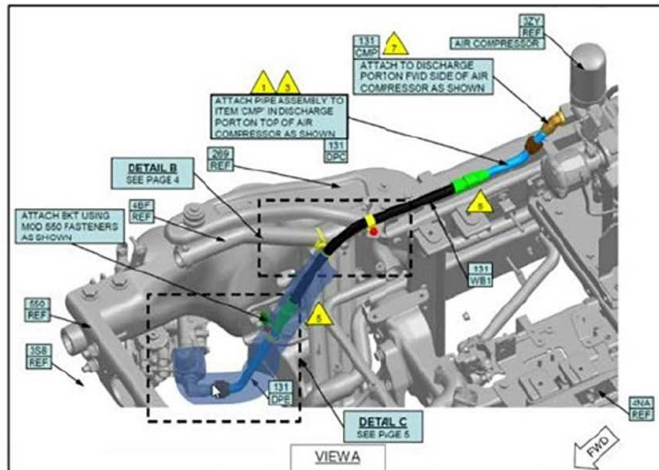
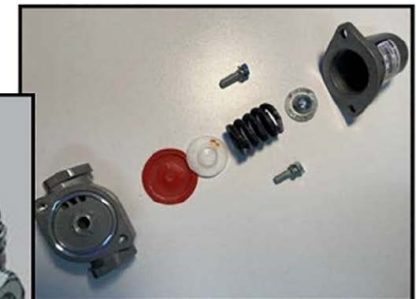
- Air compressor stops building air due to ice blockage at discharge line overflow valve.
- When discharge line becomes blocked, air compressor relieves pressure through relief valve on housing and sprays compressor oil
- Occurs in high-humidity near (+/-) freezing environmental conditions

- Moisture accumulates in spring chamber of overflow valve, then freezes, disabling valve
- Original theory was ice blockage in the air stream but this has been proven untrue

- Splash cover will be added in production mid-2025

- Service Bulletin TSB-13-007-FTL with instructions for thawing valve and installing insulation
- Service Bulletin will be revised when splash cover becomes available.
