## STAR ONLINE PUBLICATION

**Case Number:** S2523000016

**Symptom/Vehicle Issue:** Replacement Exterior Mirror Glass Connector Does Not Match For Blind Spot.

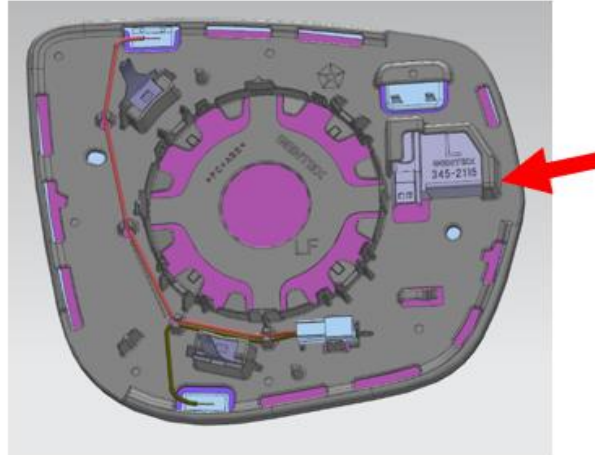
**Repair:** Remove the exterior mirror glass from the door mirror assembly. Compare the connections to the images below. Fig 1 shows an early design mirror that will require the adapter jumper harness. Fig 2 shows the new mirror glass design that does not require an adapter jumper harness.

Fig 1.  
Early Mirror Glass Design  
Requires Adapter Jumper Harness When Installing New Design Mirror Glass.

**Part Information:** Jumper Part number:68674587AA.

- If you have an old mirror and need replacement glass (Fig 1) – order a service glass + a jumper to allow a connection to the old mirror wiring. Jumper 68674587AA
- If you have a new mirror that needs replacement glass (Fig 2) – order a service glass only - no jumper needed.

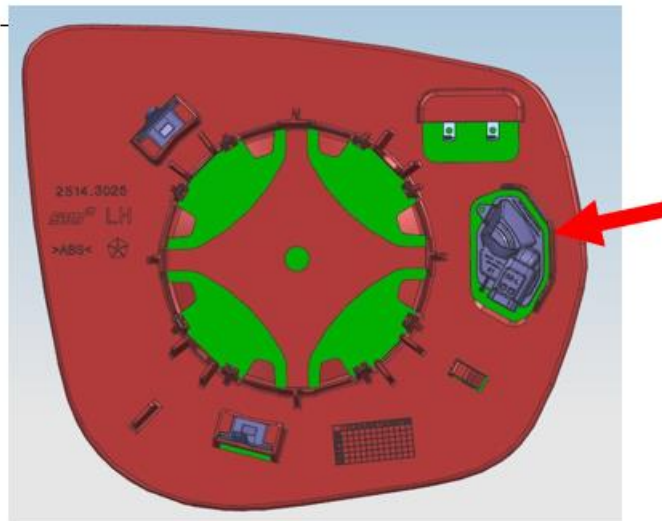
Fig 2.  
New Mirror Glass Design  
Adapter Jumper Not Needed.
