Vermeer MV Solutions, Inc.

FIELD CAMPAIGN SERVICE BULLETIN #: SMV2025-006

Debris Tank Door
Retention Clip
Replacement Kit
(VMV000097)

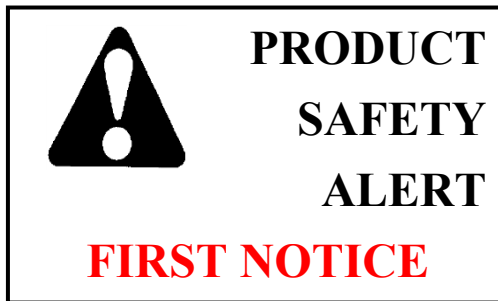
Debris tank door lift cylinder retention clip can become displaced during operation and the tank door may fall.

VMV000097 has been created to provide the necessary parts and instructions to update the retention clip. **The kit must be installed as soon as possible.**
