Warning Message “Coolant Temperature Too High”: Checking Coolant Pump and Change-Over Valve (173/21)

Model Line: **Macan S (95B) / Macan GTS (95B) / Macan Turbo (95B)
Cayenne (9YA / 9YB)**

Concerns: **Change-over valve for coolant pump**

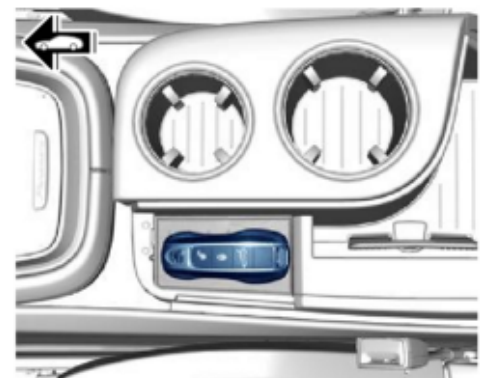
Emergency start tray (Exemplary illustration)

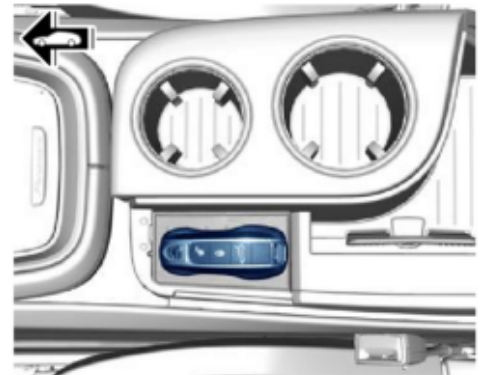
Emergency start tray (Exemplary illustration)

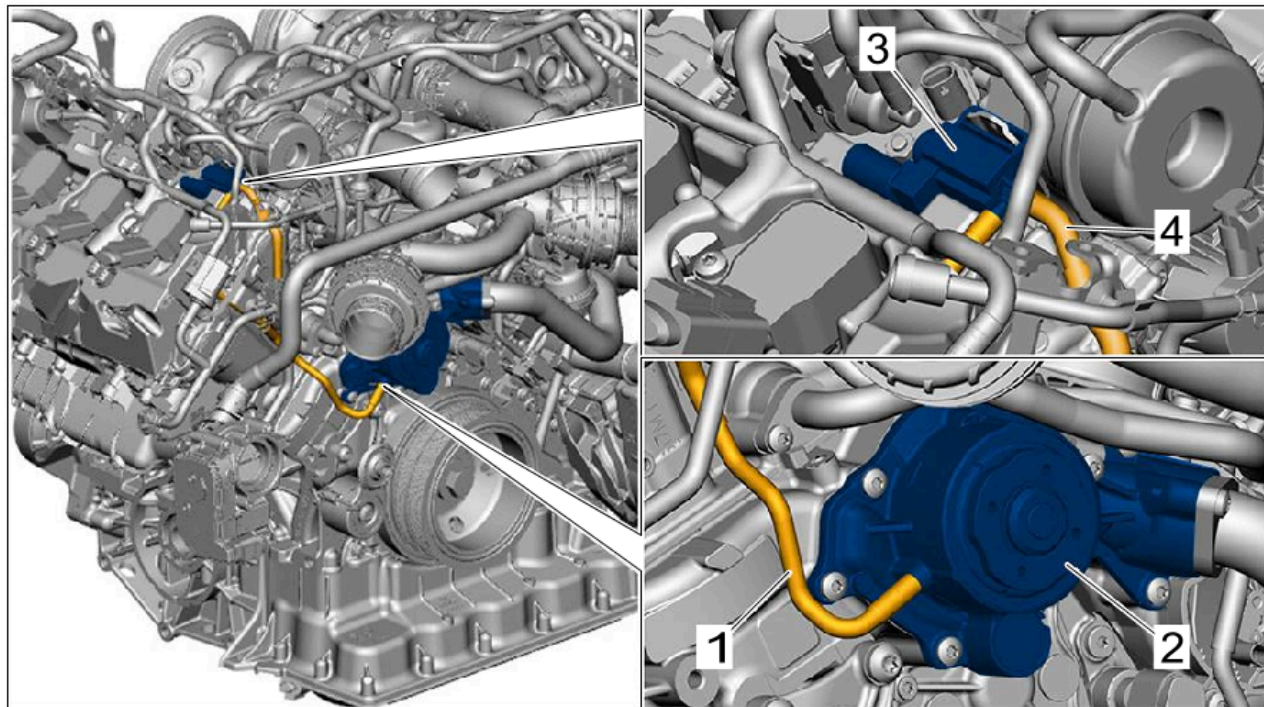
Position of change-over valve and coolant pump

- 1 Pull vacuum hose ⇒ *Position of change-over valve and coolant pump -1-* off the coolant pump ⇒ *Position of change-over valve and coolant pump -2-*.
- 2 Pull off vacuum hose ⇒ *Position of change-over valve and coolant pump -4-* from the control valve ⇒ *Position of change-over valve and coolant pump -3-*.
- 3 **VAS 6213 - Hand vacuum pump** must be ⇒ *Position of change-over valve and coolant pump -3-* connected to the change-over valve ⇒ *Position of change-over valve and coolant pump -4-* on the vacuum hose connection. Then build up vacuum.

Stop the test procedure if a vacuum cannot be built up. In this case, the change-over valve is faulty and must be replaced. Continue with Step 5. If a vacuum can be built up, continue with Step 4.

- 4.2 Select the "**Drive links/checks**" menu.
- 4.3 Select "**Drive links**" and press **F12** Next to confirm.
- 4.4 Select "**Activation of vacuum switchover valve for main coolant pump**" and press **F8** to start.
 - If the vacuum in the vacuum pump display changes, the change-over valve ⇒ *Position of change-over valve and coolant pump -3-* is intact. Continue with Step 5. In this case, only ⇒ *Position of change-over valve and coolant pump -2-* replace the coolant pump if it is faulty.
 - If the vacuum in the vacuum pump display does not change, the change-over valve ⇒ *Position of change-over valve and coolant pump -3-* and, if necessary, the coolant pump ⇒ *Position of change-over valve and coolant pump -2-* must be replaced, if the coolant pump is ⇒ *Position of change-over valve and coolant pump -2-* also faulty.

⇒ *Workshop Manual '195019 Removing and installing coolant pump (V6 biturbo)'*
- 5 Disconnect **VAS 6213 - hand vacuum pump** from the vacuum hose ⇒ *Position of change-over valve and coolant pump -1-*.
- 6 Install vacuum hose ⇒ *Position of change-over valve and coolant pump -1-* on coolant pump ⇒ *Position of change-over valve and coolant pump -2-*.

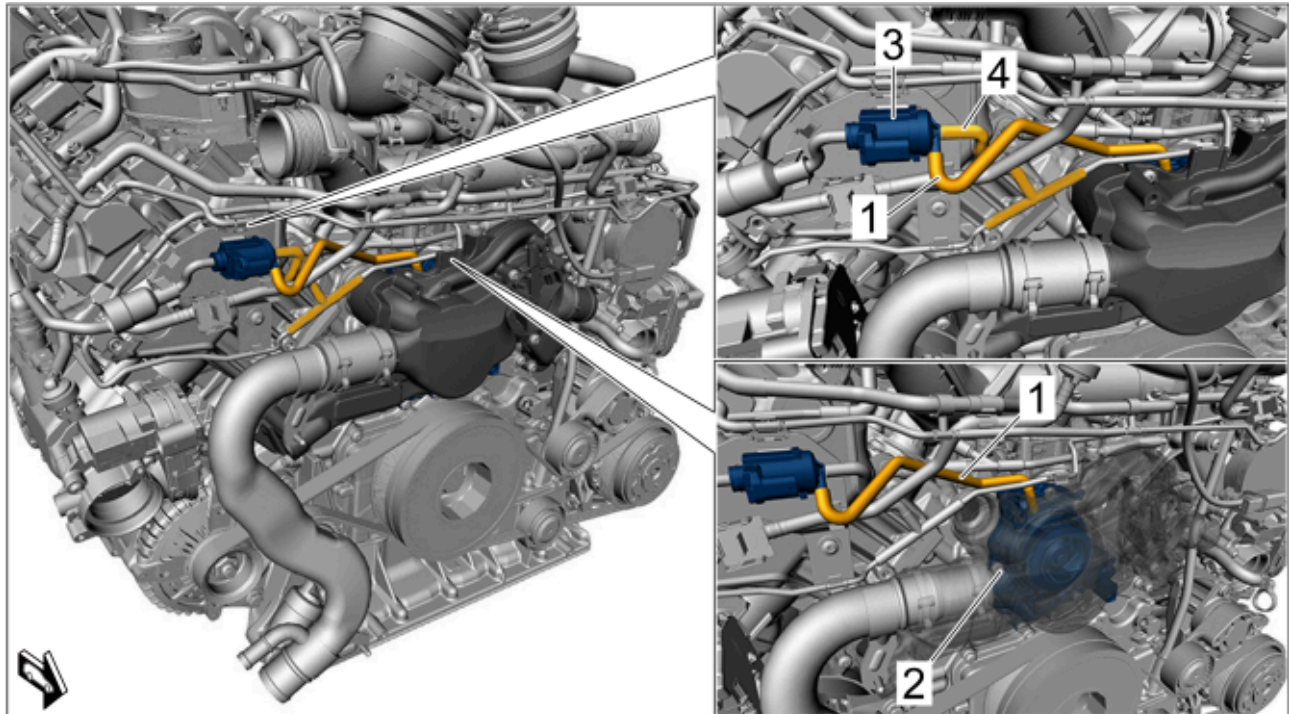
Position of change-over valve and coolant pump

- 1 Pull vacuum hose ⇒ *Position of change-over valve and coolant pump -1-* off the coolant pump ⇒ *Position of change-over valve and coolant pump -2-*.
- 2 Pull off vacuum hose ⇒ *Position of change-over valve and coolant pump -4-* from the control valve ⇒ *Position of change-over valve and coolant pump -3-*.
- 3 **VAS 6213 - Hand vacuum pump** must be ⇒ *Position of change-over valve and coolant pump -3-* connected to the change-over valve ⇒ *Position of change-over valve and coolant pump -4-* on the vacuum hose connection. Then build up vacuum.

Stop the test procedure if a vacuum cannot be built up. In this case, the change-over valve is faulty and must be replaced. Continue with Step 5. If a vacuum can be built up, continue with Step 4.

- If the vacuum in the vacuum pump display changes, the change-over valve ⇒ *Position of change-over valve and coolant pump -3-* is intact. Continue with Step 5. In this case, only ⇒ *Position of change-over valve and coolant pump -2-* replace the coolant pump if it is faulty.

- If the vacuum in the vacuum pump display does not change, the change-over valve ⇒ *Position of change-over valve and coolant pump -3-* and, if necessary, the coolant pump ⇒ *Position of change-over valve and coolant pump -2-* must be replaced, if the coolant pump is ⇒ *Position of change-over valve and coolant pump -2-* also faulty.

- ⇒ *Workshop Manual '195019 Removing and installing coolant pump (V8 Biturbo)'*
- 5 Disconnect **VAS 6213 - hand vacuum pump** from the vacuum hose ⇒ *Position of change-over valve and coolant pump -1-*.

- 6 Install vacuum hose ⇒ *Position of change-over valve and coolant pump -1-* on coolant pump ⇒ *Position of change-over valve and coolant pump -2-*.
