Cayenne (E3.I) - GTS & Turbo Low Fuel Pressure

Vehicles Affected

Models	Model Year	Model Type	VIN Range	Vehicle-Specific Equipment
Cayenne	2021	9YABG1 9YACF1 9YBBG1 9YBCF1	N/A	N/A

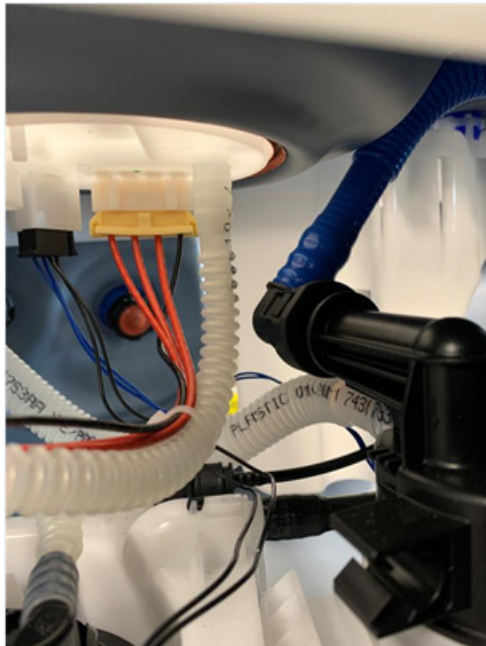
Figure 1

These faults can result from the low-pressure fuel system operating outside its pressure tolerances. In the 3D model, there is a clearance of approximately 19 mm (See Figure 1). It is possible for the component to vibrate over time, which could lead to the fuel line to be damaged, causing a leak in the fuel line (See Figure 2).

In cases with the above mentioned faults, please replace the low pressure fuel pump in accordance with the information in the table below.

Part	Part number	Workshop Manual
Low-Pressure Fuel Pump	PAB919087G	WM, 206619 Removing and installing fuel pump
