**Cayenne (E3.I) - GTS & Turbo Low Fuel Pressure**

**Vehicles Affected**

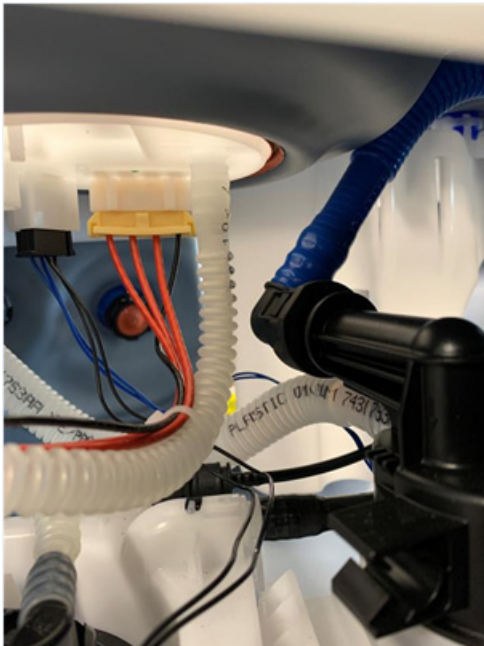
**Figure 1**

These faults can result from the low-pressure fuel system operating outside its pressure tolerances. In the 3D model, there is a clearance of approximately 19 mm (See Figure 1). It is possible for the component to vibrate over time, which could lead to the fuel line to be damaged, causing a leak in the fuel line (See Figure 2).

In cases with the above mentioned faults, please replace the low pressure fuel pump in accordance with the information in the table below.
