Ember ‘Congoleum’ Repair Instructions

This document outlines the procedure to repair the linoleum floor according to Ember quality standards.

Procedure: Patch

Procedure: Full Replacement

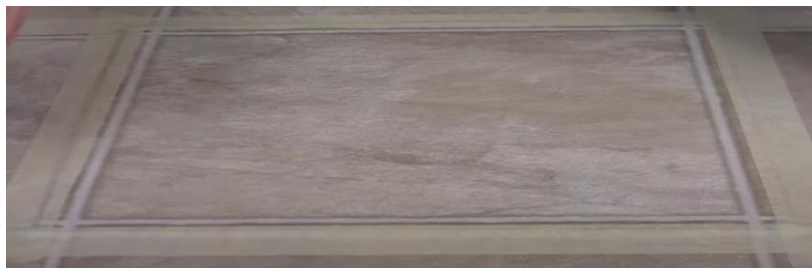
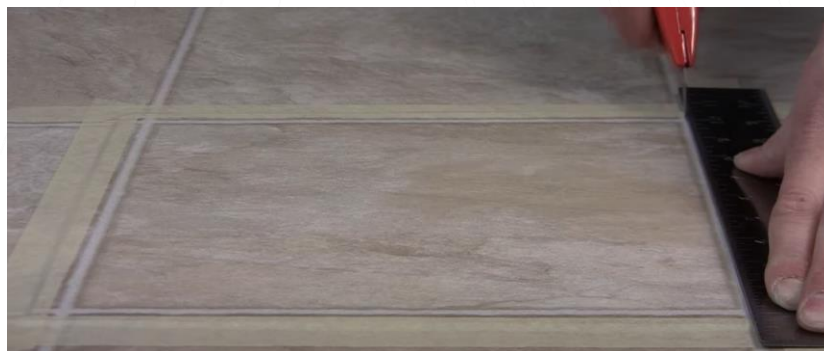
2. Secure the replacement linoleum with tape over the damaged area. Using a straight edge and utility knife cut through both layers around all four sides; be sure to have the blade perpendicular to the floor's surface.

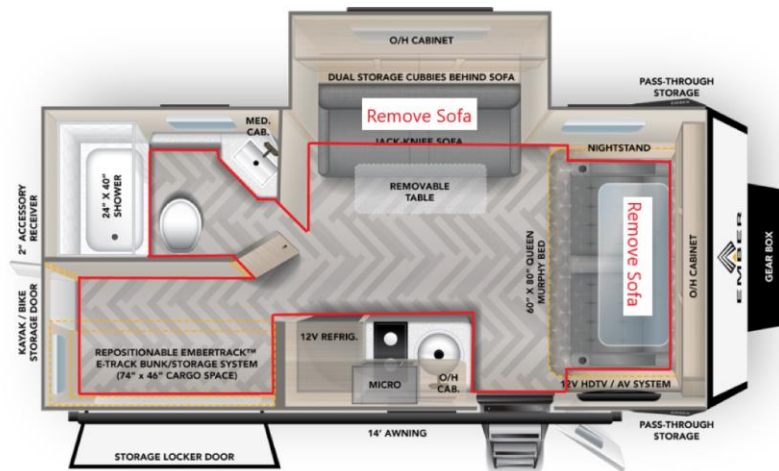
1. Remove the sofa, steps, and other furniture that is on the floor; do not remove cabinets, interior walls, or shower pan.
2. Using a utility knife remove the damaged linoleum by cutting around the cabinets.
Note: You will use the damaged linoleum as a template for the replacement linoleum.

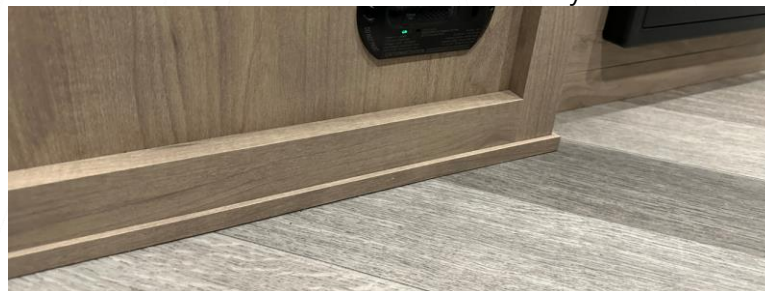
3. Clean the subfloor thoroughly and allow it to dry completely.
4. In an open area, lay the damaged linoleum over the replacement linoleum. Using a pencil trace pattern onto the replacement linoleum. Do not use a sharpie marker as it will stain and seep through the material.
5. Using heavy-duty scissors or a utility knife cut the replacement linoleum pattern.
7. Install replacement linoleum onto the subfloor and secure it with Air Step Adhesive around the floor openings. Use a small hand roller to embed the linoleum into the adhesive. Ensure the subfloor is dry before installation.
6. Use 1/2" batten trim around cabinet areas for extra security.
